Mixed Metals Impact on Reliability

Nextek Incorporated

APEX EXPO 2013

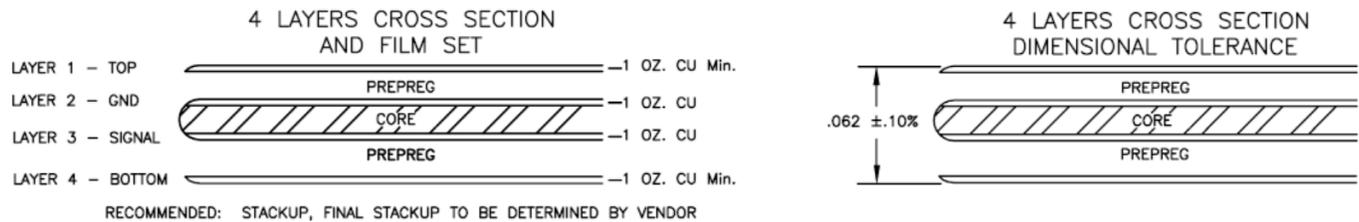
Figure 1 – PCB Stackup

PCB was designed in-house in order to accommodate all of the test requirements. The design was built with lead free compatible laminate meeting the IPC- 4101/26 requirements. The PCB was 4.0 x 3.0 x 0.062 thick and 4 layers with immersion silver finish. Figure 1 and Figure 2.

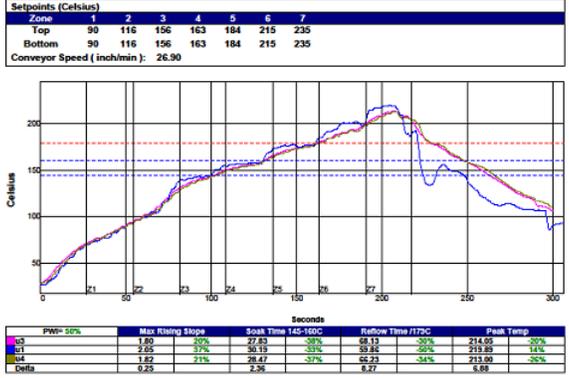
Figure 3 – Profile 1

The PCA's were reflowed in a 7-Zone, forced convection, nitrogen purged reflow oven. Three reflow profiles were used in the experiment. Profile 1 was a linear ramp reflow profile for leaded solder, peak ~ 220C, time above liquidus ~ 60 sec. Profile 2 was a modified version of profile 1, peak ~ 235C, time above liquidus ~ 110 sec. Profile 3 was a linear ramp profile, peak ~ 245C, time above liquidus ~ 60 sec.

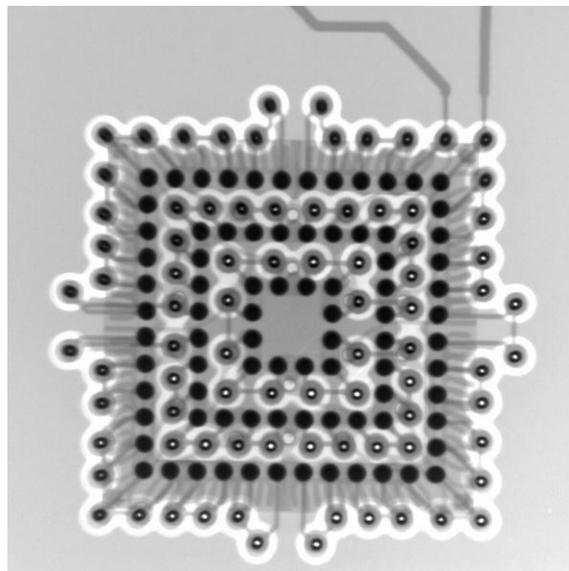
Figure 6 – U1 X-Ray After Reflow

All of the test assemblies were built in one consecutive run. Printing and solder paste inspection were performed on the production line and placement was performed on high speed modular placement platforms with +/- 30 micron accuracy. After reflow the parts were inspected 100% with X-Ray to verify no shorts or excessive voiding was present. Figure 6-9 are representative samples of the devices after reflow.

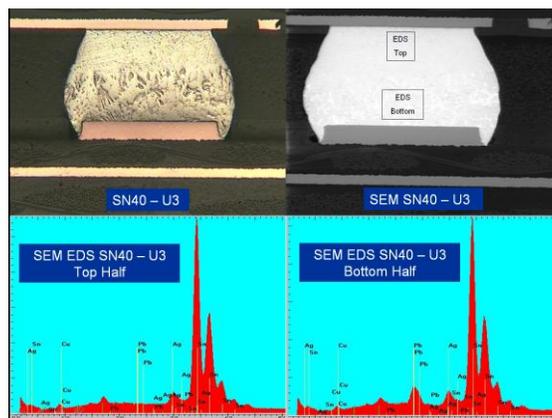
Figure 14 – Group 6

Scanning Electron Microscope (SEM) was used with Energy Dispersive Spectrometer (EDS) to determine the elemental makeup of the solder at two separate locations in each sample. Samples from groups 5 and 8 had only one alloy type involved in the solder matrix and were used as control groups. The EDS spectrum pulled for group 6 showed that the leaded solder at the circuit card did not alloy uniformly with the lead free solder ball when reflowed at 220C, see figure 14.

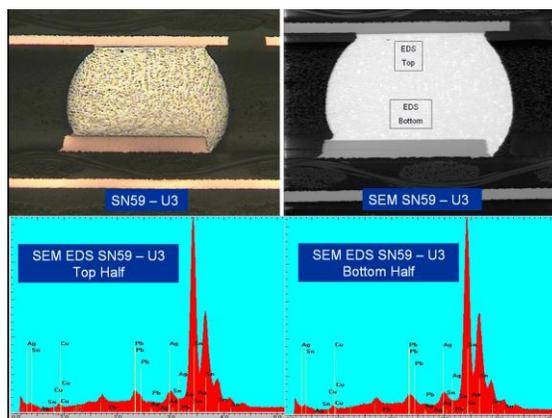
Figure 15 – Group 7

Group 7 which was the same as group 6, leaded solder with lead free solder balls but reflowed at 235C, showed uniform grain structure and alloying of the two solders, see figure 15.

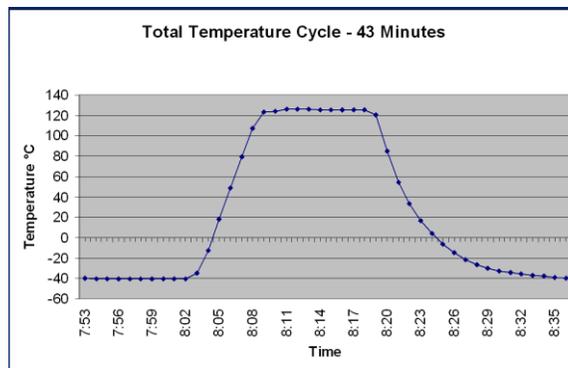
Figure 18 – Total Temperature Cycle

Temperature cycling of all groups was performed over a one year period with testing of each coupon being performed at 100 cycle intervals. Test parameters were -40C to +125C with 10 minute dwell at each extreme. Ramp rates positive and negative were not specified but were as fast as the equipment could make the transitions which turned out to be .393C/sec on the positive slope and .145C/sec on the negative slope, see figure 12, 13. The total cycle time for each cycle was about 43 minutes, see figure 18.

Total Temperature Cycle - 43 Minutes

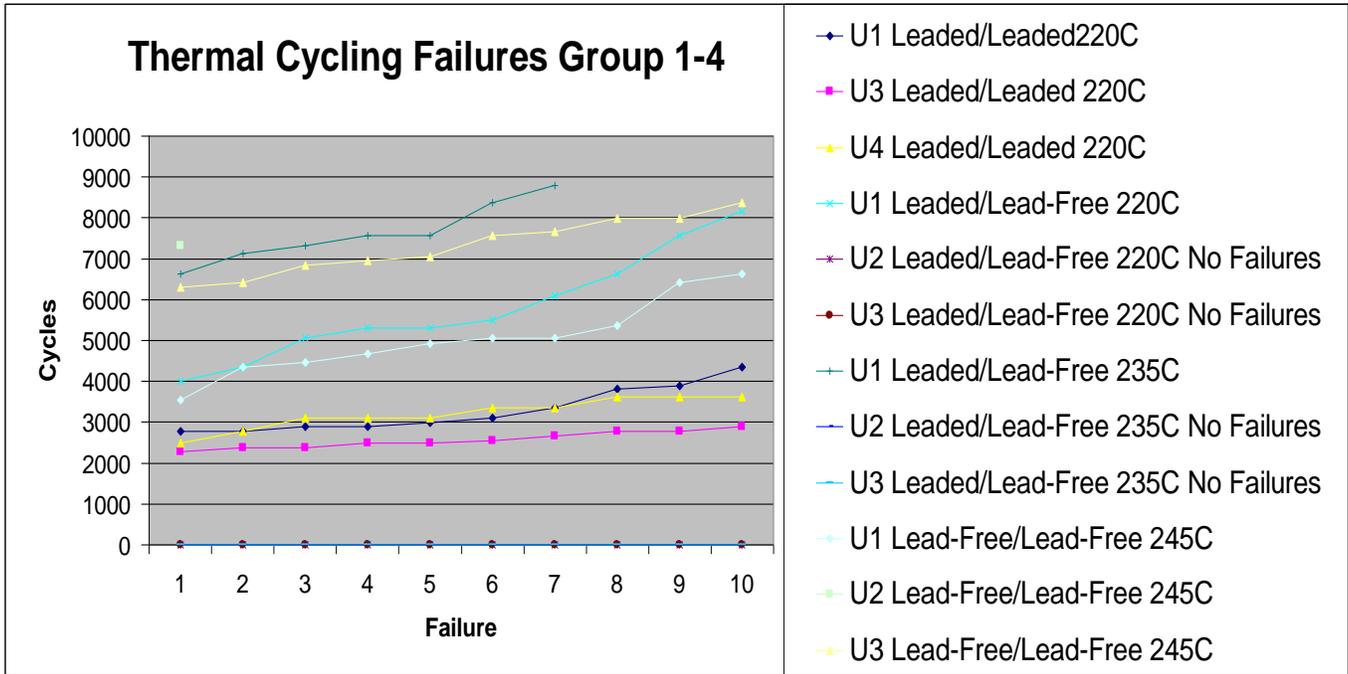
Figure 19 –Temperature Cycle Failure Data

Failures were cataloged as they occurred and the failed component was pulled from the test coupon for cross section analysis and validation. Non-underfilled devices were evaluated first by component type/pitch; figure 19 details all of the failures.

As you can see from this data there were many of the devices that did not fail or had only one failure. In Group 1, Leaded/Leaded at 220C, there were 100% failures starting at 2285 cycles and ending by 4345 cycles. In Group 2, Leaded/Lead-Free at 220C, the U1 device had 100% failures starting at 4013 cycles and finishing at 8164 cycles. There were no failures in group 2 for U2 or U3. Group 3, Leaded/Lead-Free at 235C, had 7 failures at U1 from 6631 cycles to the 7th failure at 8786 cycles. Three of the U1 devices in group 3 did not fail by the end of the testing and no failures occurred at U2 or U3. Group 4 Lead-Free/Lead-Free at 245C, had 100% failures at U1 3552 to 6631 cycles and at U3 6312 to 8378 cycles but only had one failure at U2 which occurred at 7323 cycles. Breaking out the failures by device gives us a better view of how the different groups performed by pitch of the device. Figure 16 shows U1 failure data across groups 1 to 4. Figure 20 and 21 shows failure data for the U2/4 device and the U3 device respectively.

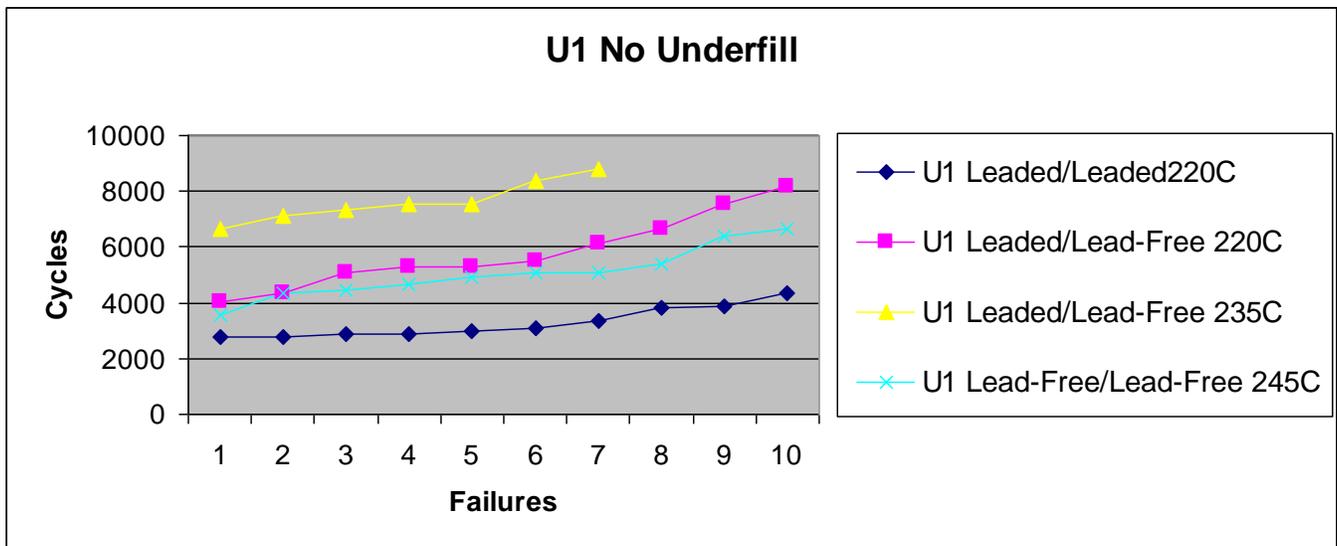
Figure 20 – U1 Failure Data

In the case of U1 it is clear that when mixing leaded and lead-free the best performance was achieved by reflowing at the 235C temperature. It is also interesting that the mixed metals soldered at 220C out performed the two control group samples.

In the case of U1 it is clear that when mixing leaded and lead-free the best performance was achieved by reflowing at the 235C temperature. It is also interesting that the mixed metals soldered at 220C out performed the two control group samples.

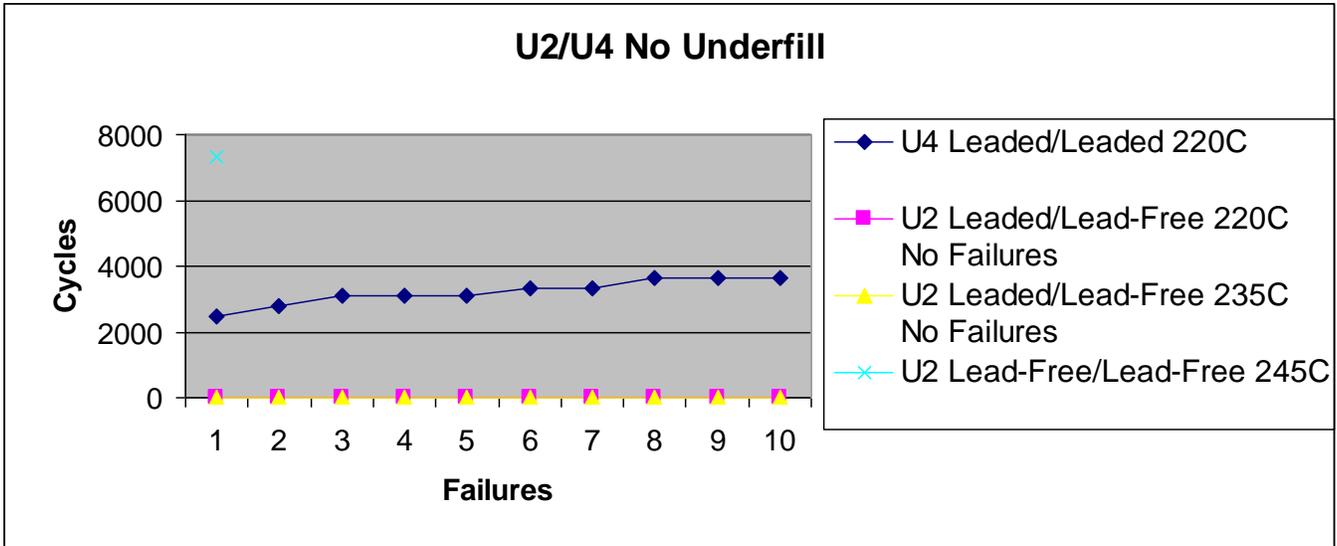
Figure 21 – U2/4 Failure Data

The U2/4 component failed in the leaded group 100% and only had one failure in the lead-free 245C group. The mixed metals groups have no failures.

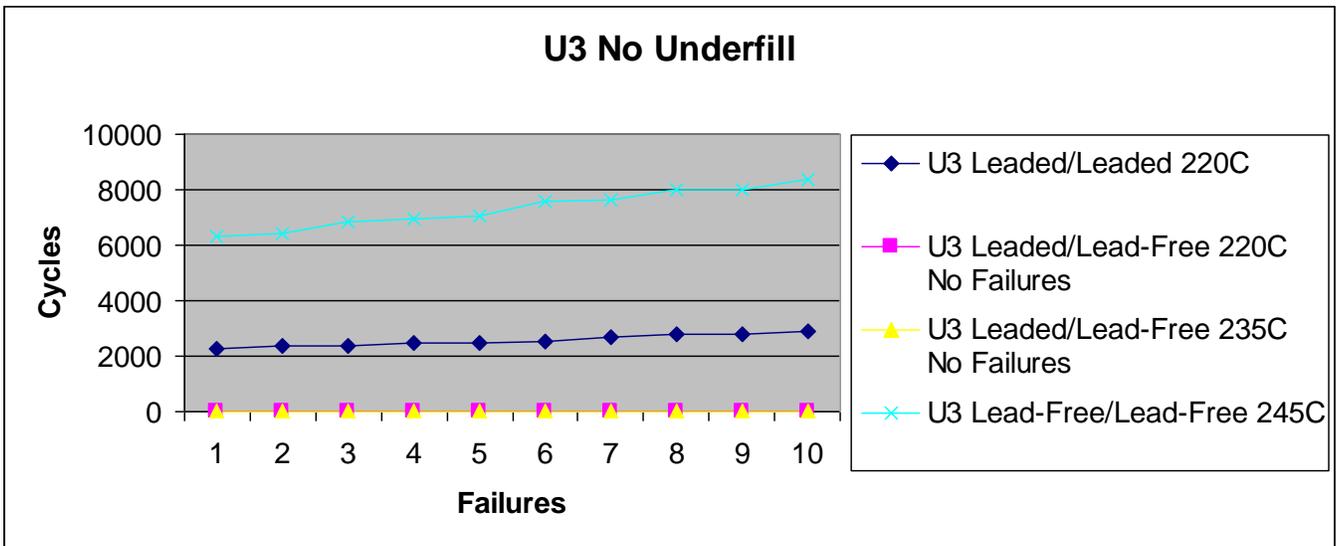
Figure 22 – U3 Failure Data

Failures in the U3 devices occurred only in the two control groups with no failures occurring in the mixed metals groups. This is an important trend that follows from package to package. The trend shows that mixed metals assemblies are outperforming the two control groups in every case.

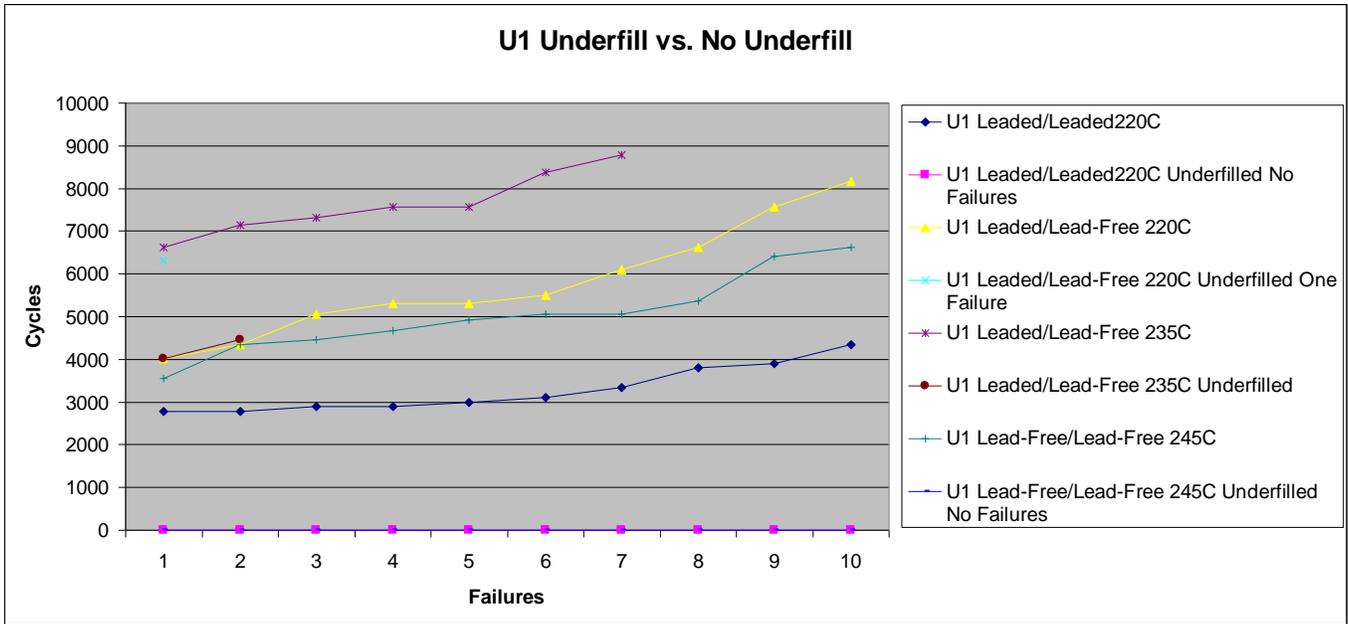
Figure 23 – U1 Underfill vs. No Underfill

The U1 package/location has three underfilled devices that experienced a failure compared to 100% of the non-underfilled U1

The U1 package/location there were three underfilled devices that experienced a failure compared to 100% of the non-underfilled U1 packages.

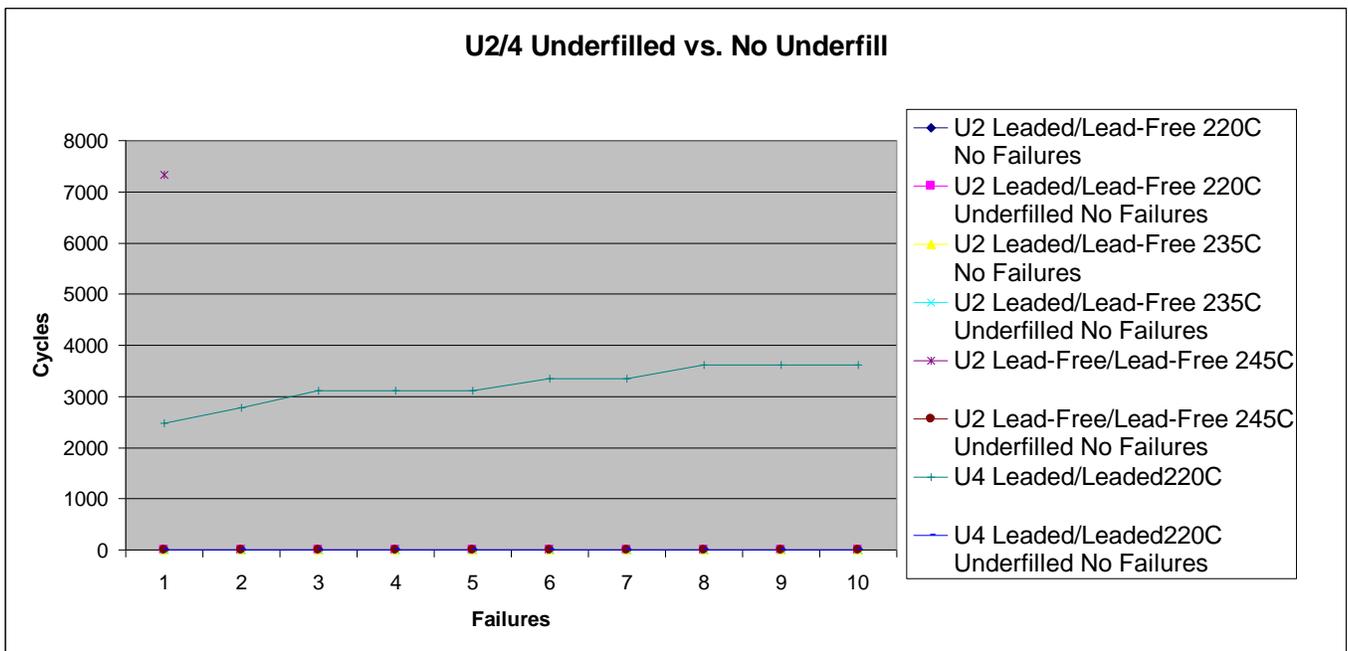
Figure 24 – U2/4 Underfill vs. No Underfill

The U2/4 package/location had no failures in the underfilled assemblies.

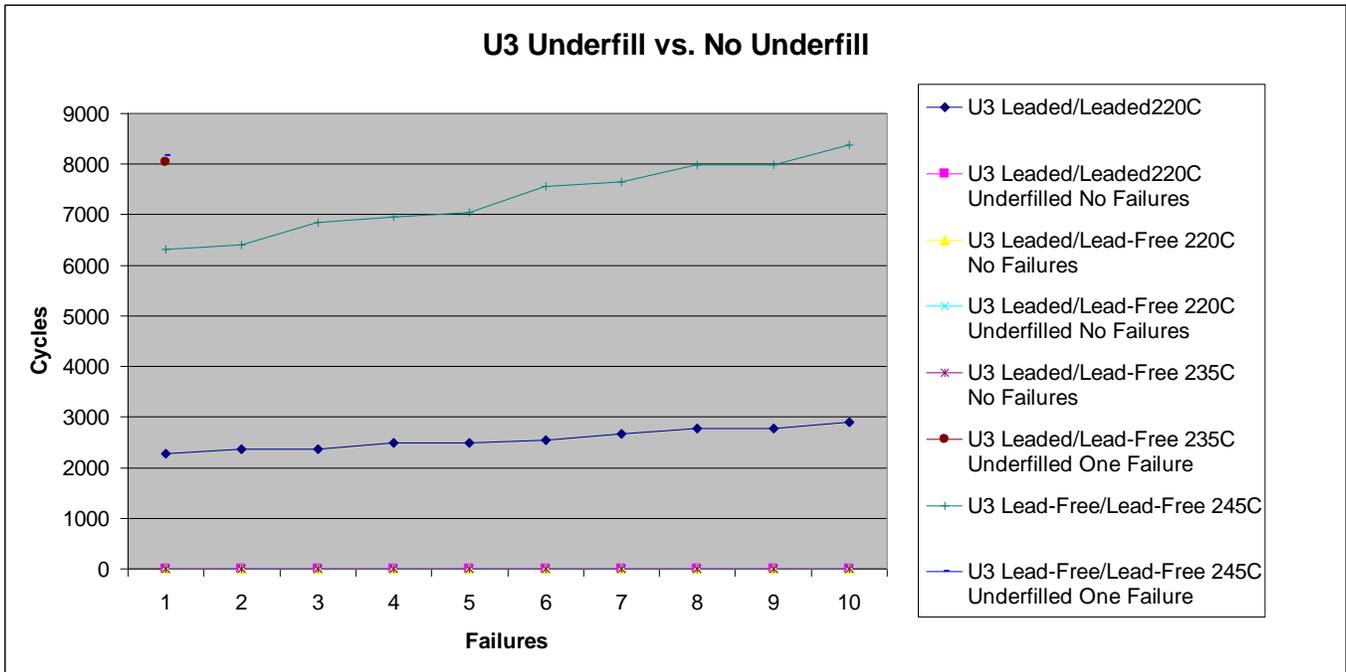
Figure 25 – U3 Underfill vs. No Underfill

The U3 package/location there were two failures in the underfilled groups and both were out beyond 8000 cycles. Across all groups underfill improves the reliability of these devices by 50% on average compared to not underfilling.

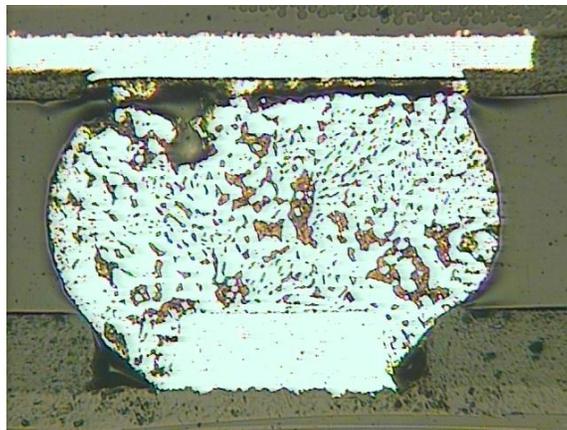
Figure 26 – Group 1 U1 Component Side Failure

Cross sections of the failed packages were performed to evaluate where the failure occurred. On U1 device/locations across all groups the failures occurred 86% of the time at the package interface. 7% of the failures at U1 were at the PCB interface and 7% of the failures had fractures at both package and PCB interface. Failures on the other devices followed with similar results. The only group that had a full set of failures and was group 1, leaded/leaded at 220C, and they all failed at the PCB interface.

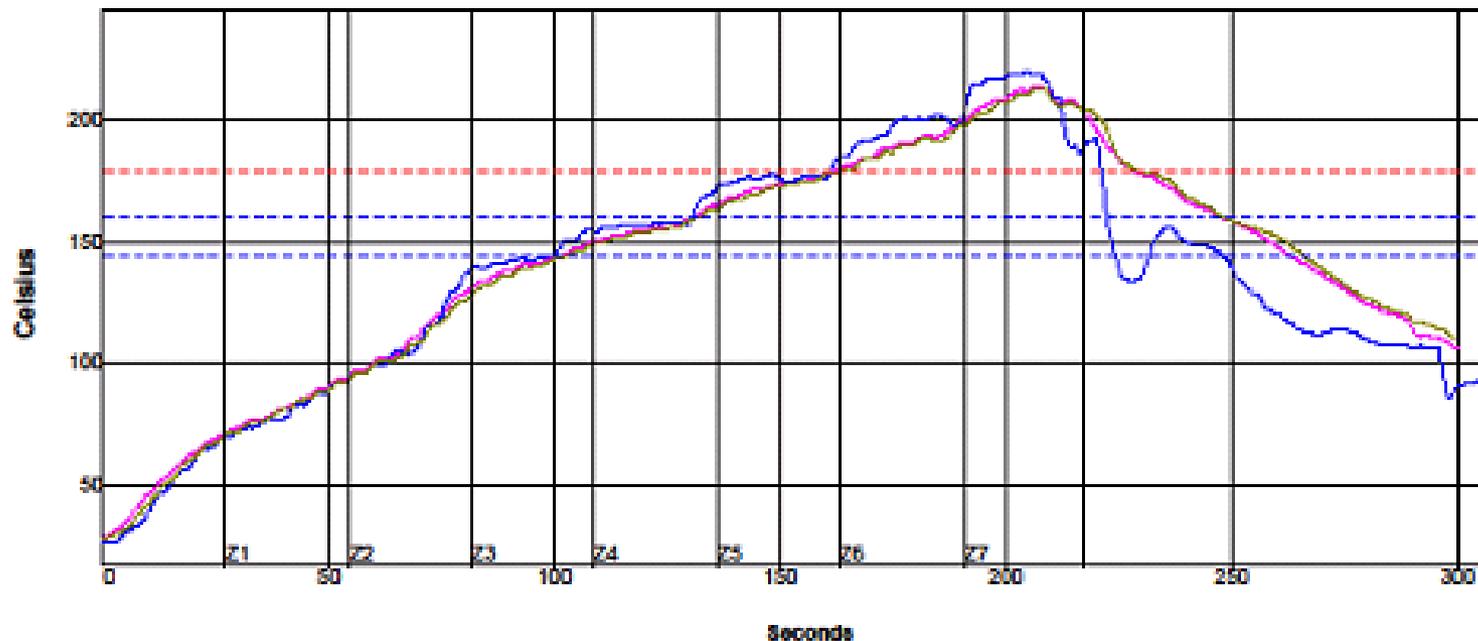
Leaded Reflow Profile – 220C

Setpoints (Celsius)							
Zone	1	2	3	4	5	6	7
Top	90	116	156	163	184	215	235
Bottom	90	116	156	163	184	215	235

Conveyor Speed (inch/min): 26.90

PWF= 50%	Max Rising Slope		Soak Time 145-160C		Reflow Time /175C		Peak Temp	
u3	1.80	20%	27.83	-38%	68.13	-30%	214.65	-20%
u1	2.05	37%	30.19	-33%	59.86	-50%	219.89	14%
u4	1.82	21%	28.47	-37%	66.23	-34%	213.00	-36%
Delta	0.25		2.36		8.27		6.88

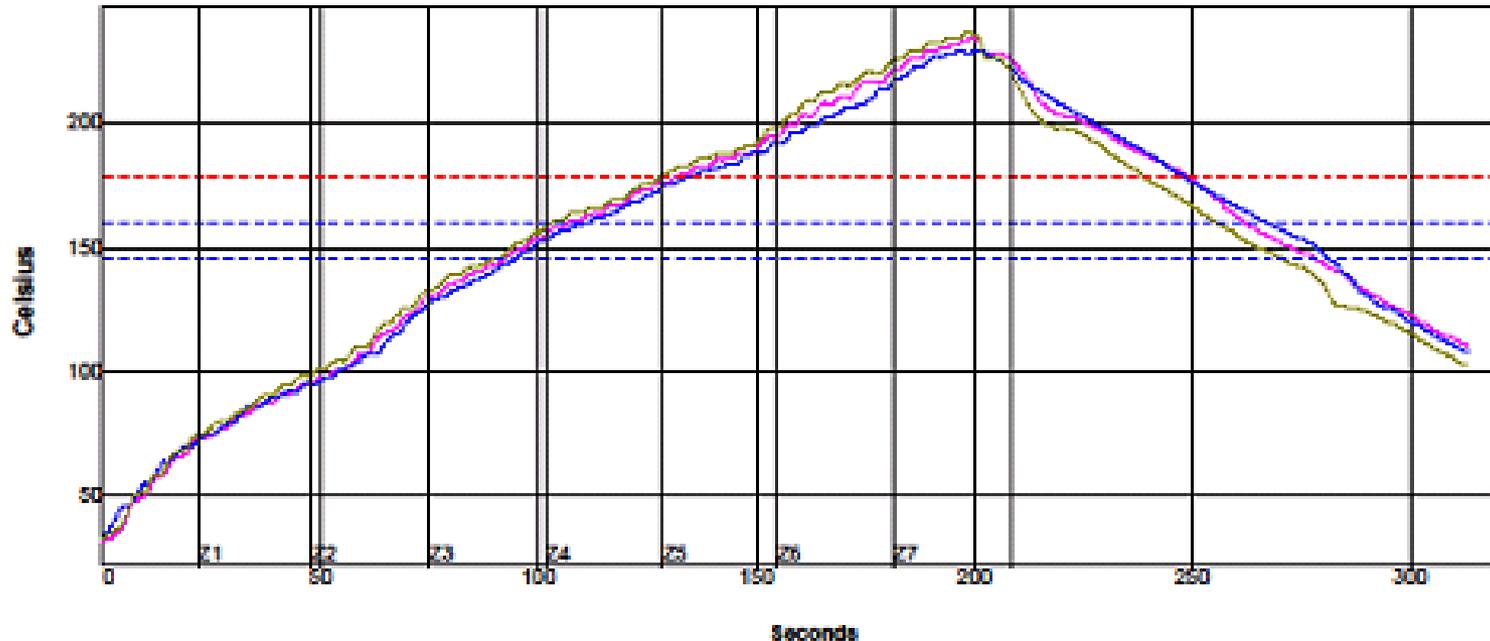
Elevated Leaded Reflow Profile – 235C

Setpoints (Celsius)							
Zone	1	2	3	4	5	6	7
Top	100	120	160	180	200	245	255
Bottom	100	120	160	180	200	245	255

Conveyor Speed (inch/min): 28.00

PWR= 100%	Max Rising Slope		Soak Time 145-160C		Reflow Time /173C		Peak Temp	
u3	1.30	33%	14.84	-67%	116.88	92%	234.17	95%
u1	1.80	20%	16.96	-42%	112.09	80%	229.28	87%
u4	2.62	35%	13.47	-70%	110.74	77%	236.61	109%
Delta	0.22		3.49		6.14		7.33

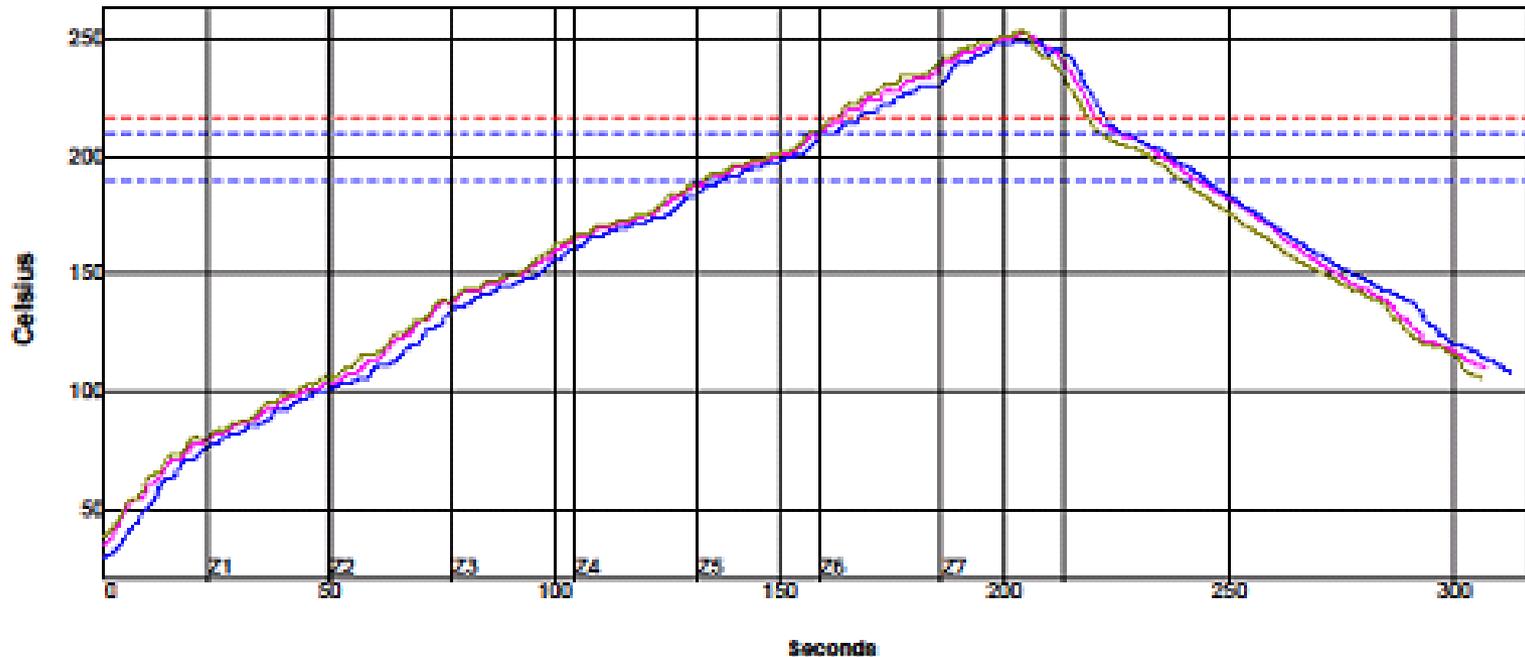
Lead Free Reflow Profile – 250C

Setpoints (Celsius)							
Zone	1	2	3	4	5	6	7
Top	100	120	162	185	211	258	271
Bottom	100	120	162	185	211	258	271

Conveyor Speed (inch/min): 27.00

PW= 78%	Max Rising Slope	Soak Time 190-210C	Reflow Time /217C	Peak Temp
u3	2.14	25.85	55.94	252.21
u1	2.20	24.91	54.32	243.51
u4	2.05	23.52	55.35	253.34
Delta	0.14	2.34	1.63	3.63

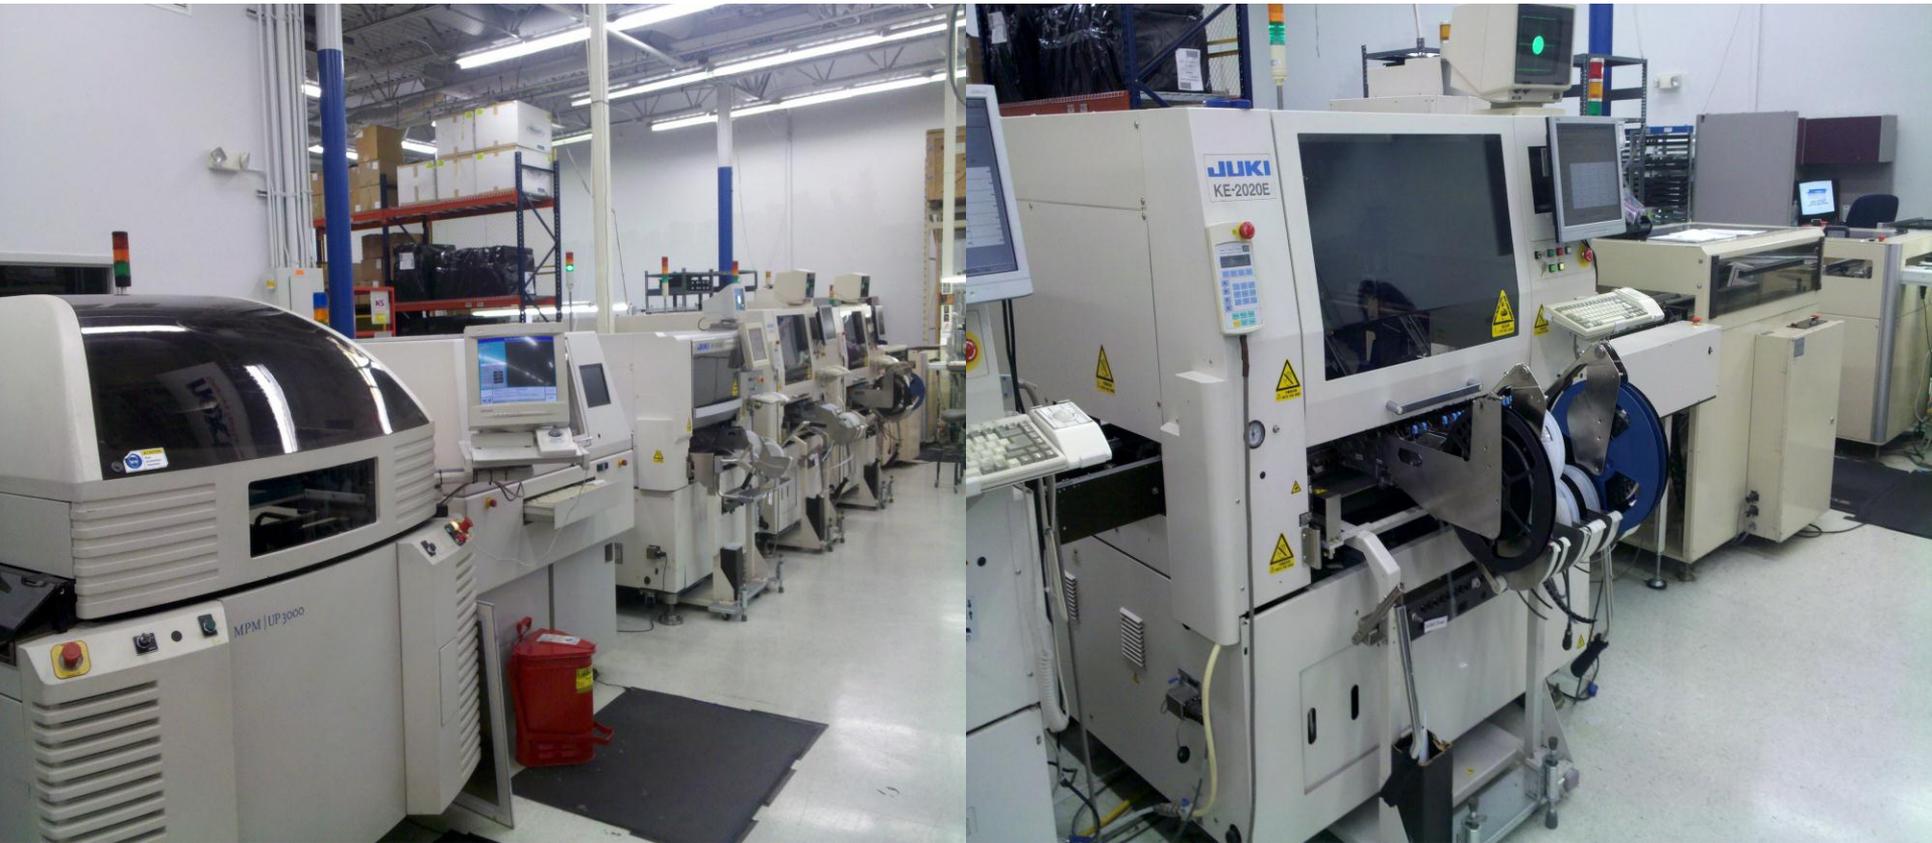
Assembly Tools

MPM UltraPrint 3000 – Screen Printing

5mil Laser Etched Solder Stencil

Juki KE-2020E

SMT Placement Platform

+/- 30 micron accuracy

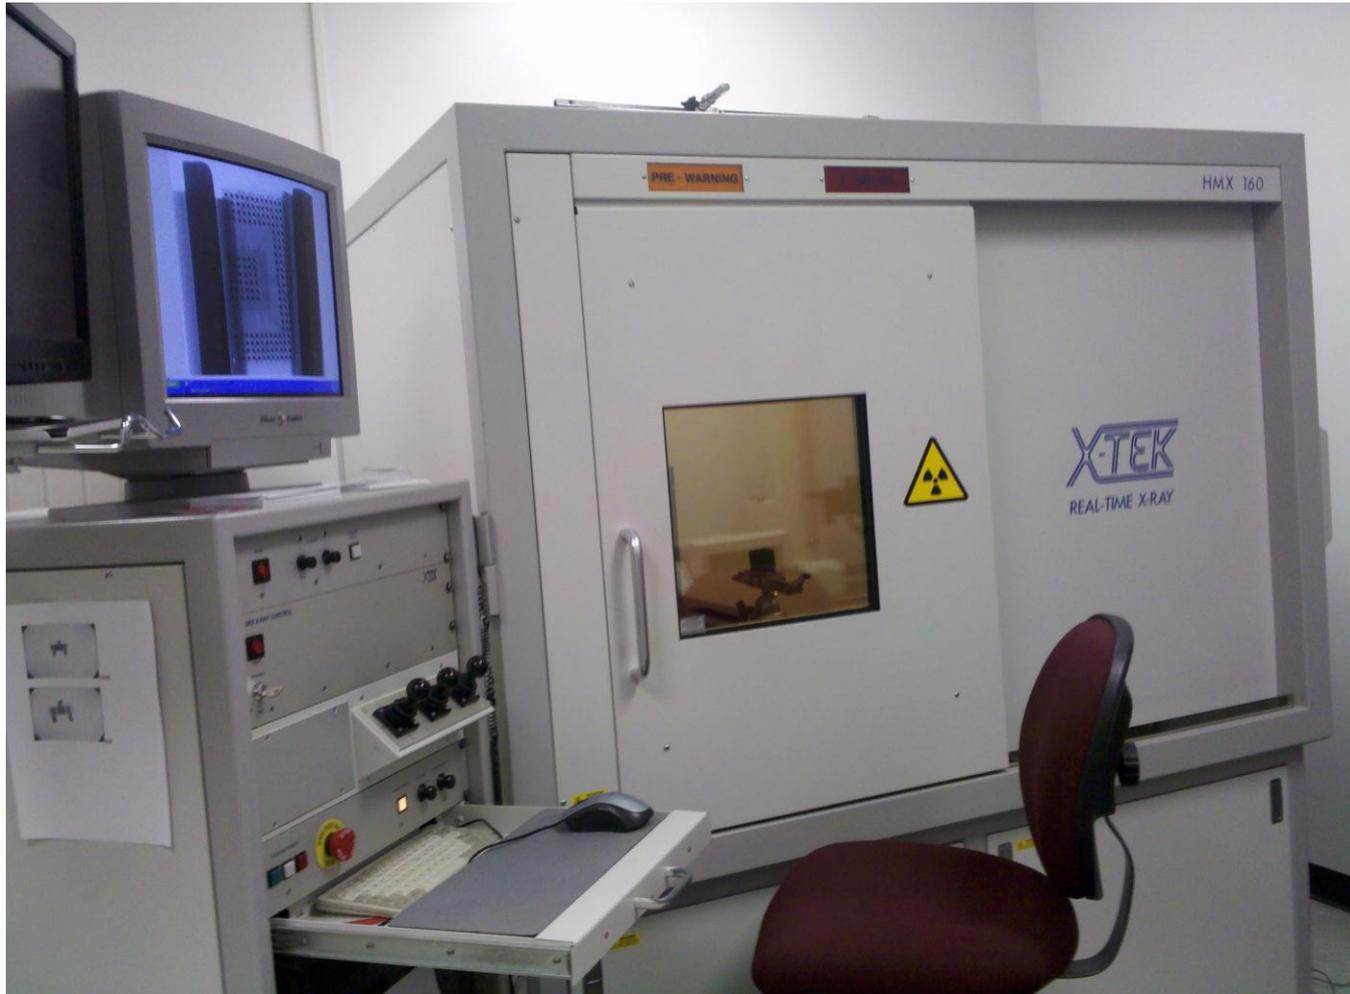
X-Ray Analysis - Analytical Lab

First Articles of all BGA's were X-Rayed using the X-TEK System

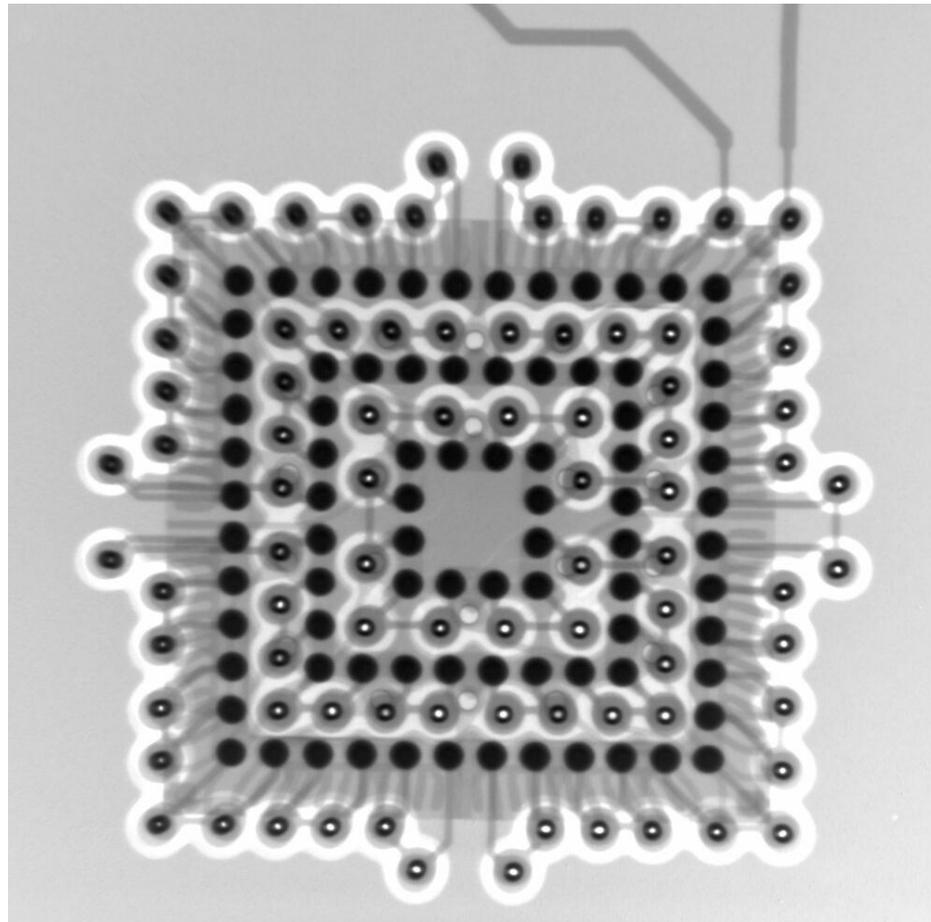
X-Ray Analysis Leaded Profile 235C - U1

No Voids or Bridges

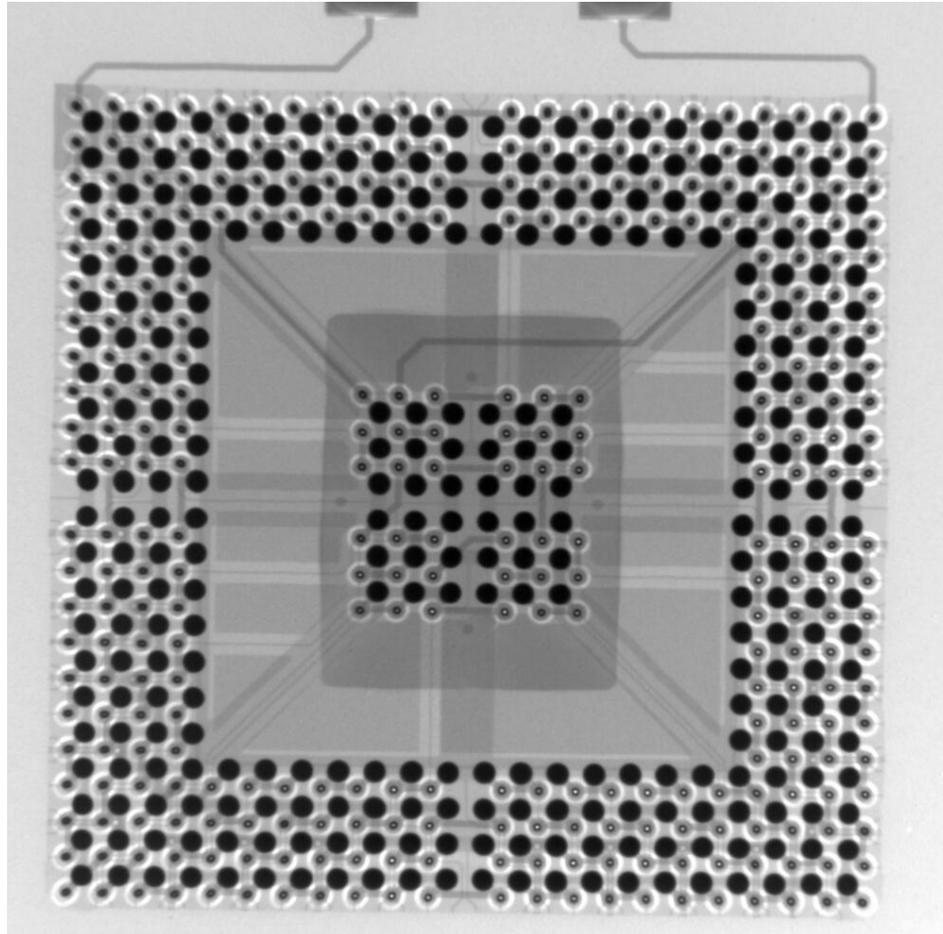
Leaded Profile 235C - U3

No Voids or Bridges

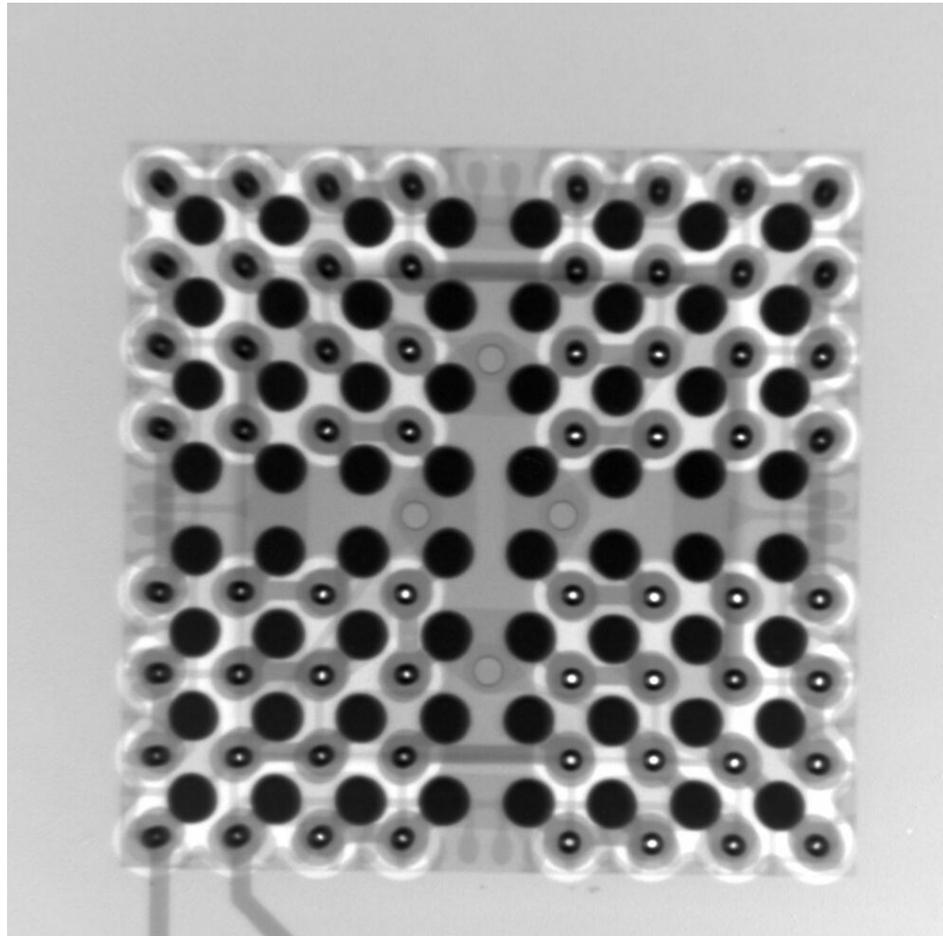
Leaded Profile 235C - U4

No Voids or Bridges

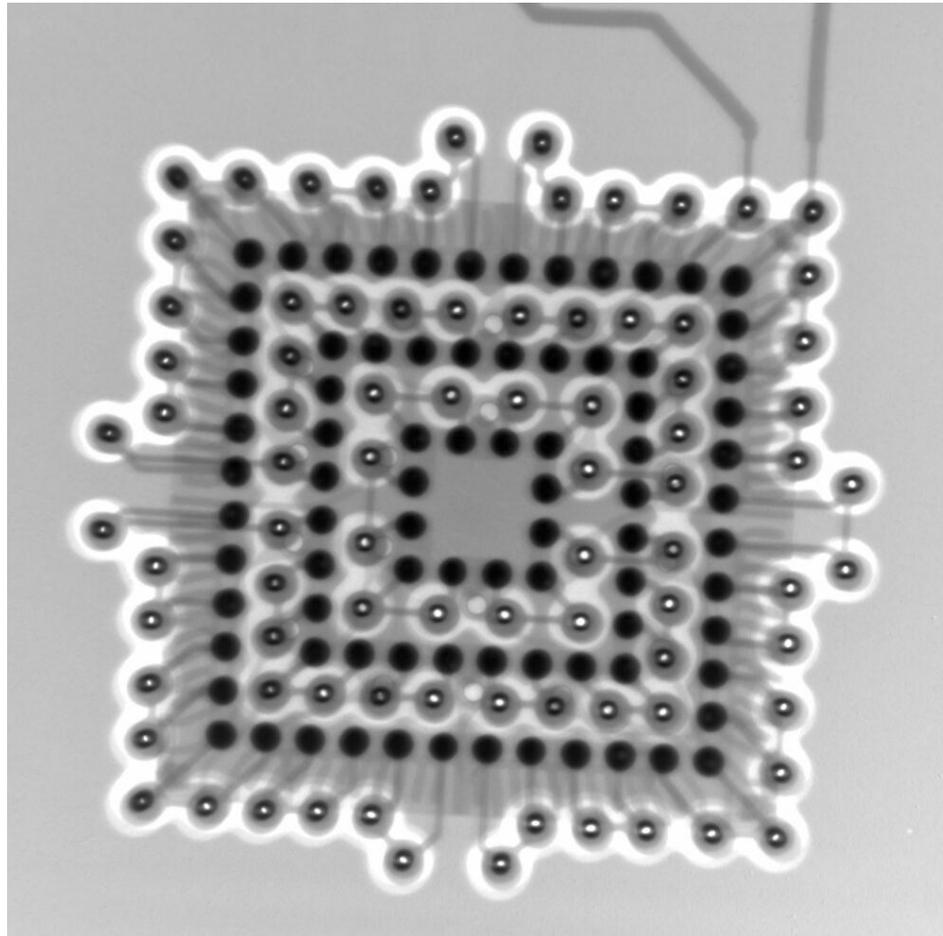
Lead Free Profile 250C - U1

No Voids or Bridges

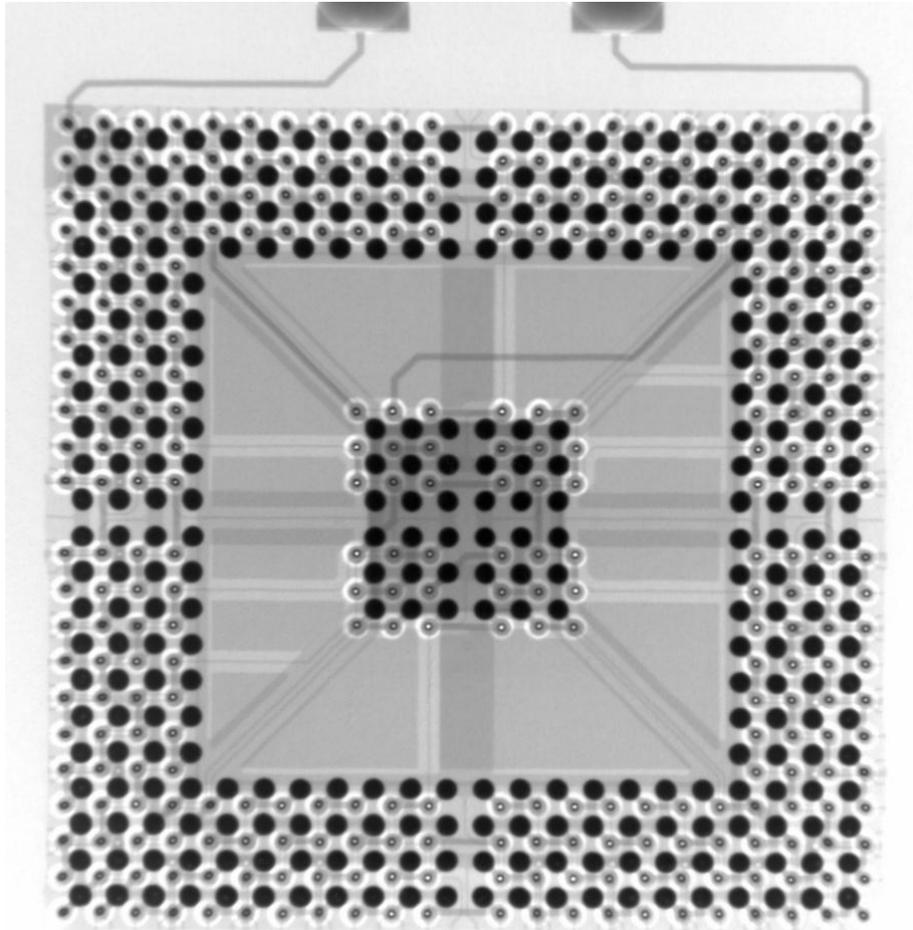
Lead Free Profile 250C – U3

No Voids or Bridges

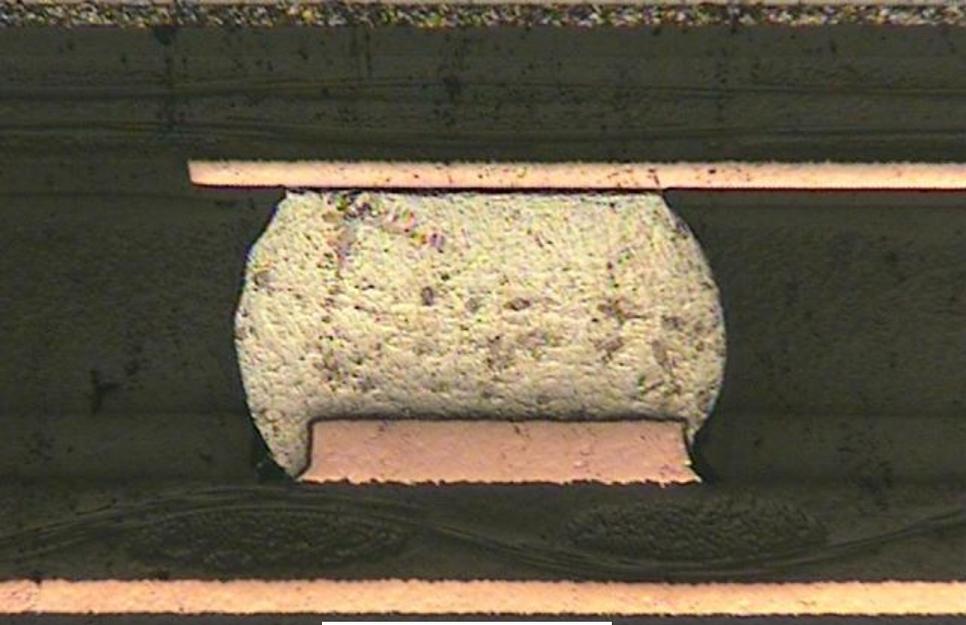
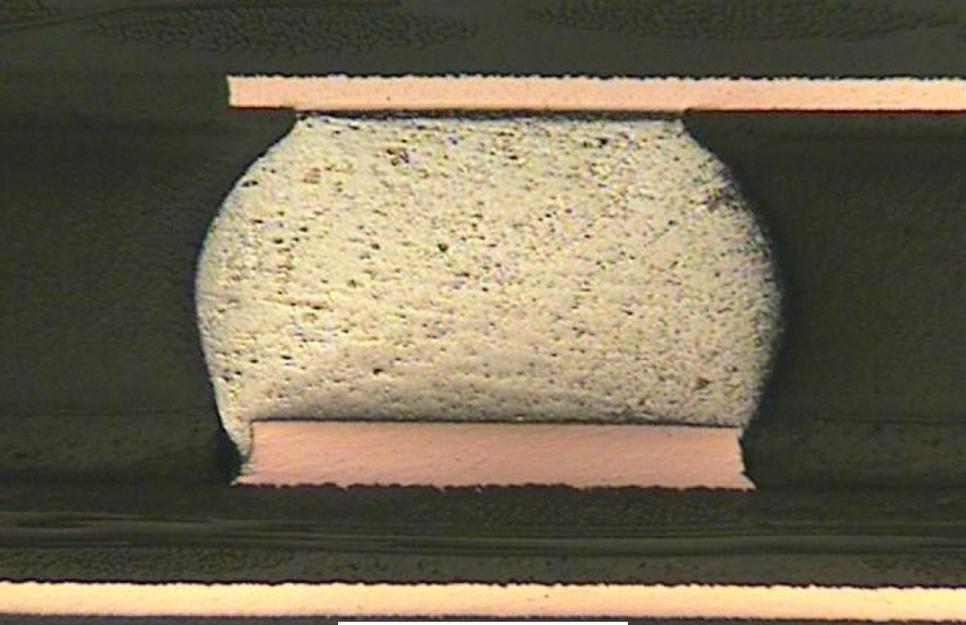
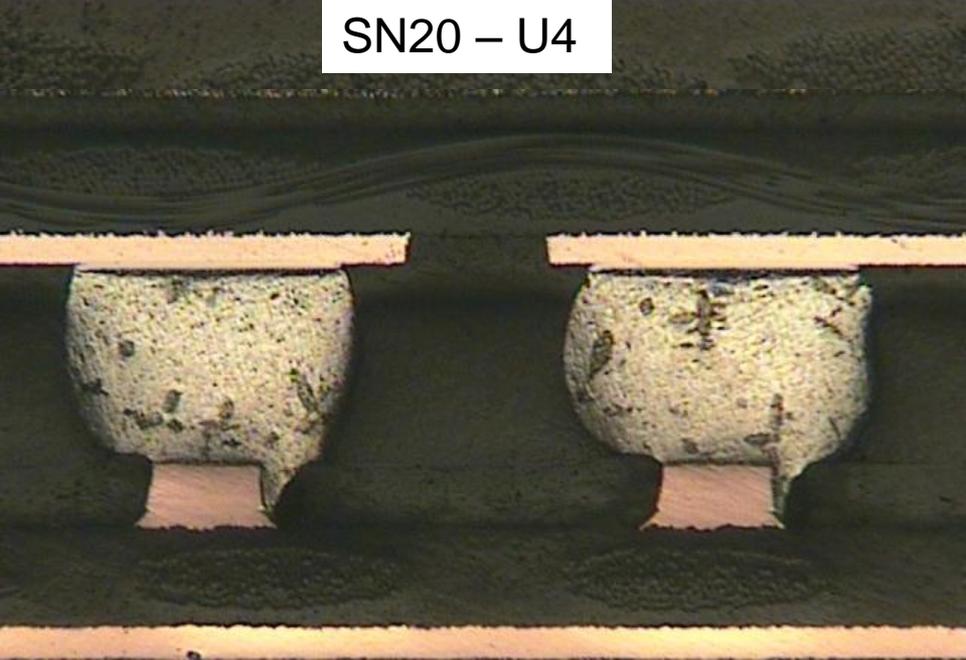
- Prior to temperature cycling cross sections were pulled from each of the variable groups for analysis.
- Post temperature cycling cross sectional analysis was also performed.
- All failed assemblies were cross sectioned for failure analysis.

Leaded BGA
Leaded Solder
Underfill

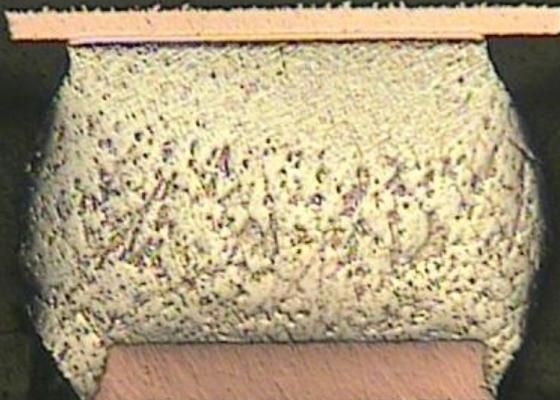
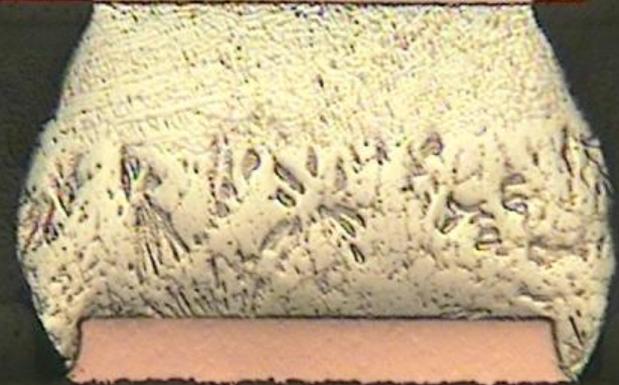
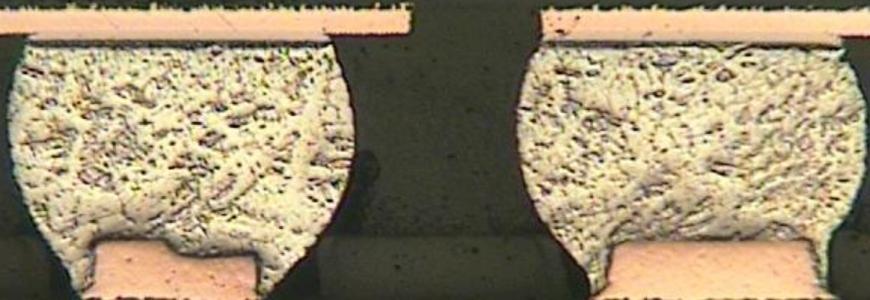
Lead-Free BGA
Leaded Solder
Peak Reflow 220C
Underfill
