Mixed Metals Impact on Reliability

Nextek Incorporated

APEX EXPO 2013

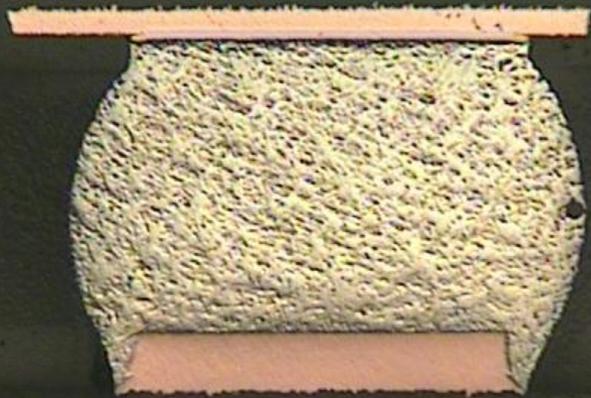
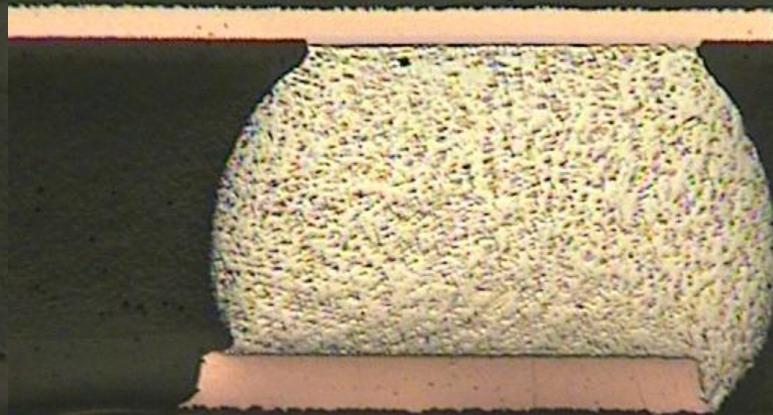
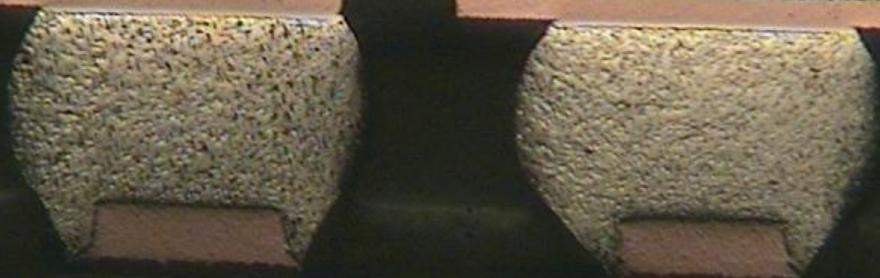
Lead-Free BGA
Leaded Solder
Peak Reflow 235C
Underfill

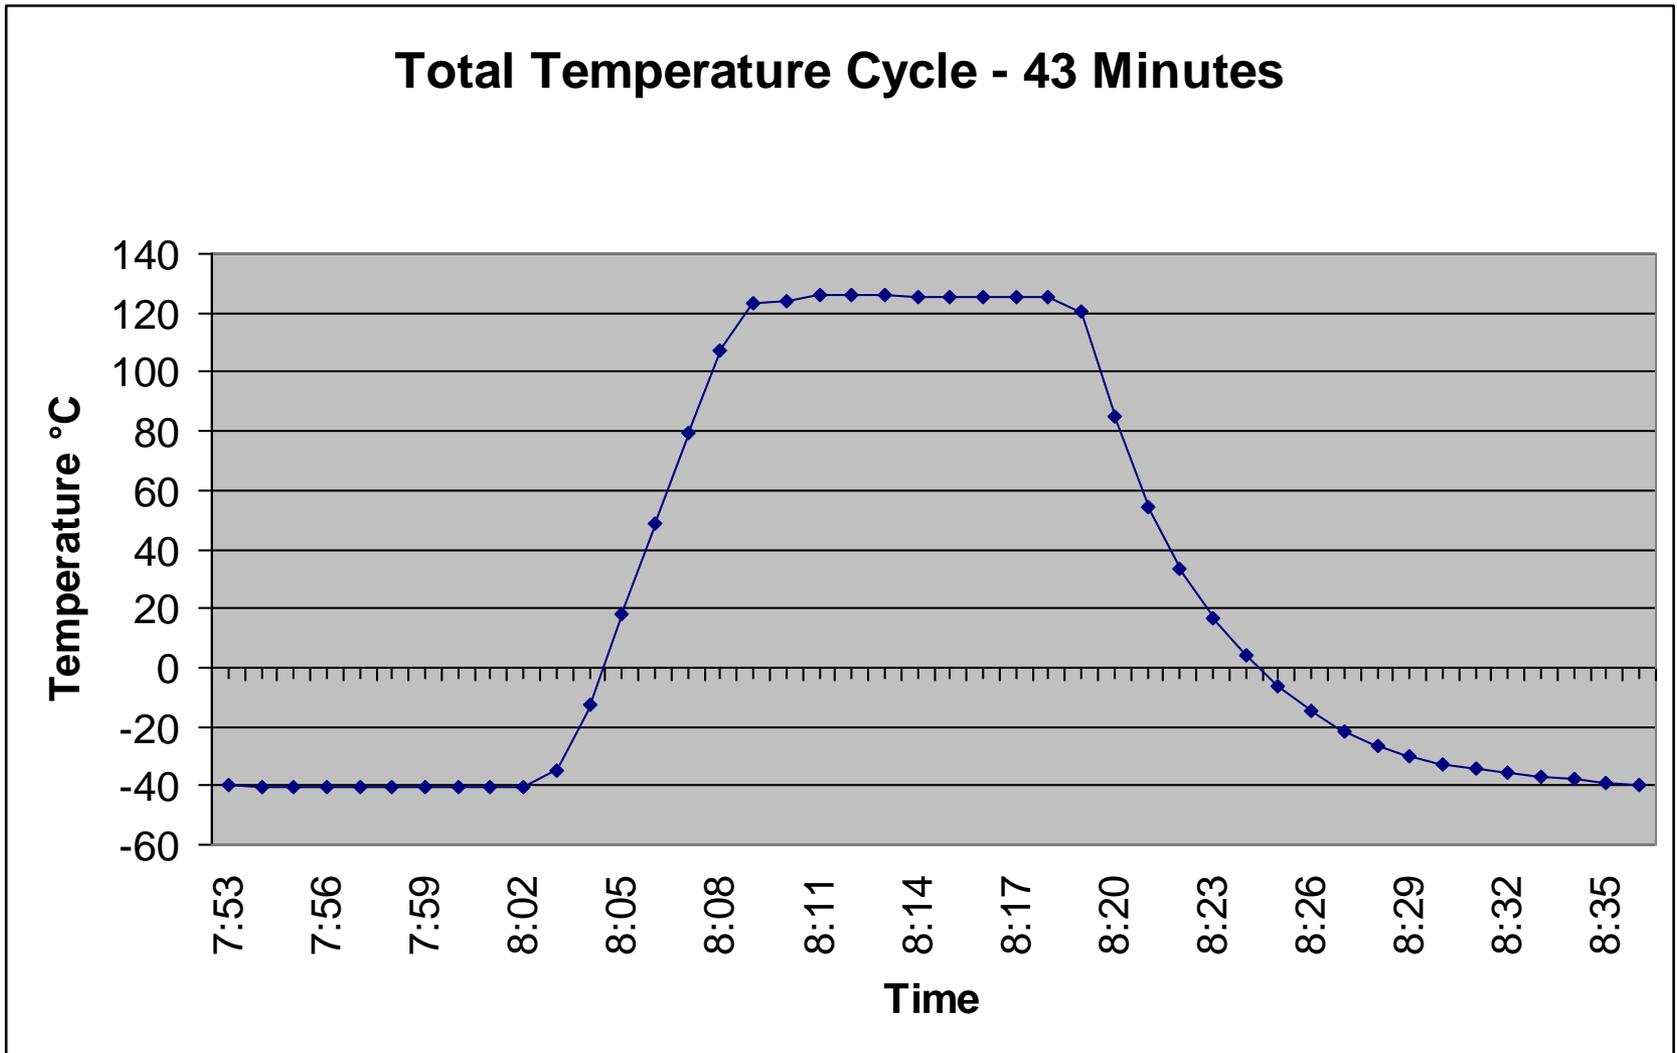
Total Temperature Cycling Profile

- Thermotron Environmental Chambers
- -40C to +125C
- 10 Minute Dwell at each extreme
- Ramp Rate positive ramp .393 C/Sec
- Ramp Rate negative ramp .145 C/Sec

Total Temperature Cycle - 43 Minutes

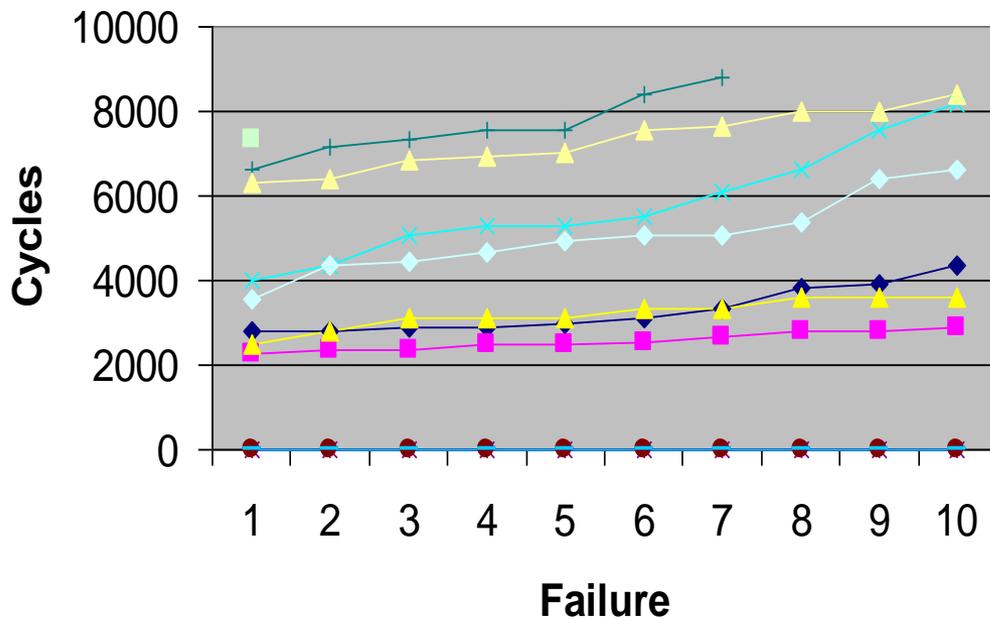
Thermal Cycling Failures Group 1-4

- ◆ U1 Leaded/Leaded 220C
- U3 Leaded/Leaded 220C
- ▲ U4 Leaded/Leaded 220C
- × U1 Leaded/Lead-Free 220C
- * U2 Leaded/Lead-Free 220C No Failures
- U3 Leaded/Lead-Free 220C No Failures
- + U1 Leaded/Lead-Free 235C
- U2 Leaded/Lead-Free 235C No Failures
- U3 Leaded/Lead-Free 235C No Failures
- ◇ U1 Lead-Free/Lead-Free 245C
- U2 Lead-Free/Lead-Free 245C
- ▲ U3 Lead-Free/Lead-Free 245C

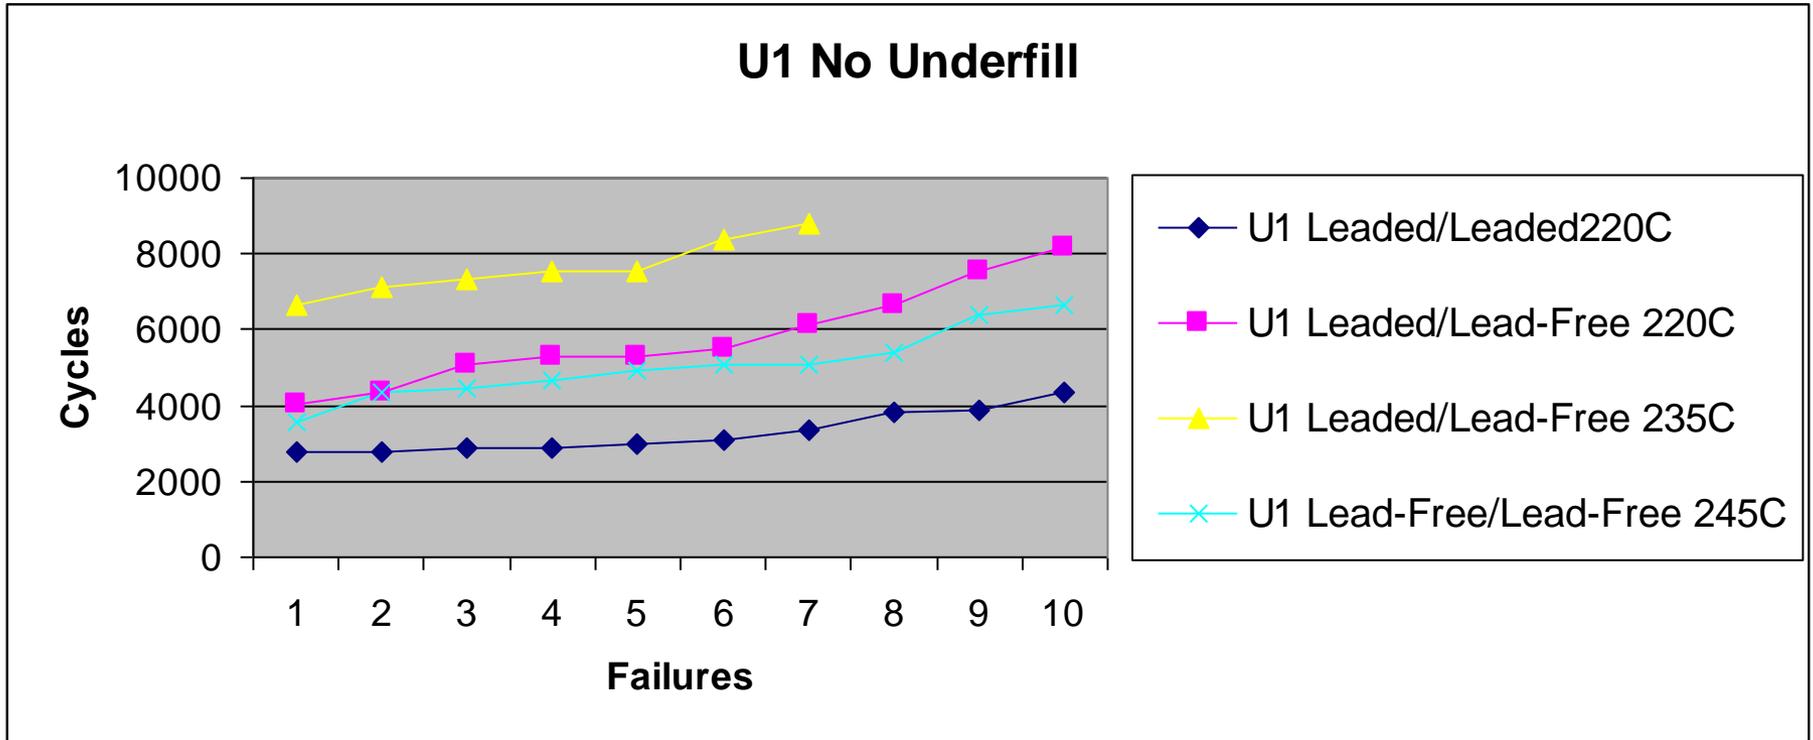
In the case of U1 it is clear that when mixing leaded and lead-free the best performance was achieved by reflowing at the 235C temperature. It is also interesting that the mixed metals soldered at 220C out performed the two control group samples.

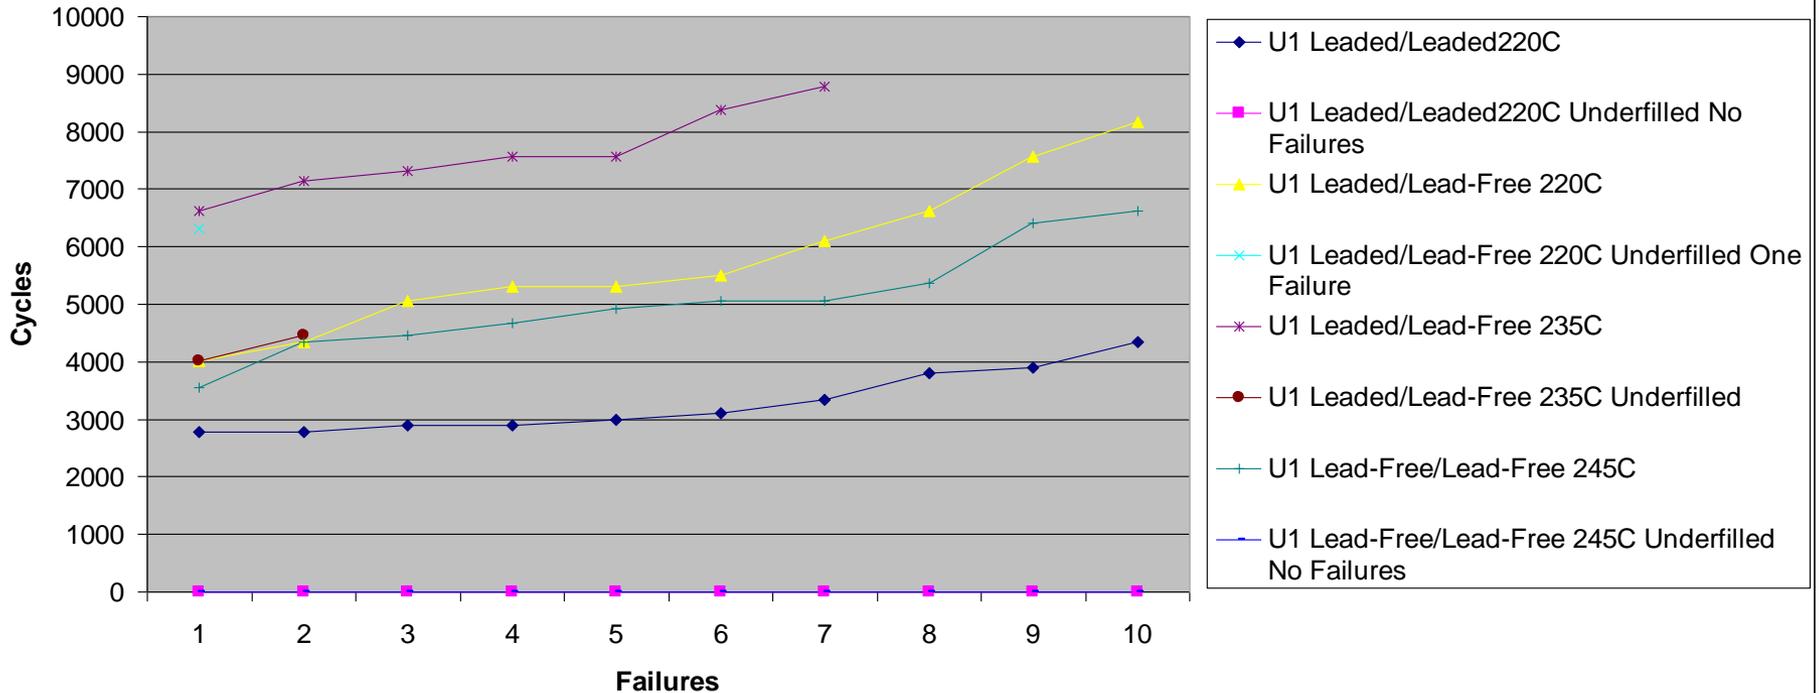
U1 Underfill vs. No Underfill

The U1 package/location there were three underfilled devices that experienced a failure compared to 100% of the non-underfilled U1 packages.

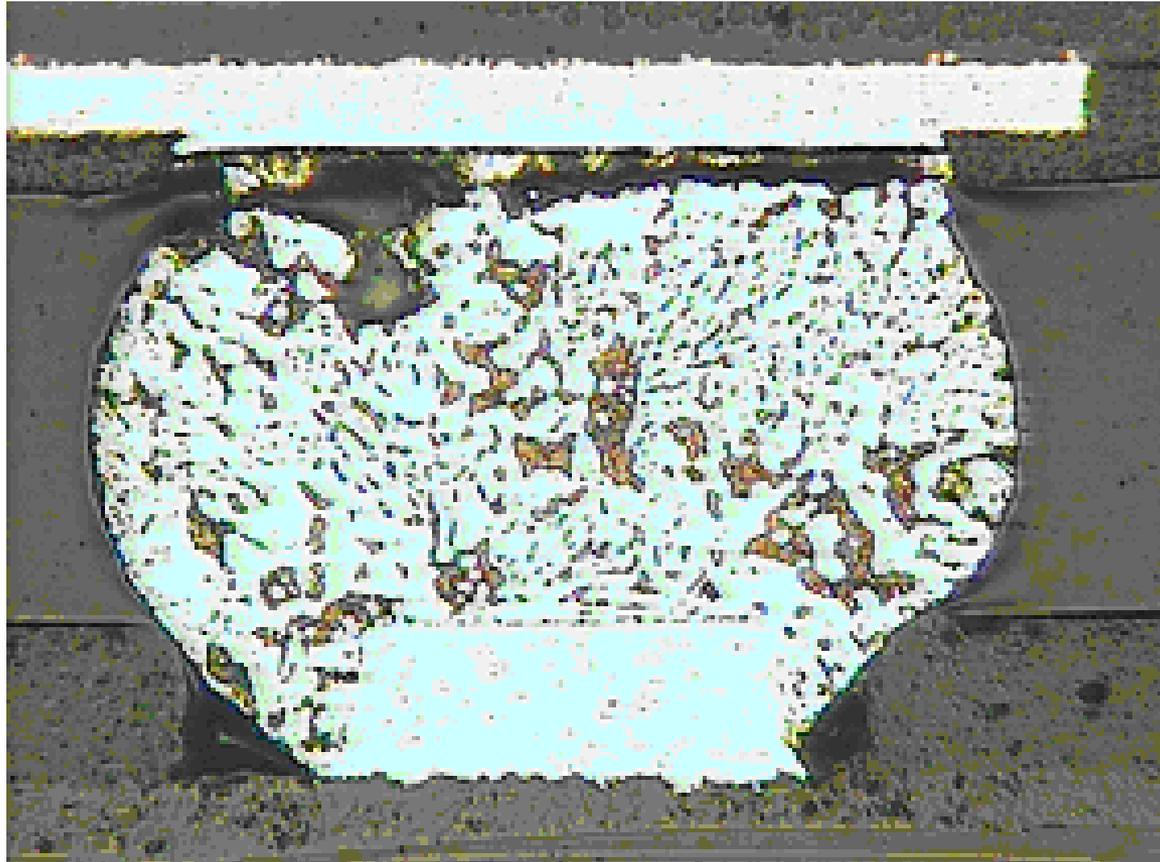
Group 1 U1 Component Side Failure

Cross sections of the failed packages were performed to evaluate where the failure occurred. On U1 device/locations across all groups the failures occurred 86% of the time at the package interface. 7% of the failures at U1 were at the PCB interface and 7% of the failures had fractures at both package and PCB interface. Failures on the other devices followed with similar results. The only group that had a full set of failures and was group 1, leaded/leaded at 220C, and they all failed at the PCB interface.
