Control of the Underfill of Surface Mount Assemblies by Non-Destructive Techniques

Shaïma Enouz-Vedrenne, Jean-Claude Clement
Thales Research and Technology
Palaiseau, France

Control of the Underfill of Surface Mount Assemblies by Non-destructive Techniques

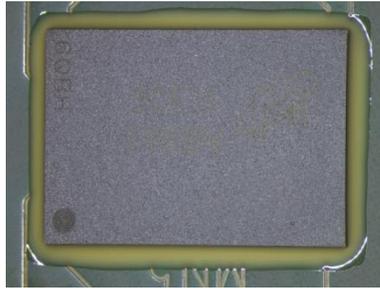
Figure 1 - Global view of an underfilled BGA

As it can be understood from the above picture, the visual inspection of an underfilled BGA is very limited and only permits to control the resin fillets and overflow on surrounding components. Possible defects under the BGA device such as underfill voids or cracks cannot be checked by this inspection method. Destructive horizontal cross-sectioning is needed to expose and control the array of BGA solder balls encapsulated by the underfill material.

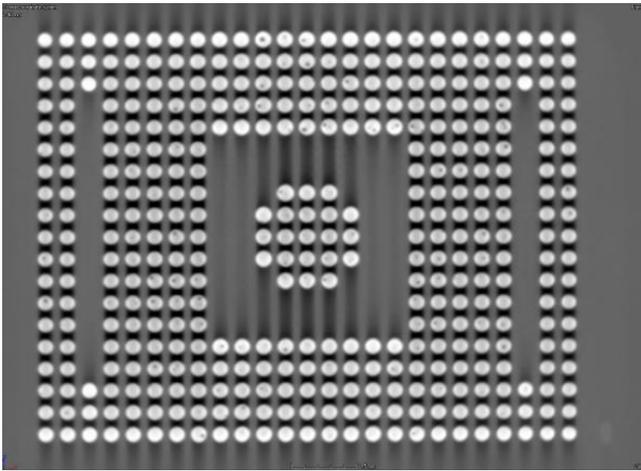
Figure 2 - X-ray virtual cross-section view of a BGA component

Another limit of X-ray CT is the so called beam hardening artifact which is caused by the polychromatic nature of the X-ray source and the energy dependent characteristics of the object. The presence of a dense object (e.g. metal, solder) within the field of view of a CT can create severe artifacts in the reconstructed images in particular dark shading between solder balls in a BGA component as illustrated in Figures 2 and 3.

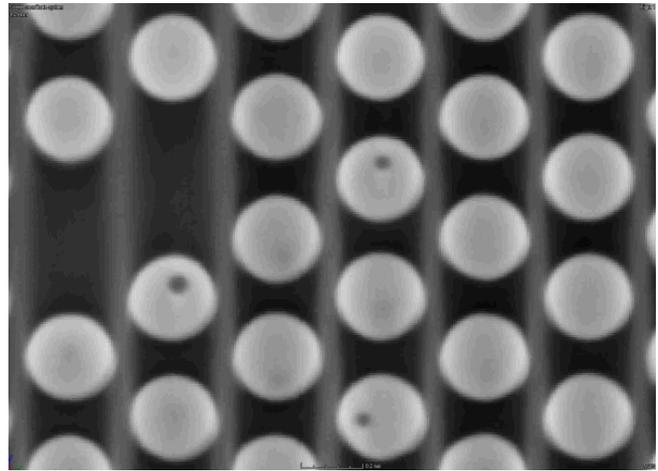
Figure 3 - Dark streaks connecting the dense objects in the image are visible.

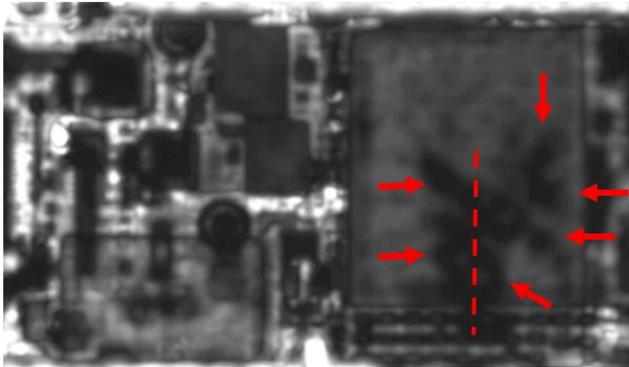
Figure 4 - Through-scan mode of an underfilled board. Voids in the underfill under an LGA assembly (red arrows).

On the illustration below, underfilled assemblies from a smartphone mainboard were analyzed in through scan mode. Large voids in the resin under an underfilled LGA component could be detected using this technique and were confirmed by a destructive cross-section.

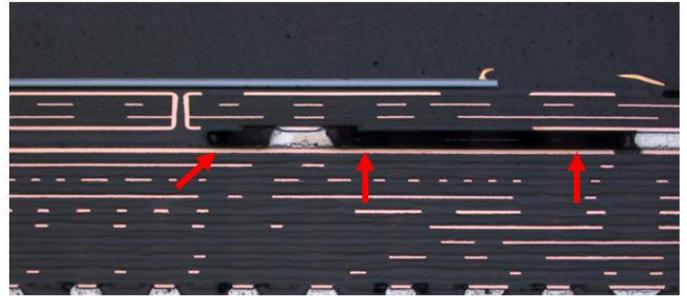
Figure 5 - Cross-section on the underfilled LGA assembly. Voids in the underfill (red arrows).

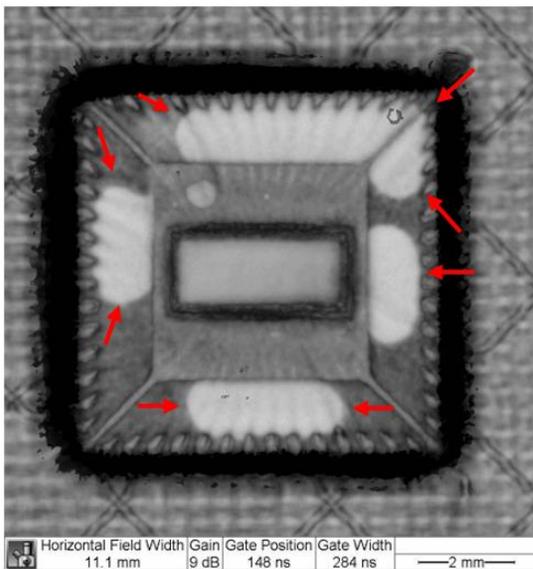
Figure 6 - C-scan mode of an underfilled QFN assembly. Large voids in the underfill (red arrows).

With a dedicated experiment where QFN components were underfilled on a PCB test vehicle board, C-scan turned out to be efficient in detecting voids within the underfill resin. By reducing the frequency, it was possible to go through all the molding compound thickness and directly image the underfill. In through-scan mode, underfilled QFN could also be inspected but at a lower resolution. As illustrated, the two pictures hereafter show the compared results of underfilled QFN with a high level of underfill voids analyzed at 30 MHz in both C-scan and through-scan modes.

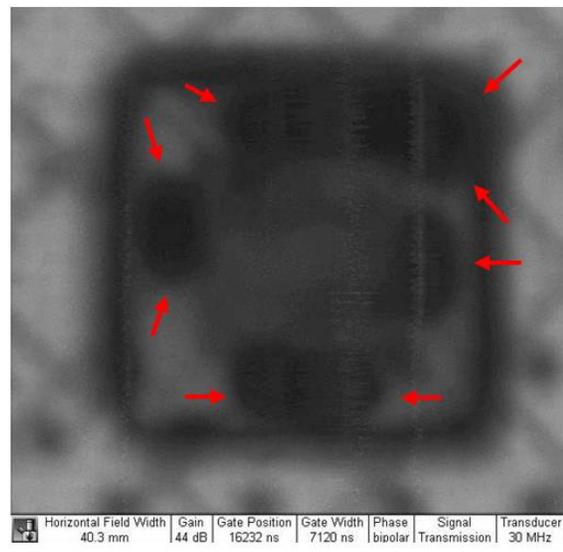
Figure 7 - Through-scan mode of an underfilled QFN assembly. Large voids in the underfill (red arrows).

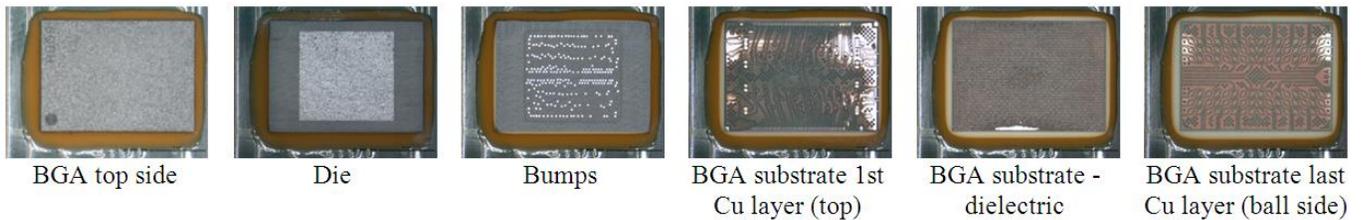
Figure 8 - Progressive planar cross-section of an underfilled BGA assembly with the high precision micro-polishing machine

Planar cross-sectioning was performed on different types of underfilled BGA but the conventional mechanical polishing was replaced by a high precision micro-polishing performed on a production preparation machine [8]. This kind of micro-polishing is typically dedicated to component decapsulation and dies backside analyses. The sample is mounted on a specially designed moving table that oscillates in the X and Y directions. A z-axis controlled rotating tool ensures a precise and reproducible grinding down to a specified thickness as well as a scratch-free mirror polish finishing. With this tool, it is possible to control the thinning and stop just before the component/underfill interface prior to SAM analysis.

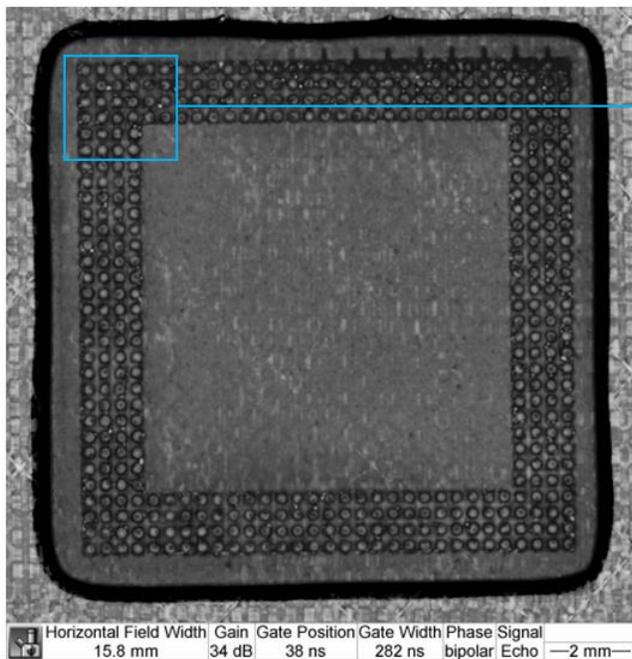
Figure 9 - C-scan mode of an underfilled BGA assembly after micro-mechanical polishing.

C-scans were performed directly on the last copper layer of the BGA substrate (ball side) at a 150 MHz frequency. The whole BGA area and both component/underfill and underfill/board interfaces could be analyzed with a lateral resolution around 50 μm . With such high resolution, small voids can be detected including in the most difficult areas between the BGA solder joints. The technique enabled to evidence different kinds of underfill voids like local voids at the base of BGA solder joints or larger voids bridging the gap between two adjacent joints (see figures 9 and 10).

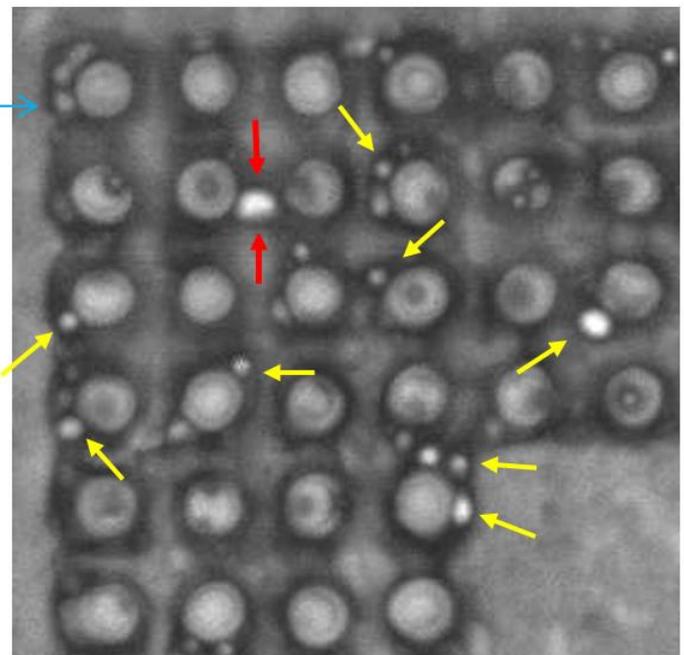
Figure 10 - Detailed view of the underfill between solder joints : Voids in the underfill (yellow arrows) and void that encircles two solder joints (red arrows)

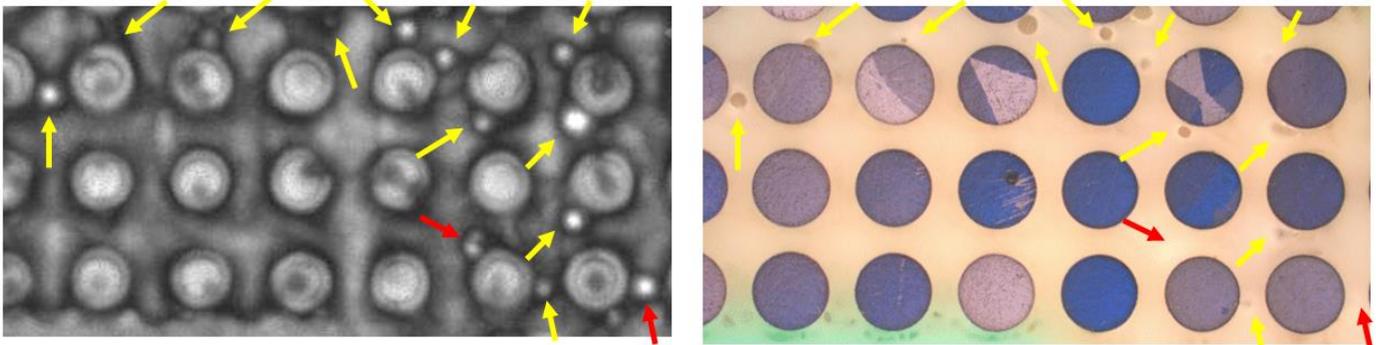
Figures 11 - Same area of the underfilled BGA assembly after micro-mechanical polishing in C-scan mode (left) and in optical under polarized light after further planar polishing (right). Voids in the underfill correlated between C-scan and optical inspection (yellow arrows) and voids not detected optically in this planar axis (red arrows)

To correlate the voids observed in C-scan, the planar cross-section was pursued step by step from the BGA/underfill interface down to the PCB/underfill interface with optical observations at multiple intermediate depths. Several planar cross-section axes were necessary to observe all the voids revealed in SAM. Some were even hardly seen as illustrated in figures 11. Clearly, the SAM inspection is more exhaustive and displayed a better sensitivity.

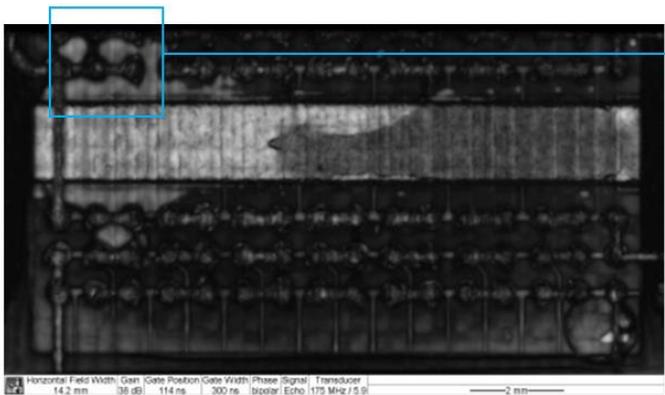
Figure 12 - C-scan mode of an underfilled BGA assembly after micro-mechanical polishing. Evidence of a delaminated area

A preliminary conventional cross-section was performed on the failed row, which revealed some delaminations at the underfill/BGA substrate interface on one side of the row generating cracks in the solder joints. To better understand the failure mechanism and the origin of the delamination, the BGA component was thinned by a planar cross-section until reaching the BGA substrate. SAM performed with a high frequency transducer at 150 MHz permitted to analyze the underfill and correlate the delamination at the BGA substrate/underfill interface. The delamination occurred between the underfill resin and the solder mask of the BGA substrate as illustrated in the figure 12.

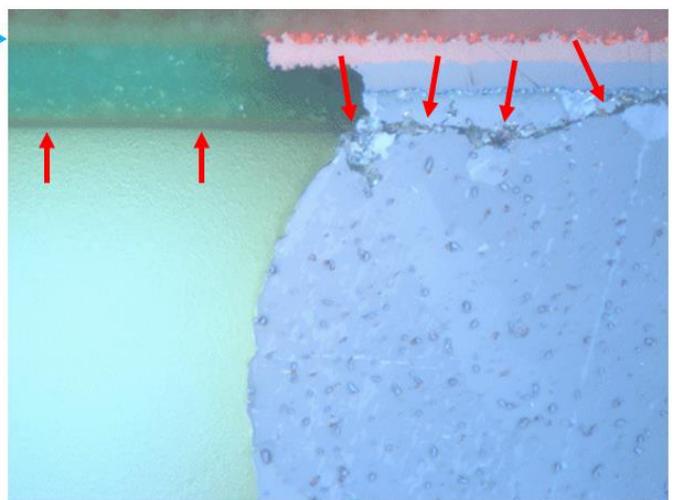
Figure 13 - Optical view in cross-section of the underfill between solder joints : delamination at underfill/BGA interface generating cracks in the solder joints (red arrows)

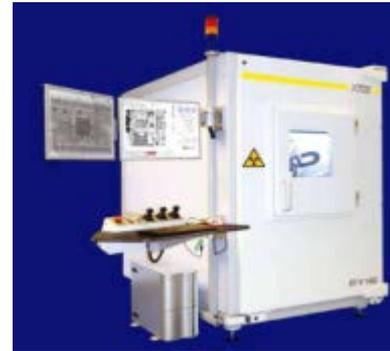
- ◆ X-ray spot size: $1\mu\text{m}$
- ◆ Max electron beam power : 20W
- ◆ Max kV: 160kV

- ◆ Amorphous Silicon Digital X-ray imager
- ◆ 1024 x 1024 pixel matrix flat panel

- ◆ 5 axis: X,Y,Z, rotation 360° , tilt 0- 70°
- ◆ Large tray: samples up to 510mm in length

**X-tech XTV160
equipment from
Nikon metrology**

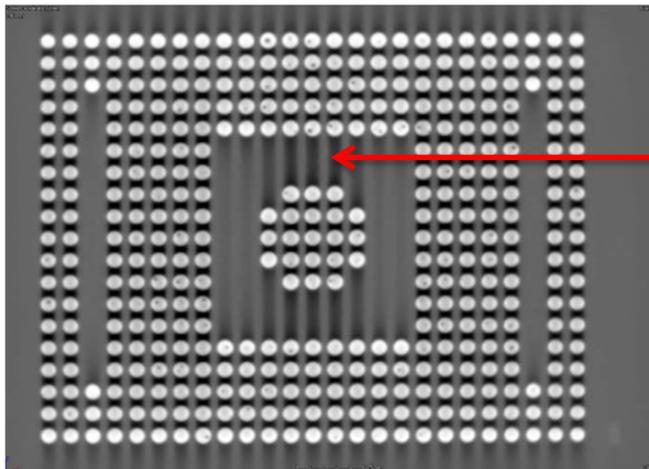
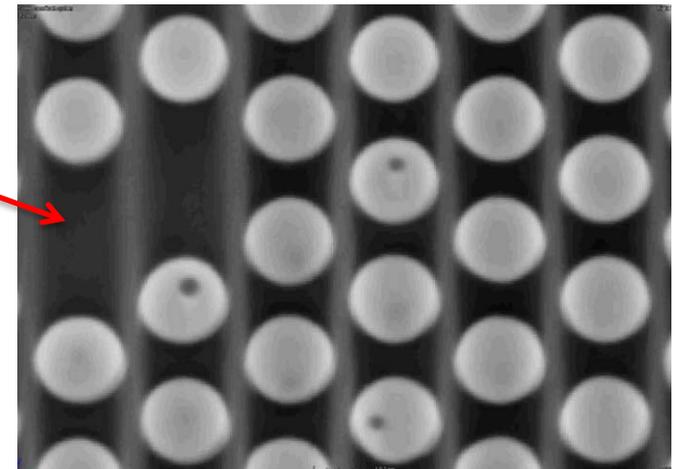
- ◆ **Poor imaging contrast** between voids in underfill and underfill material.
- ◆ **Beam hardening (BH) artifacts :**
 - ◆ Caused by the polychromatic nature of the X-ray source and the energy dependent characteristics of the object.
 - ◆ Leading to dark shading between solder balls in a BGA

BH artifacts

X-ray CT not compatible with underfill inspection

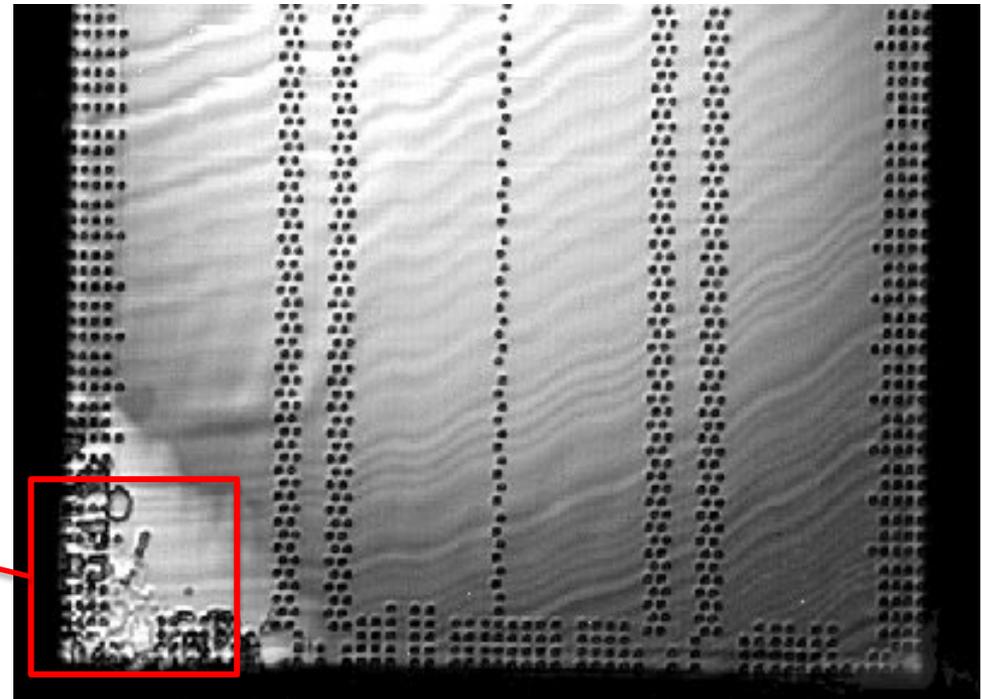
SAM image of a flip-chip BGA: underfill delamination and bumps resoldering

SAM is efficient for bumps and underfills of flip-chip components analysis

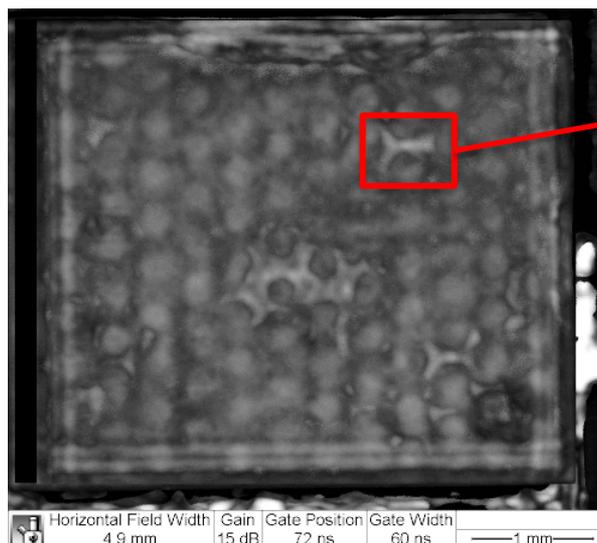
SAM image : **underfill delamination**

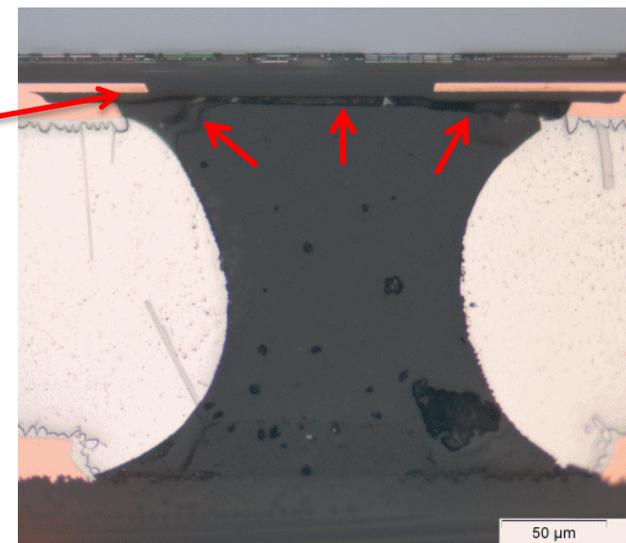
Cross-section view of the **delamination between underfill and WLP**

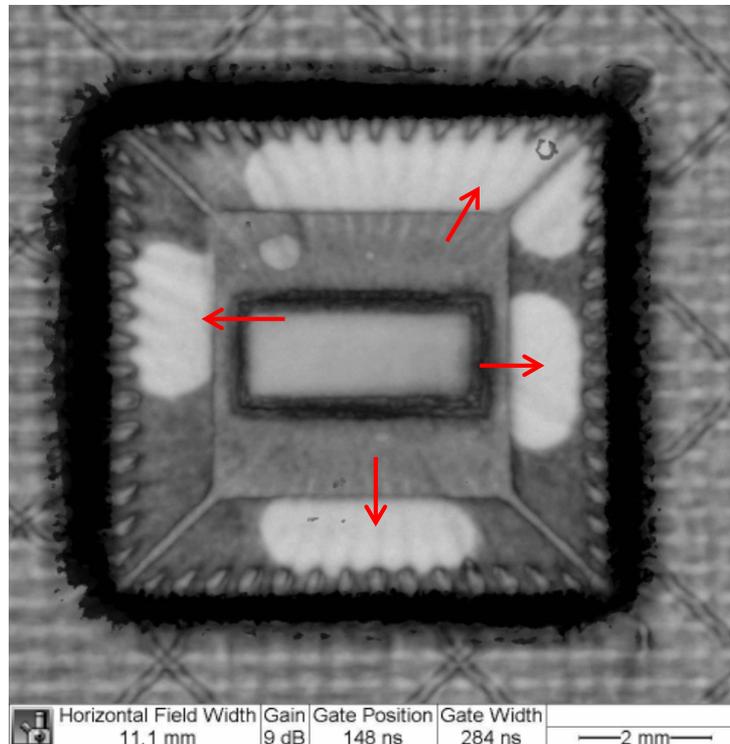
SAM image:
Large voids detected

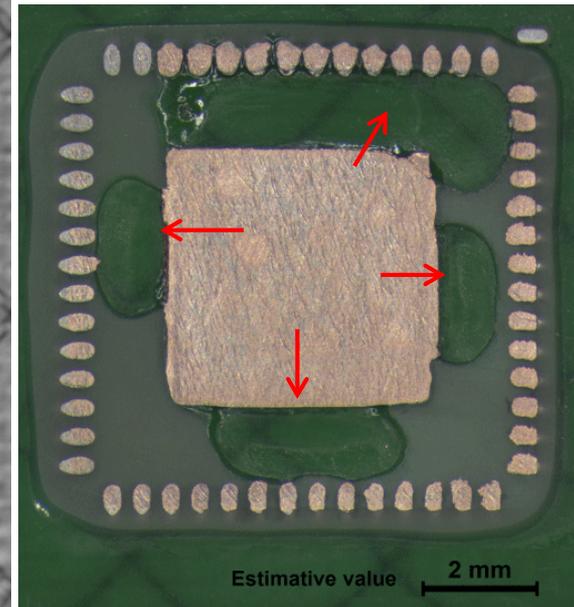
Planar cross-section:
Large voids confirmed

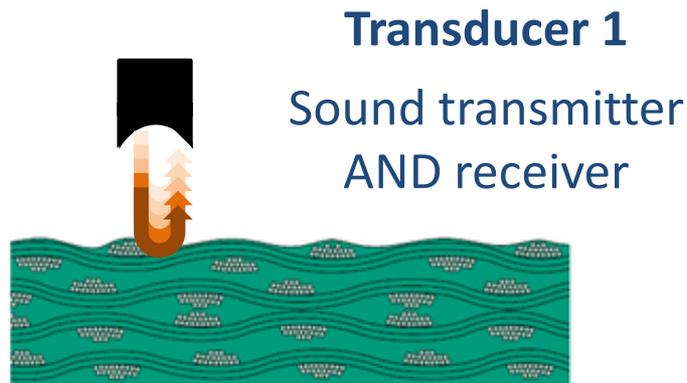
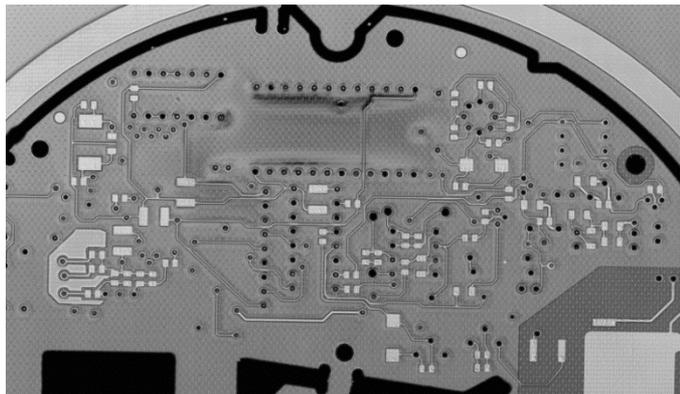
Reflexion mode : C-scan

C-scan: No defect detected

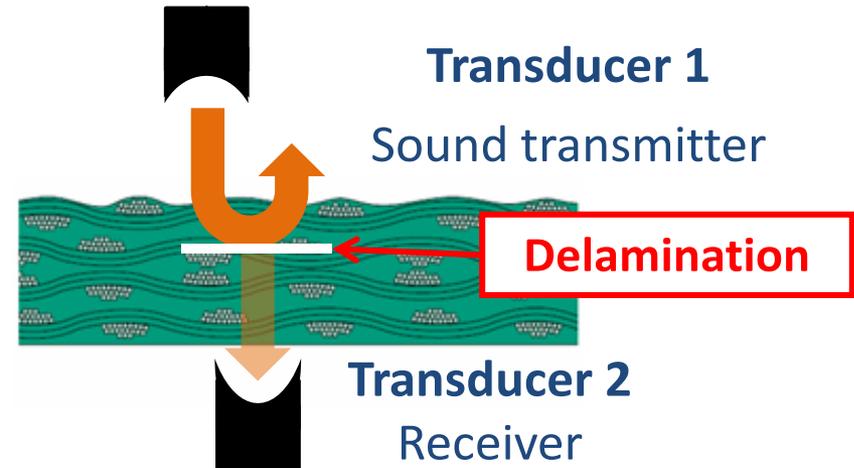
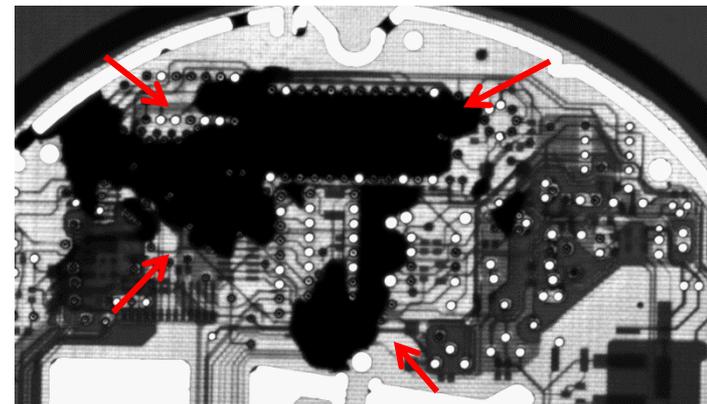
Transmission mode : Through-scan

Through scan: Black area =
Delamination in PCB

Through-scan is an option for PCB but has a low resolution

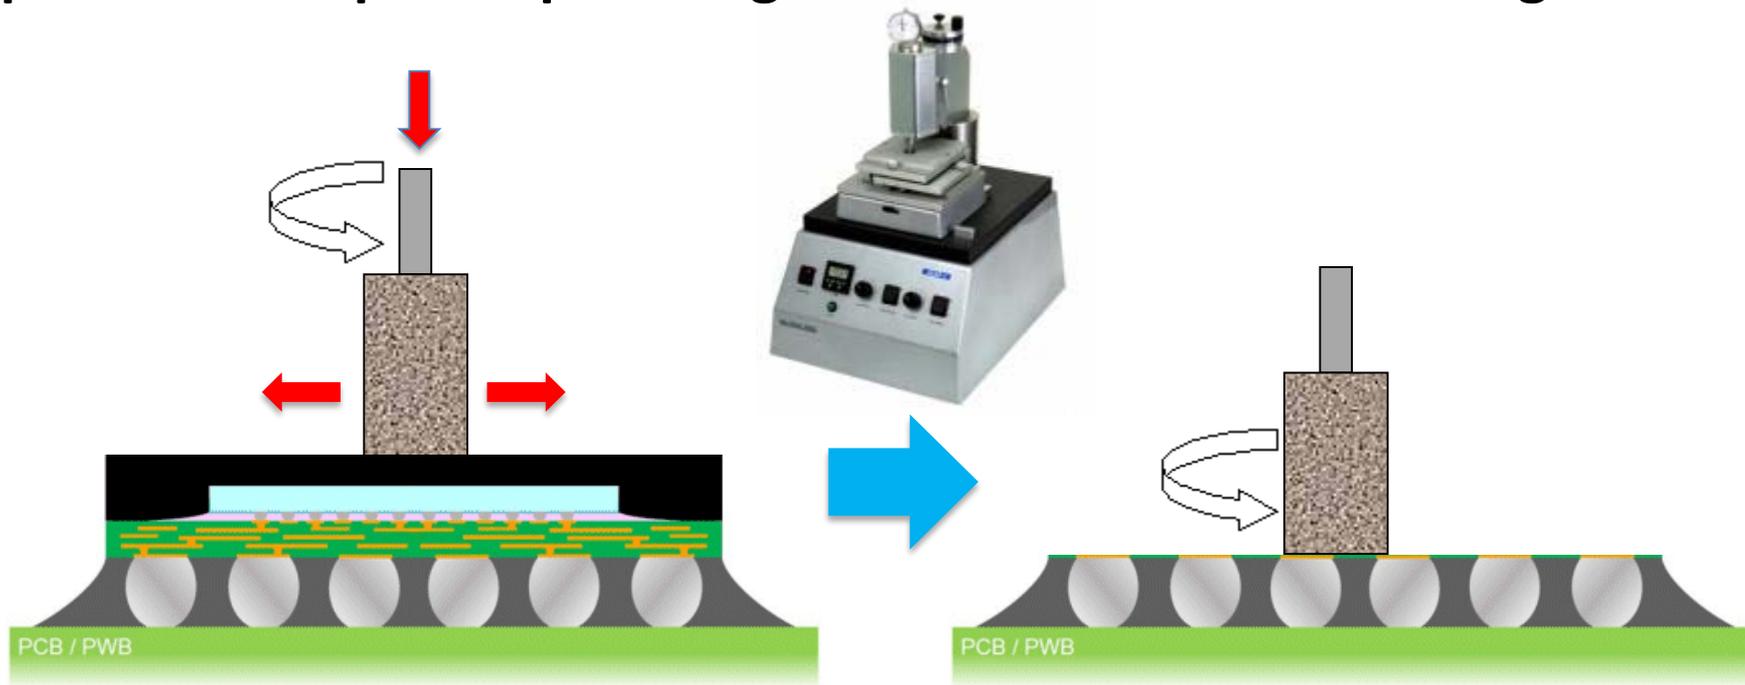
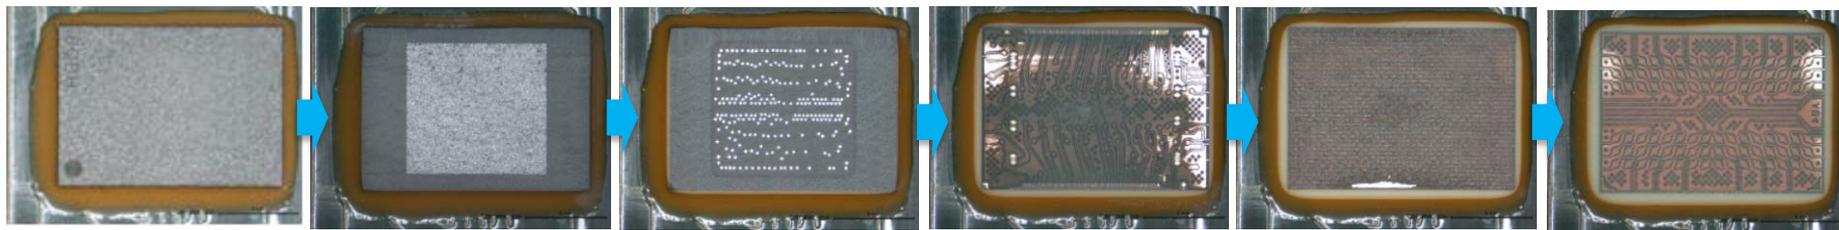
Step by step polishing of an underfilled BGA on board

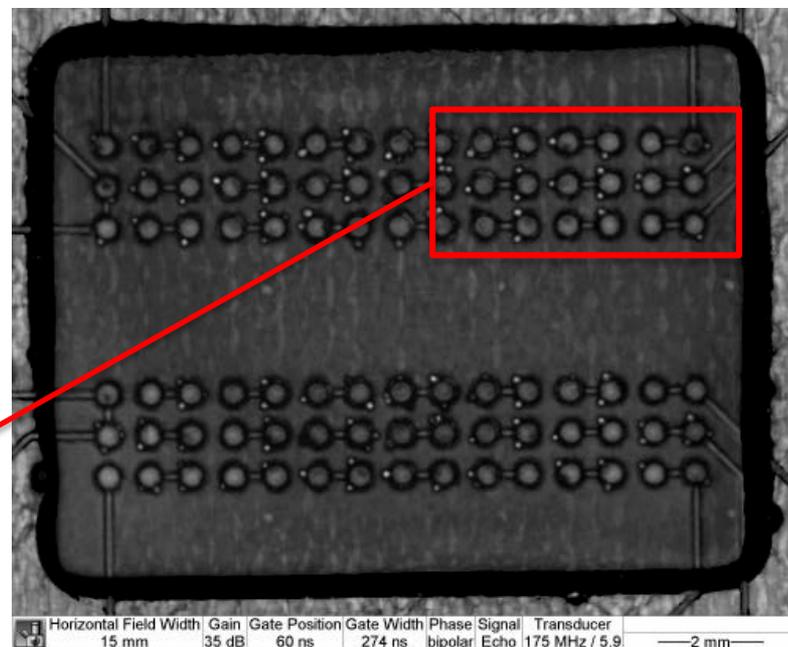
SAM image in C-scan of an underfilled BGA assembly after micro-mechanical polishing

Voids inside the underfill are detected with a lateral resolution down to 50 μ m by this technique

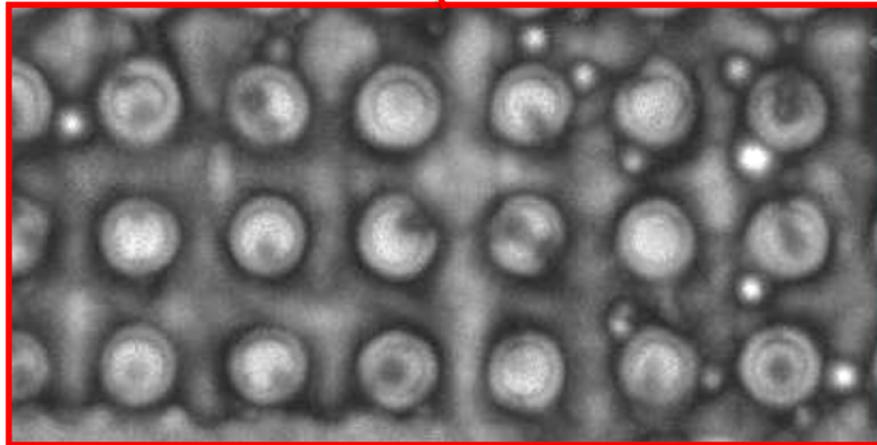
C-scan mode after micro-mechanical polishing

SAM inspection is more exhaustive and has a better sensitivity

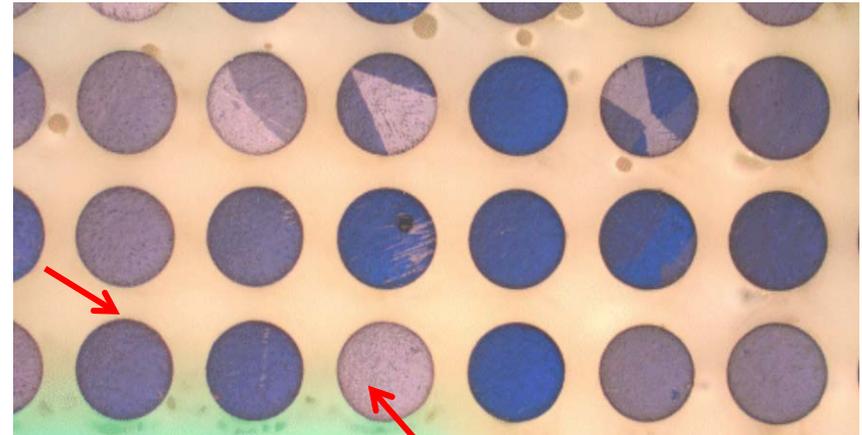
Optical inspection under polarized light after further planar polishing

Voids not detected optically

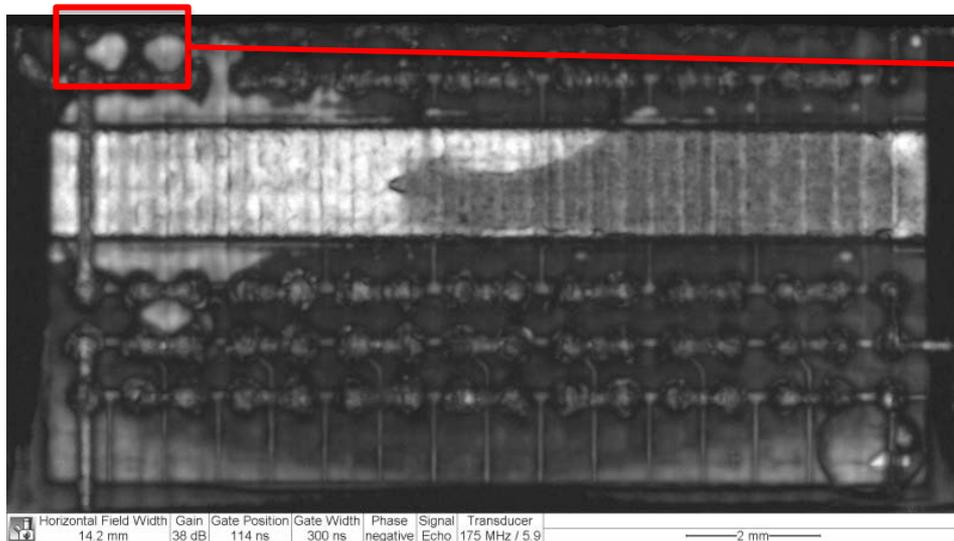
C-scan mode of an underfilled BGA assembly after micro-mechanical polishing:
delamination at underfill/BGA interface

BGA component failed open after only 645 cycles. The open was electrically localized on the first external solder joints row

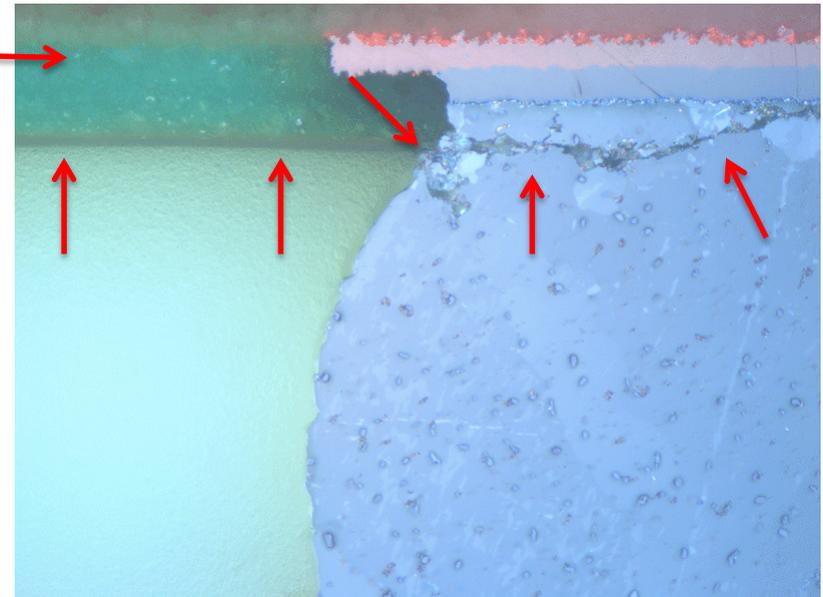
Cross-section view:
delamination at underfill/BGA interface generating cracks in the solder joints
