# IPC-CC-830B Versus the ‘Real World’: Part 2

Carolyn Taylor, Phil Kinner\*  
Electrolube Ltd  
Leicestershire, UK  
phil.kinner@electrolube.com

## Abstract

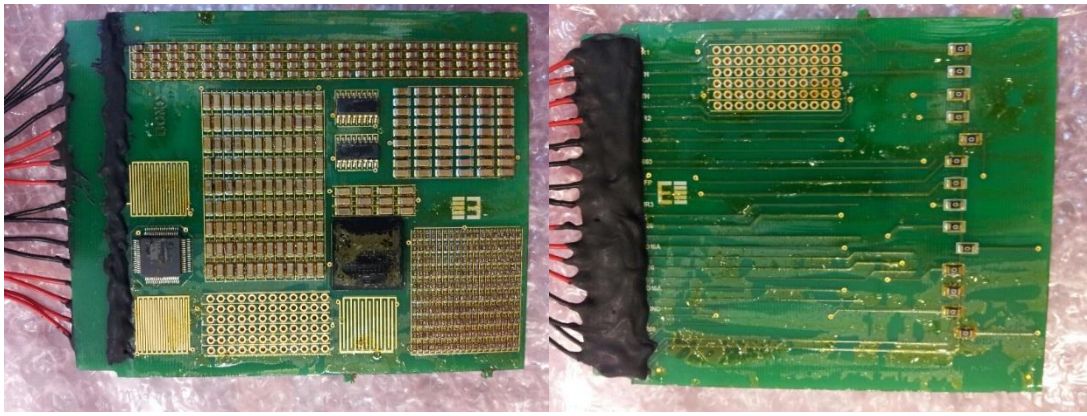
**Fig 7. Soldering and Potting of interconnects**

Since the thermal shock test regime was to be evaluated solely by visual inspection, the interconnects were not soldered until after the conformal coating process and thermal shock cycles had been completed. 1 mm, Teflon insulated, solid copper wire was hand soldered to the required test points, using a no-clean lead-free cored solder wire as shown in figure 7. A shield was used to prevent flux-reside spitting onto the test-board. The residues were left un-cleaned to minimize the potential for damage to the applied coating. To prevent the interconnect solder joints from being the cause of salt-spray failures, the solder joints and zero-Ohm resistors were completely encapsulated with a soft and flexible, hydrophobic polyurethane potting material, known to have good salt-spray resistance. The potting material was cured in accordance with the manufacturer's recommendations.

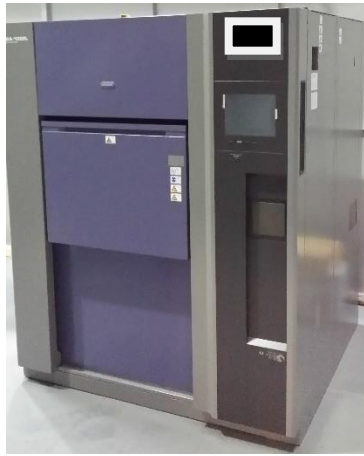
**Fig 9. Production thermal shock chamber**

Thermal shock testing is intended to fatigue the coating prior to evaluating long-term performance of the conformal coating in surviving rapid transitions in temperature. The IPC TM650 2.6.7.1 test-method was used for the purpose of this evaluation, although it was extended to 1000 cycles, typical of automotive applications, and was performed in a newly delivered, factory calibrated production chamber (shown in figure 9). Assemblies were subjected to 1000 cycles from -65°C (-85°F) to 125°C (257°F), with 15 minute dwells at temperature extremes in accordance with IPC TM650 2.6.7.1. Boards were removed after 100 cycles and then at 250, 500, 750 and 1000 cycles and visually inspected for cracks, delamination and other deleterious conditions at 10X magnification.

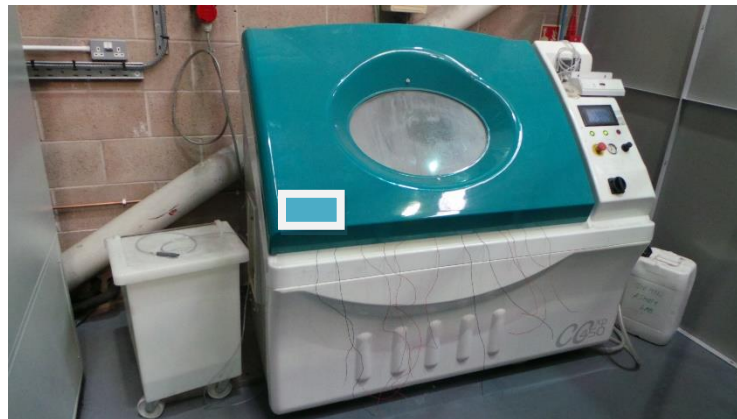
**Fig 10. Humidity / Salt-mist chamber**

Performed in accordance to IEC 60068-2-11, using 5% NaCl<sub>(aq)</sub> solution, in a calibrated production chamber (fig 10). Coupons were mounted in the chamber in vertical orientation to provide some draining, as typically seen in mounted assemblies. In a departure from the IEC test, bias was applied continuously during the test period, which was extended from 96 hours to 120 hours. The SIR of the test patterns were measured pre-, during (twice daily), and 48 hours post-test.

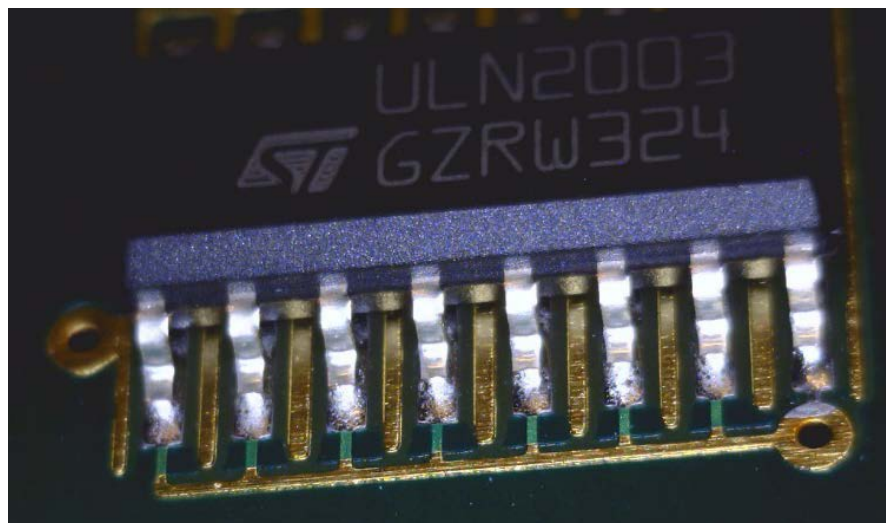
Leads at same bias
