# Improving Thermal Cycle and Mechanical Drop Impact Resistance of a Lead-free Tin-Silver-Bismuth-Indium Solder Alloy with Minor Doping of Copper Additive

<sup>1</sup>Koki Company Ltd., Japan, <sup>2</sup>Koki Solder America Inc., USA

## Abstract

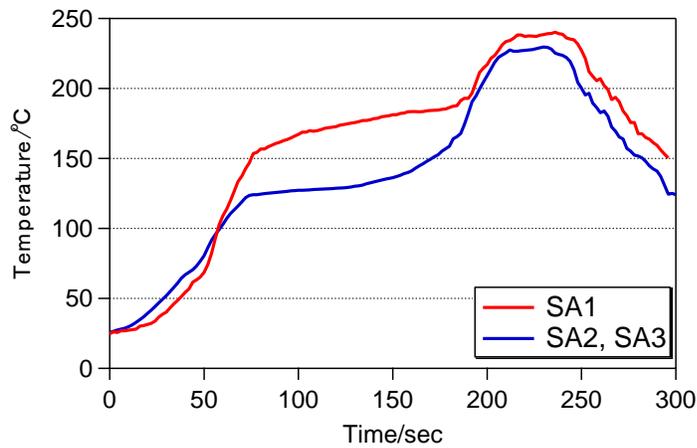
**Figure 2 - Reflow Profile(Air Atmosphere)**

The PCBs for this experiment were assembled using solder paste containing Type 4 solder powder of each alloy and no-clean flux. Solder pastes were printed using a 120µm thick metal stencil and reflowed using the specific reflow profile indicated in Figure 2 in air atmosphere. The time over liquidous temperature for the SA1 profile was 52 seconds and peak temperature of 245°C. The time over liquidus temperature for the SA2, SA3 profile was 53 seconds and peak temperature of 240°C. Different PCBs and components were used for thermal fatigue and drop tests.

- Type 4 solder pastes
- 5 mil thick metal stencil
- Air reflow
- TAL for SA1: 52 s and Peak Temp: 245°C.
- TAL for SA2 and SA3: 53 s and Peak Temp: 240°C.

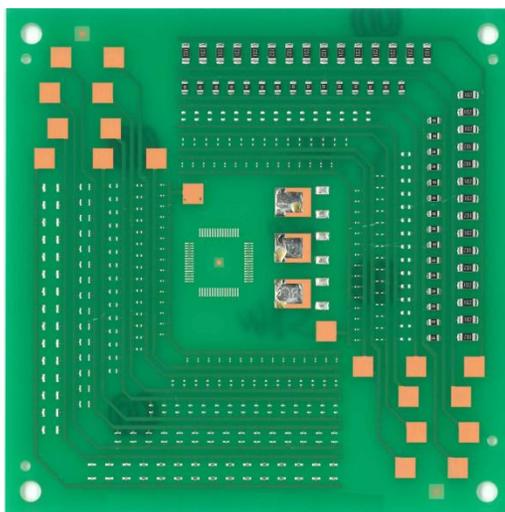
**Figure 3 - Test PCB for Thermal Cycling Test Evaluation (100x100mm)**

The test vehicle for the thermal fatigue test is shown in Figure 3. This test vehicle was intended to measure the electrical resistance of the soldered circuit as well as to measure the shear strength of the 1206 (3216 metric) and 0805 (2012 metric) chip resistors. Two different PCBs with surface finishes Cu-OSP and ENIG with the same 1.6mm thickness and FR-4 grade material were used.

Test vehicles were then placed in two separate test chambers. One was set to cycle from  $-40^{\circ}\text{C}$  to  $+125^{\circ}\text{C}$  and the other is set to cycle from  $-40^{\circ}\text{C}$  to  $+150^{\circ}\text{C}$ . Dwell time at each temperature was 30 minutes; which makes each thermal fatigue cycle about an hour.

The test PCB for the thermal cycling test is shown in Figure 3. The condition of the thermal cycle is  $-40^{\circ}\text{C}$  to  $+150^{\circ}\text{C}$ . The combined resistance was measured 10 to 20 minutes after the chamber was switched to the dwell time at high temperature, to let the sample temperature stabilize. Measurements were taken at a high temperature because the circuit is likely to be open, as the thermal expansion enlarges the crack. On the contrary, measurement during the dwell time at the low temperature was omitted as at a low temperature, cracks close up. In such a case, even if the solder joint has already been open owing to a penetrating crack, it may appear to be conducting on the measurement data.

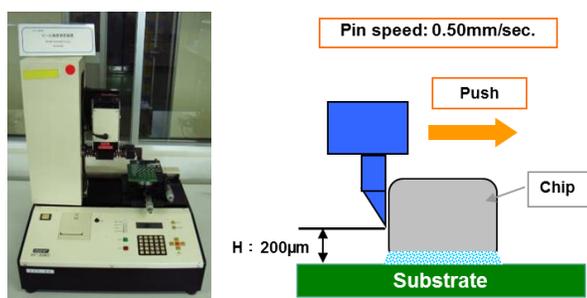
**Figure 4 - Bond Tester Equipment (Left) and Schematic of test method(Right)**

Shear strength tests were performed on the soldered test vehicles after taking some of the boards out every 500 cycles for each of the two profiles. The bond tester for the shear strength test is shown in the left of Figure 4 and the schematic image of the shear strength test is illustrated in the right of Figure 4, respectively. The clearance between the shearing jig and PCB is 0.2mm and the shear strength was calculated at a tool speed of 0.5mm/sec. Shear strength was recorded based on the maximum load that caused solder joint failure.

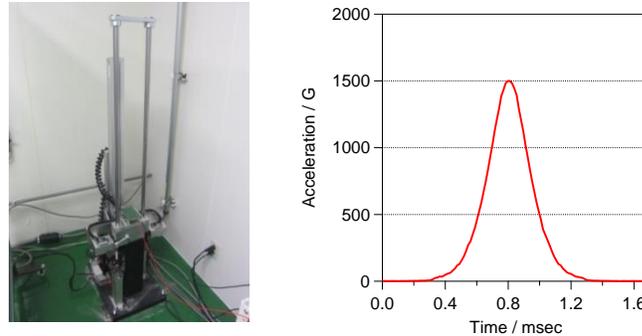
**(a)Test Equipment (b)Shock Wave**  
**Figure 5 - Drop Impact Test Equipment and Shock Wave**

To evaluate the shock resistance property of each solder alloy, board level drop tests were performed. Figure 5(a) shows the drop test machine and Figure 5(b) shows the shockwave. The drop test machine drops the test PCB from a pre-determined height to generate a 1500G, 0.5msec half sine impulse, the image of which is shown in Figure 5(b), until the voltage monitor detects electrical discontinuity.

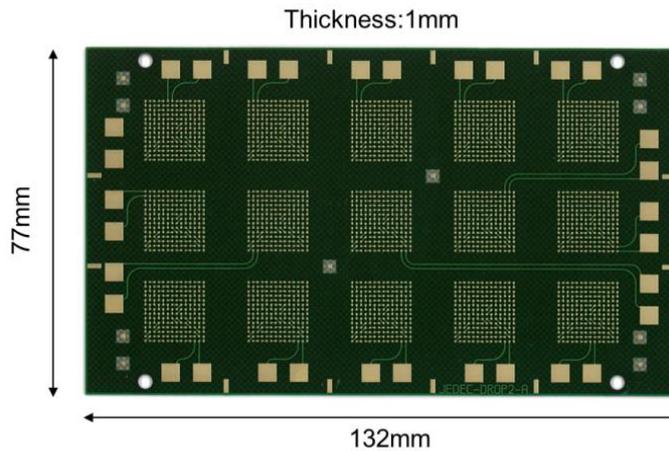
**Figure 6 - Test PCB for Board Level Drop Testing**

The test PCB for the board level drop test is indicated in Figure 6. This PCB has 8 layers and is 1 mm thick. The material is FR-5 grade and the board surface finish is Cu-OSP or ENIG. To detect the circuit failure by electrical discontinuity, the circuit is patterned so that all BGA balls are in one series circuit. One 15mm x 15mm BGA with 196 pins was mounted at the center of the test PCB. Solder balls on the BGA were Sn-3Ag-0.5Cu. The test PCB was then aged in an air atmosphere oven set at  $150^{\circ}\text{C}$  for 500 hours to promote the growth of the intermetallic compound phase at the solder joint interface. Bias voltage was constantly monitored to detect any change derived from the drop shock and to determine whether the circuit had failed [3]. Any change which exceeded bias voltage by more than 20% was regarded as a failure.

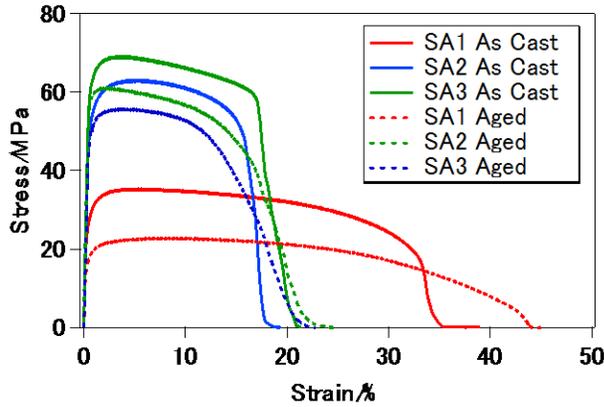
Figure 7 - Stress Strain Curves (SA1, SA2, SA3 alloys: as-cast and aged)

Figure 7 shows stress-strain curves from the tensile test. SA2 (SABI - SnAgBiIn) and SA3 (SABI + Cu - SnAgBiIn + Cu) display almost 3 times higher pull strength than SA1 (SnAgCu), a normal Sn-Ag-Cu type solder alloy. Since the difference between SA2 and SA3 is 0.8% Cu in their compositions, they were not significantly different. SA2 and SA3 had lower

elongation than SA1, which suggests that ductility is reduced by Bi in the solder structure.

All aged samples of tested alloy compositions showed reduced pull strength and increased elongation compared to as-cast samples. However, although SA1's pull strength reduced almost by half, SA2 and SA3, which contained In and Bi, showed rather insignificant loss of pull strength after aging. It can be noted that In and Bi are forming solid solution in the Sn matrix which strengthen the alloys.

- Both SABI (Sn-Ag-Bi-In) and SABIX (Sn-Ag-Bi-In +Cu) alloys had lower elongation than SAC305. Bi reduces ductility.
- SAC305 pull strength reduced to almost half after aging.
- In both SABI as well as SABIX alloys, the reduction in strength after aging is not as drastic as SAC305.
- This can be due to solid solution strengthening by In and Bi in Sn matrix

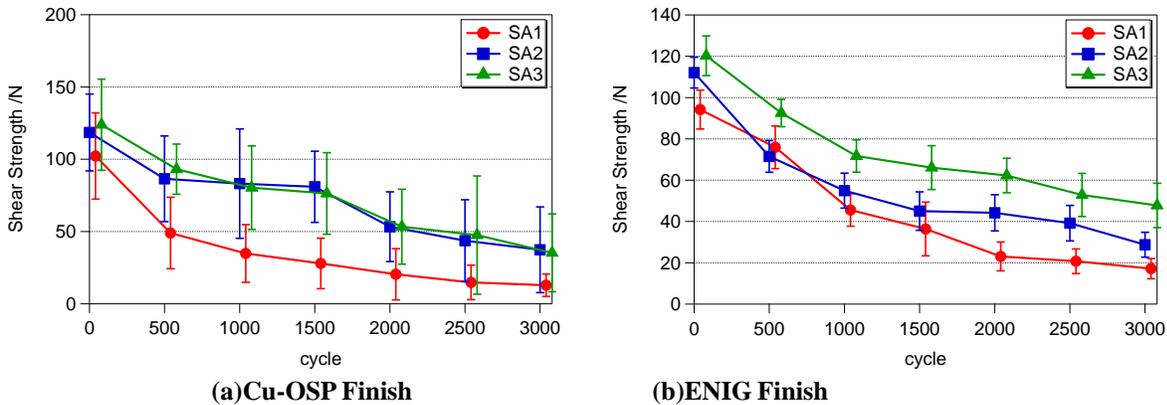
Figure 8 - Shear Strength Transition by Thermal Cycle for SA1, SA2, SA3 Alloys, (a) Cu-OSP Board Finish and (b) ENIG Board Finish

Shear strength test results for 1206 (3216metric) chip resistors after reflow (As Reflow) and after every 500 thermal cycles up to 3000 thermal cycles from -40°C to +125°C, are provided in Figure 8 (a) and Figure 8 (b) for Cu-OSP finish and ENIG board surface finishes, respectively. According to the transition of the shear strength, loss of strength was about the same between SA2 and SA3 on ENIG. In addition, SA2 and SA3 exhibited a smaller degree of strength loss as cycles increased. On the contrary, SA2 on ENIG board finish showed a more significant loss of the strength than on the Cu-OSP board finish, and the difference between SA2 and SA3 was larger on the ENIG board surface finish.

- As expected, both SABI and SABIX performed similarly on Cu-OSP surface finish.
- The loss of shear strength was about the same for either of the alloys
- Both the alloys outperformed SAC305 considerably.

- The minor alloying addition of Cu does seem to help SABI alloy in retaining the shear strength over the course of thermal fatigue cycling
- SABI alloy however significantly dropped in strength on ENIG as compared to Cu-OSP.
- The difference between strengths of SABI and SABI X seem to be larger on ENIG than that on Cu-OSP.

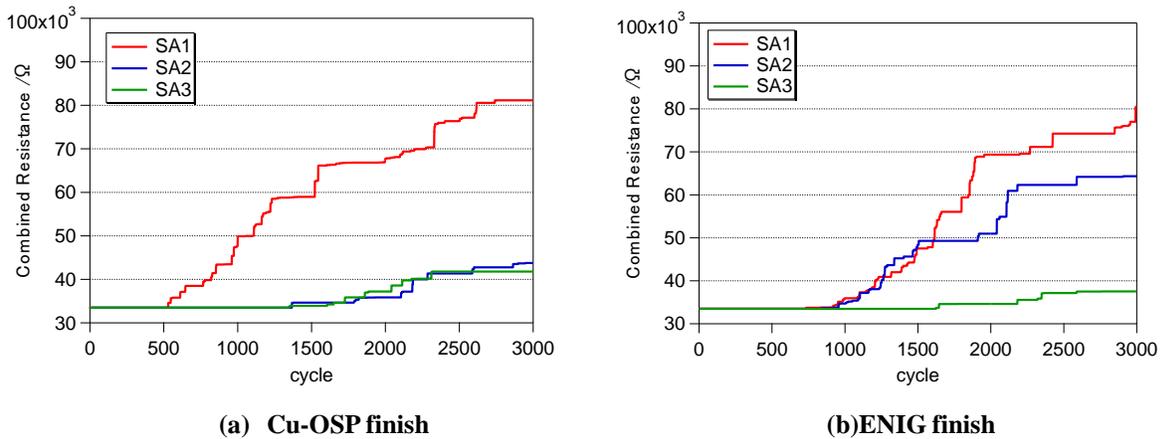
**Figure 9 - Transition of Combined Resistance of the Chip Resistors in Parallel during Thermal Cycling**

The combined resistance of the chip resistors during the thermal cycling test at -40°C to +125°C is shown in Figure 9. In this data, increase in measured resistance indicates decrease in n from Eq.(1), which means more solder joints in the circuit became open. At the beginning of the thermal cycling test, 30 chip resistors were electrically conducting; therefore, the combined resistance was  $3.3 \times 10^4 \Omega$ . Similar to the behavior seen in the shear strength test, increase in resistance is suppressed for SA2 and SA3 compared with SA1. In addition, SA2 and SA3 perform similarly in terms of an increasing trend in combined resistance on Cu-OSP board finish, whereas on ENIG board finish SA2 shows a more significant increasing resistance trend than SA3. According to these observations, it can be stated that SA2 and SA3 solder joints on ENIG board finish show different crack propagation behavior, unlike the solder joints of SA2 or SA3 on Cu-OSP board finish.

- Increase in combined resistance indicates solder joints in the circuit are failing.
- Increase in resistance is rather contained for SABI and SABIX alloys as compared with SAC305.
- In addition, as expected both SABI and SABIX performed similarly in terms of resistance increase on Cu-OSP.

- Increase in combined resistance indicates solder joints in the circuit are failing.
- Increase in resistance is rather contained for SABIX alloys as compared with SAC305 and SABI alloy.
- SABIX alloy outperformed both SAC305 as well as SABI alloy on ENIG surface finish which implies the minor addition of Cu does seem to help strengthen the alloy.

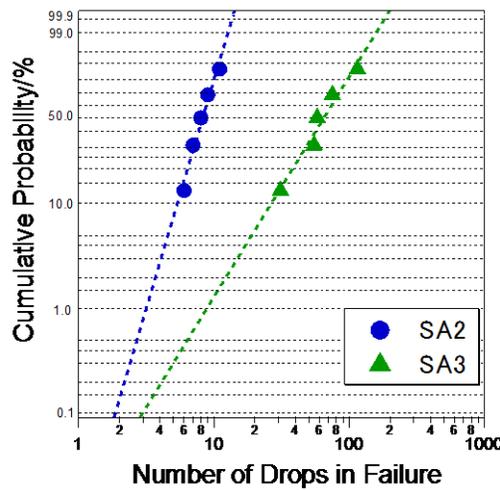
**Figure 10 - The Weibull Plot of the Number of Drops for Failure at the BGA's Circuit During Mechanical Drop Testing (SA2 and SA3 alloys after ageing on ENIG board finish)**

Board level drop testing was conducted on test samples prepared by soldering SA2 and SA3 solder alloys on ENIG board finish and ageing at high temperature. Five samples were prepared and dropped repeatedly until circuit failure was detected. The number of drops until circuit failure was plotted as Weibull plots as shown in Figure 10. Although the sample size was small for the Weibull plot, SA3 shows significantly better mechanical drop shock resistance as the solder alloy than SA2.

- SAC 305 BGA, daisy chained, isothermally aged at 150°C for 500 hours before starting the test.
- As the sample size is small (5), we are not trying to conclude anything but we can certainly see some positive result trends.
- SABIX alloy lasted at least 10 times more as compared to SABI alloy on ENIG surface finish after aging.
- Comprehensive test is going on and we will report the results in future work.

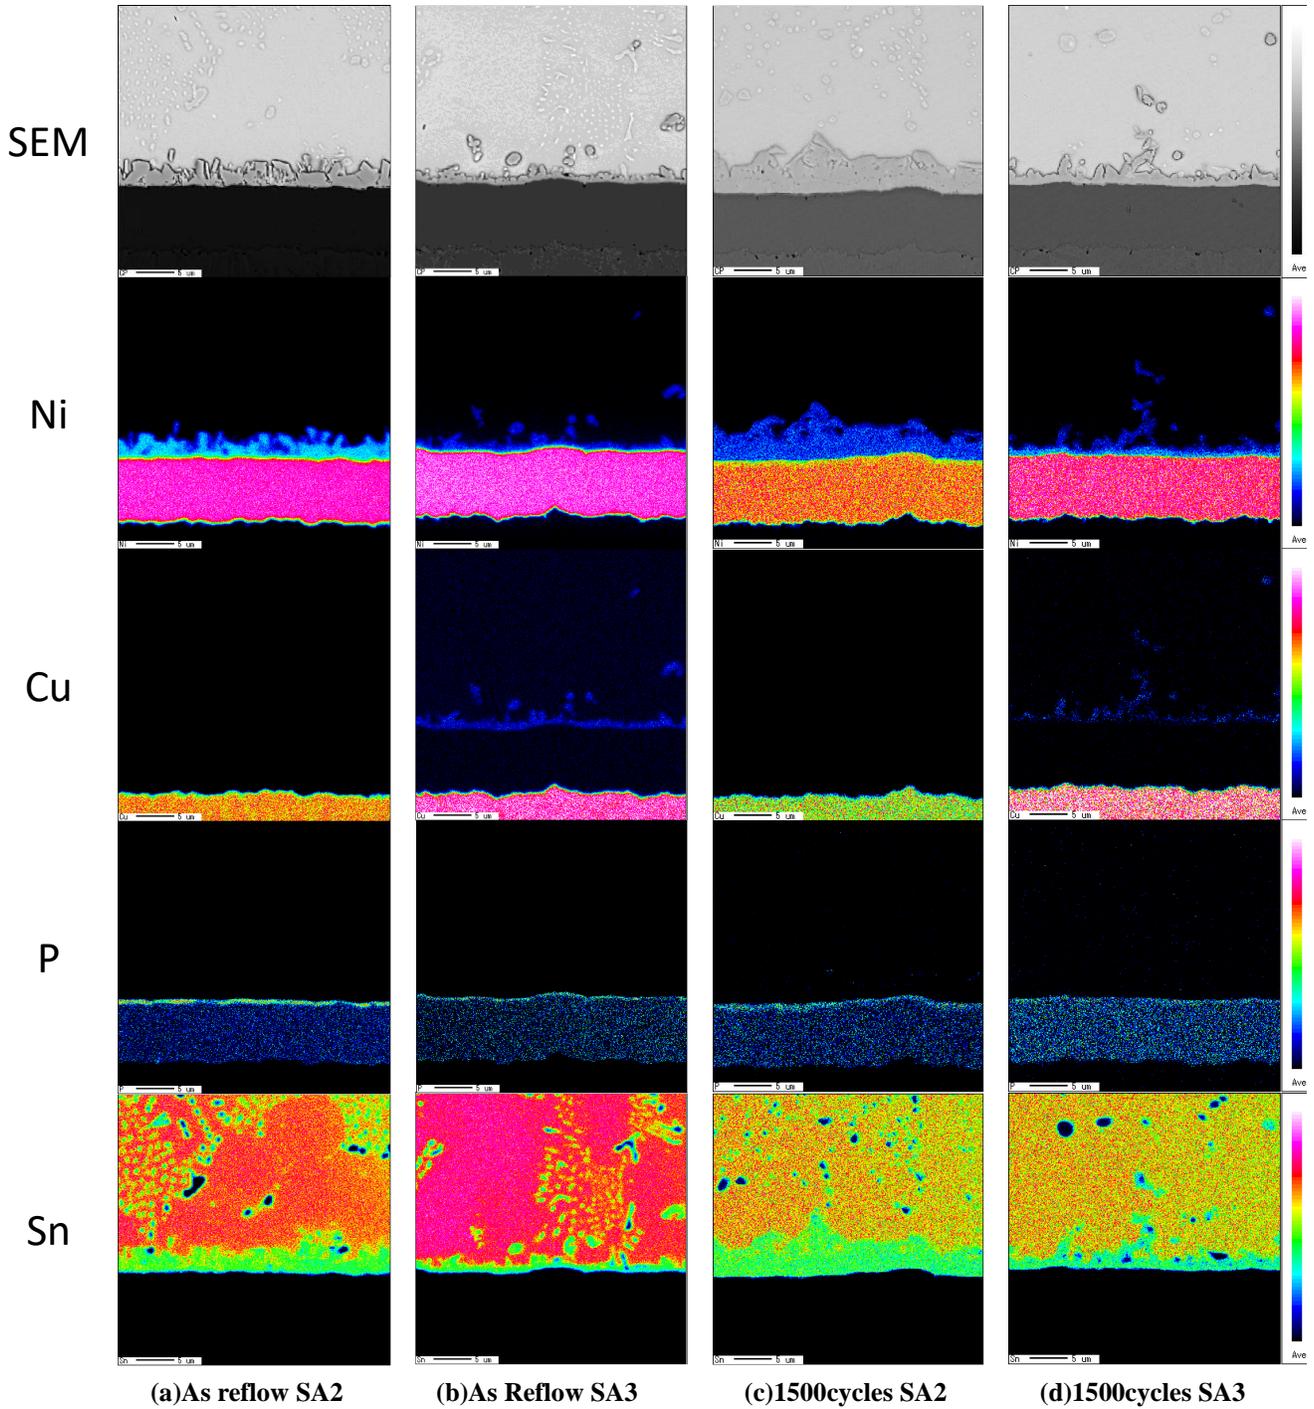
**Figure 11- Solder Joint Interface of ENIG Board Finish: As Reflowed and Thermal Cycled (Ni, Cu, P, Sn Analyzed)**

Two of the tested solder alloys, SA2 and SA3, were reflowed on test PCBs with ENIG board finish and cross-sectioned for the analysis by SEM-EDX. For each solder alloy, as reflowed and thermal cycled (from  $-40^{\circ}\text{C}$  to  $+125^{\circ}\text{C}$  for 1500 cycles) samples were prepared. SEM and elemental mapping images for different elements are shown in Figures 11 and 12.

As the lands on the PCB have ENIG surface finish, Phosphorus (P) exists in the Ni layer and Au exists on top of the Ni layer. Comparison between SA2 and SA3 for as reflowed samples revealed that the intermetallic compound layer at the joint interface was thicker for SA2. The compound layer for SA2 mainly consisted of Sn-In-Cu, while SA3's compound layer consisted of Sn-Cu-Ni. By adding a small amount of Cu in the solder alloy, the intermetallic compound layer at the joint interface on ENIG board finish incorporates Cu, and inhibits the growth of the compound layer. This has contributed to improved joint reliability performance during the thermal cycling for SA3 versus SA2 soldered on the ENIG finished PCBs.

P is slightly concentrated at the interface between the intermetallic compound layer and the Ni layer. This suggests that originally, Ni and P were uniformly distributed in the Ni layer, but while Ni moved to the compound layer, the P did not move but rather concentrated around the interface. Thus, when compared to SA3, SA2 exhibits a higher P concentration at the intermetallic/solder interface as its Ni layer at the joint interface has been eroded further.

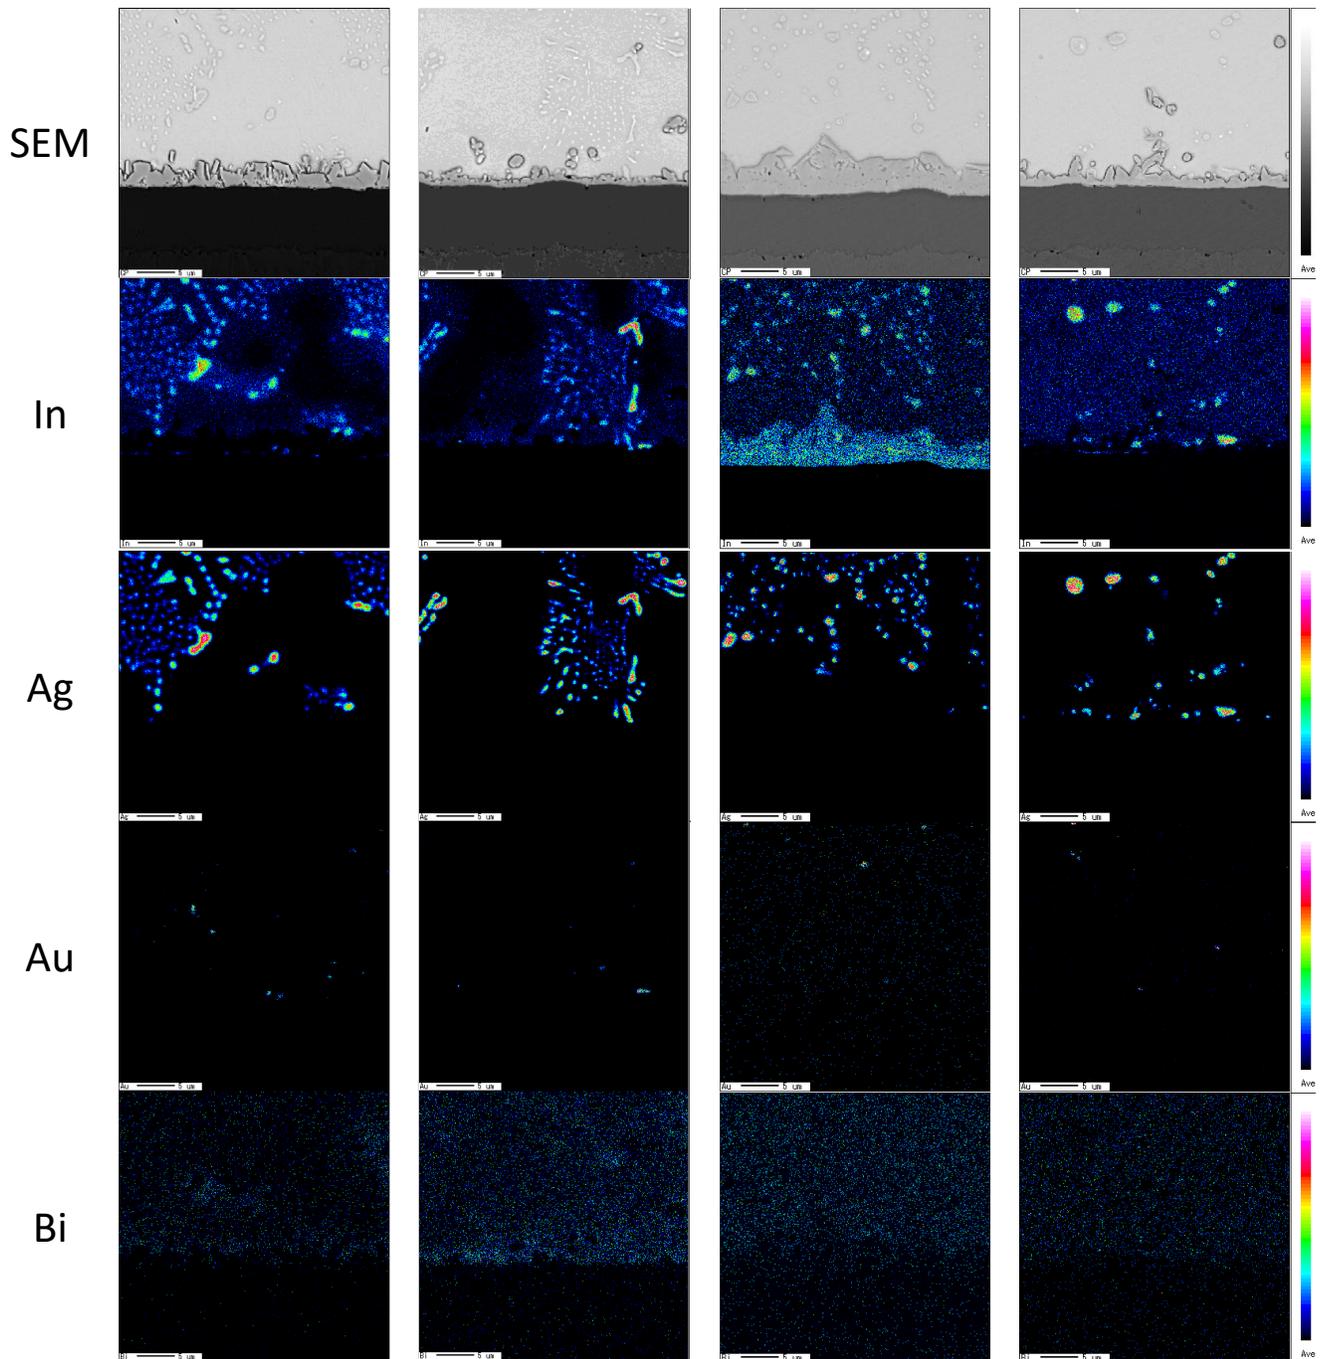
(a)As reflow SA2 (b)As Reflow SA3 (c)1500cycles SA2 (d)1500cycles SA3  
**Figure 12- Solder Joint Interface of ENIG Board Finish: As Reflow and Thermal Cycled (In, Ag, Au, Bi Analyzed)**

As for the Ag, it forms an intermetallic compound with Sn and In in the solder phase; however, it is scarcely detected within the compound layer with Ni content at the joint interface. Au, the plated and outermost layer of the ENIG finish, and Bi, an additive element in the solder alloy, are not detected in the vicinity of the joint interface and are difficult to identify, as they are forming solid solution uniformly in the solder phase.

- **For as reflowed samples, thicker IMC for SABI as compared to SABIX**
- **SABI IMC consisted of Sn-In-Cu**
- **SABIX IMC consisted of Sn-Cu-Ni**
- **Minor alloying by Cu seems to inhibit IMC growth for SABIX alloy after TC which explains superior drop shock reliability as compared to SABI alloy.**
- **SABI alloy seems to exhibit stronger P concentration at interface as compared to SABIX alloy.**

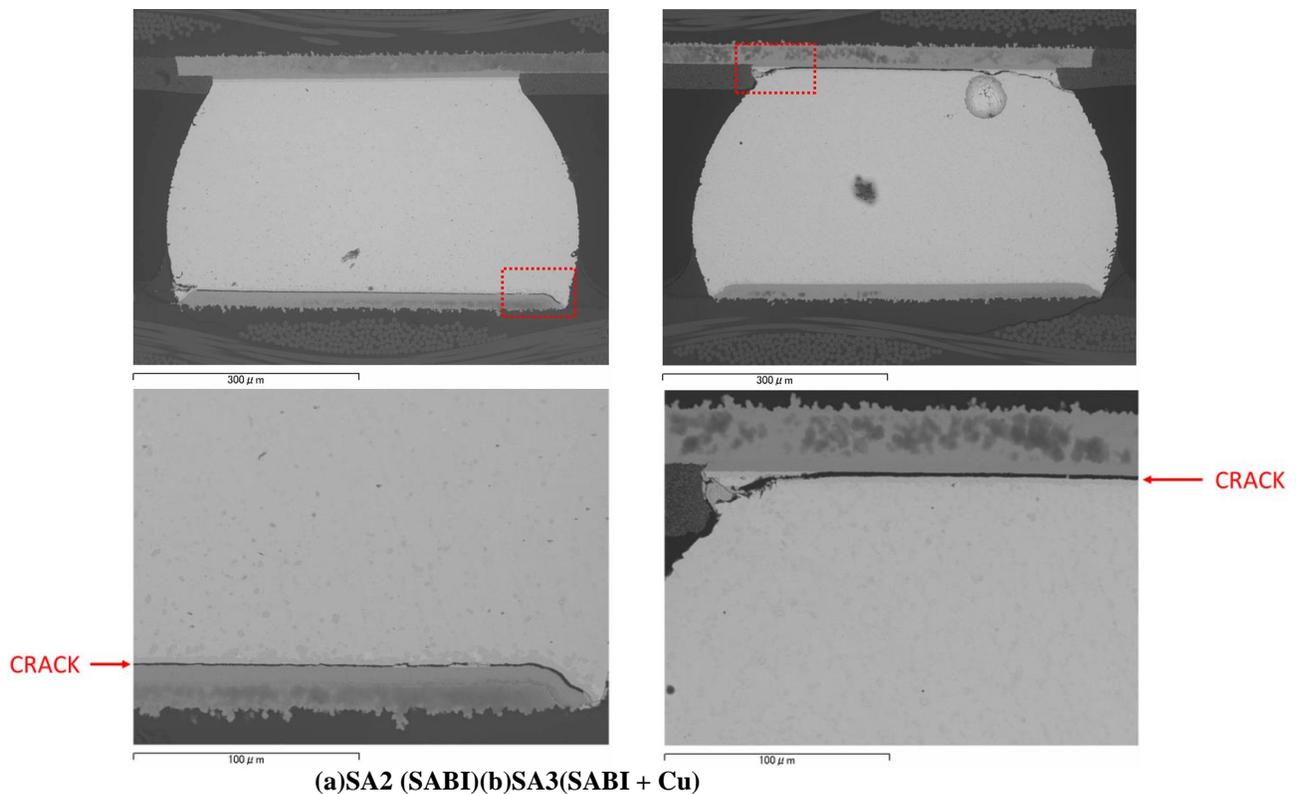
**Figure 13– Solder Joints Fractured in Board Level Drop Testing (Top: Whole Cracked Ball, Bottom: Magnified Crack) (a) SA2 (b) SA3**

Figure 13 shows the cross-sectioned solder joints after they failed in the board drop tests. Each sample suggests that the joint fracture initiated from one of four corners as it is assumed that these four corners are exposed to the most stress, as the joint fracture occurs when the board is warped by the drop impact and the solder joints beneath the BGA are stressed.

Evaluation of the fractured solder joint at the BGA revealed that the location of the fracture is different between SA2 and SA3. For SA2 fracture occurred between the solder ball and PCB, and for SA3, fracture occurred between the solder ball and the component. Since the lands on the PCB are larger than those on the component, it is anticipated to fracture at the component side. However, on all SA2 samples, all fractures occurred between solder ball and PCB.

In the board drop testing, abrupt loads were applied to the test PCB, and it was expected that the most vulnerable location prone to fracture would be the interface where materials with different hardness values meet. This is due to high speed strains causing cracking at the interface of materials of different hardness, an example being the tin-bismuth ball bump not being cracked in the bulk ball but at the interface with the substrate.

The most vulnerable location in the solder joint is the joint interface. In this test, test PCBs were prepared by printing SA2 and SA3 solder paste, mounting the BGA with Sn-Ag-Cu type solder balls and reflowing. During the reflow, SA2 and SA3 pastes melted first, as their melting points are lower than SAC305, forming joints between the solder ball and land on the PCB. Thus, the solder joint composition between the solder ball and land mainly consisted of SA2 and SA3, while the solder joint composition between solder ball and component side mainly consisted of SAC305.

As for the distinctively short life in the board level drop test and the fracture at solder ball and land interface on the PCB side, phosphorus may have contributed to these phenomena. Phosphorus concentration causes embrittlement of the metal; therefore, once the P concentrates at the interface as seen in the SA2 element mapping in Figure 11, the embrittlement effect can be accelerated which can deteriorate impact resistance. The phosphorus concentration layer of SA2 is thicker than that of SA3.

- For SABIX alloy, fracture occurred at board side and for that of SABIX alloy it occurred at component side.
- As we used SAC305 BGAs, component side was predominantly SAC305.
- The failure location difference may be accounted for by the higher P concentration.

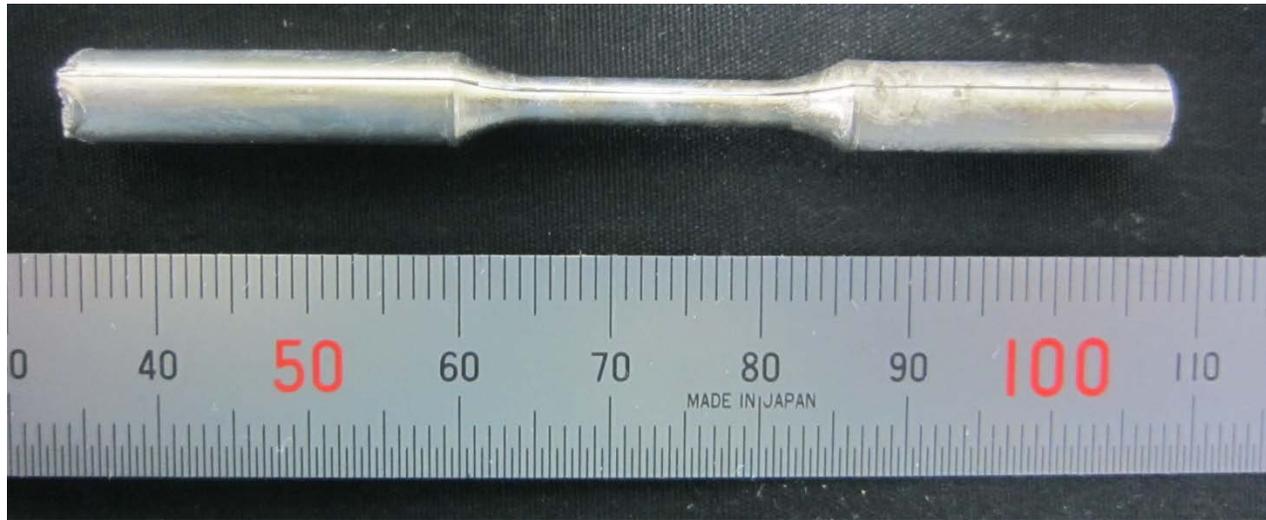
- Pull test on cast micro-dumbbell, of which the diameter at the section is  $\phi$  3mm.
- Since the microstructure of the solder alloys after soldering is the same as the structure of the casted metal, the micro-dumbbell for the evaluation was cast using a die.

- To obtain equivalent microstructure as the actual solder joint, molten alloys were casted into a die preheated at 573K (300°C).
- Then the filled die is cooled down in a cooling solution which is formulated to obtain the same cooling rate as actual soldering process, about 5K/s
- Observation on the cross section at the gauge marks of the prepared dumbbell revealed uniform microstructure as intended.

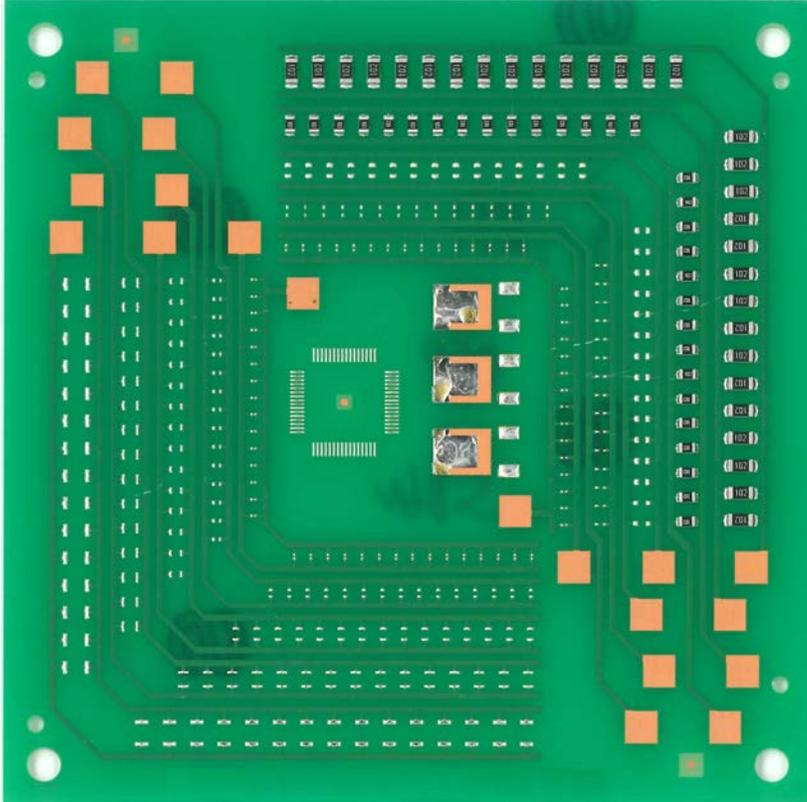
Test PCB for Thermal Cycling Test  
Evaluation(100x100mm)

- 1.6mm thickness and FR-4
- 1206 (3216 metric) and 0805 (2012 metric) chip resistors.
- Two different PCBs:
  - Cu-OSP and
  - ENIG
- Two different thermal cycles:
  - -40C to + 125°C
  - -40C to + 150°C
- 30 min dwell at each extreme.

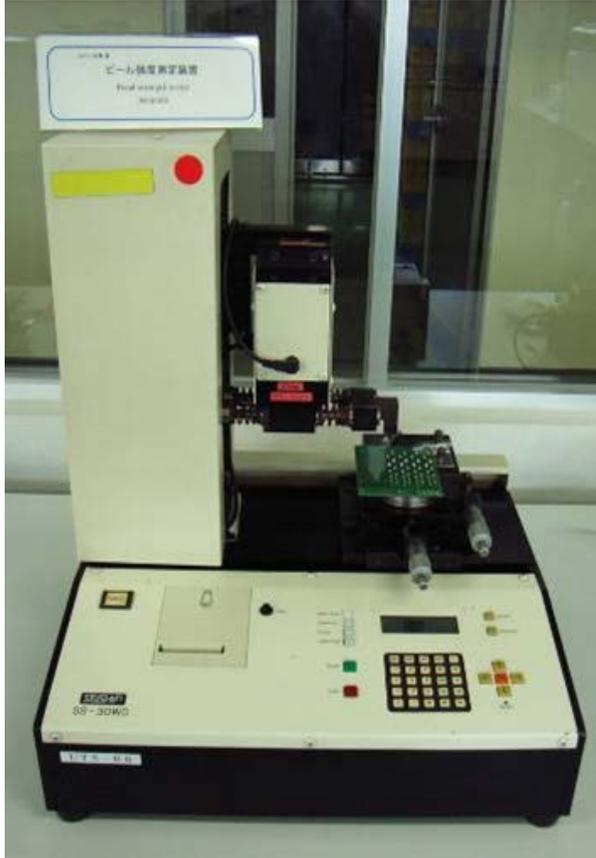
Bond Tester Equipment

- Test performed after:
  - Time 0 (As-Reflowed)
  - Every 500 cycles till 3000 cycles
- Some boards taken out after every 500 cycles
- Shear Speed: 0.5 mm/s
- Stand-off height: 0.2 mm

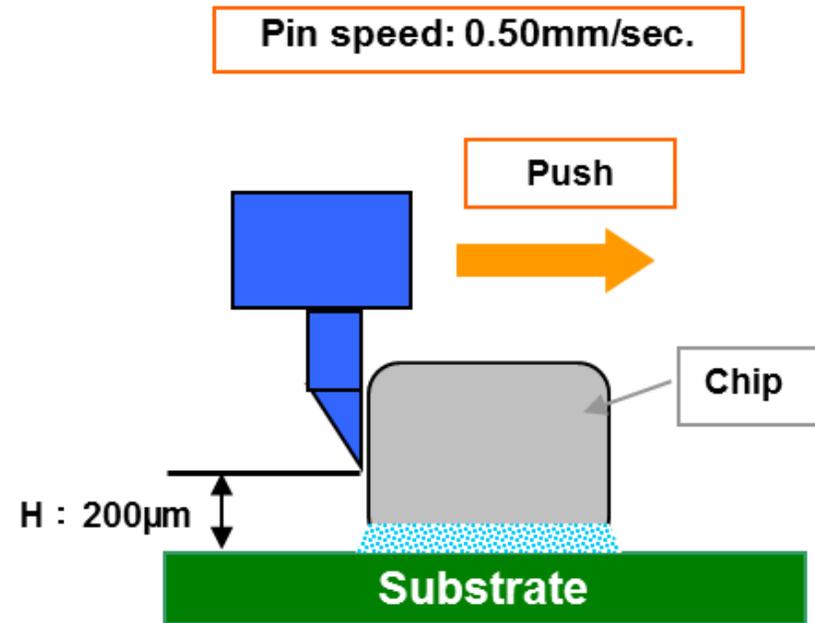
Schematic of shear test

Pin speed: 0.50mm/sec.

H : 200µm

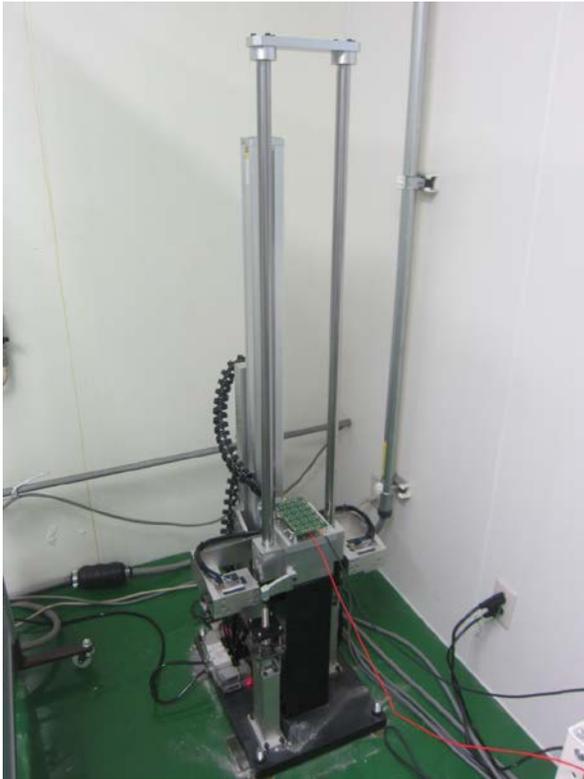
Test Equipment

- Test performed at:
  - 1500G
  - 0.5 msec half sine impulse
- Stopped after detecting discontinuity in voltage monitor

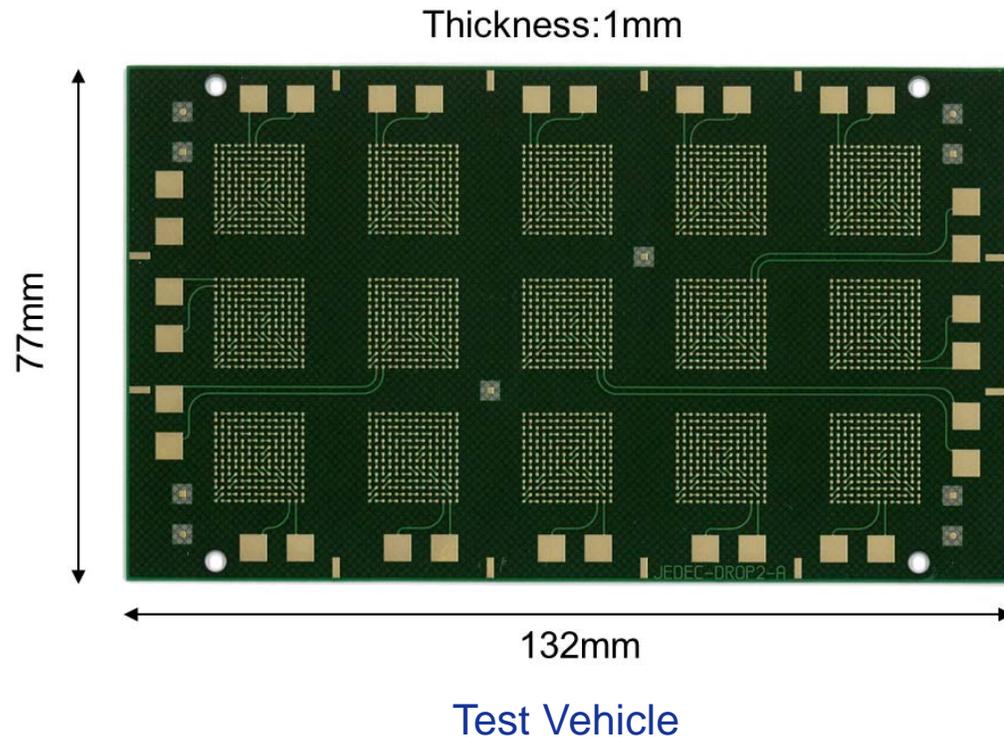
- 8 layers, FR-5 grade
- Two different board finishes :
  - Cu-OSP and
  - ENIG
- Daisy chain circuit
- One 15mm x 15mm BGA with 196 pins per board. (Solder Balls – SAC 305)
- Isothermal Aging at 150 °C for 500 hours before begin the test for IMC growth
- Failure recorded after >20% increase in bias voltage

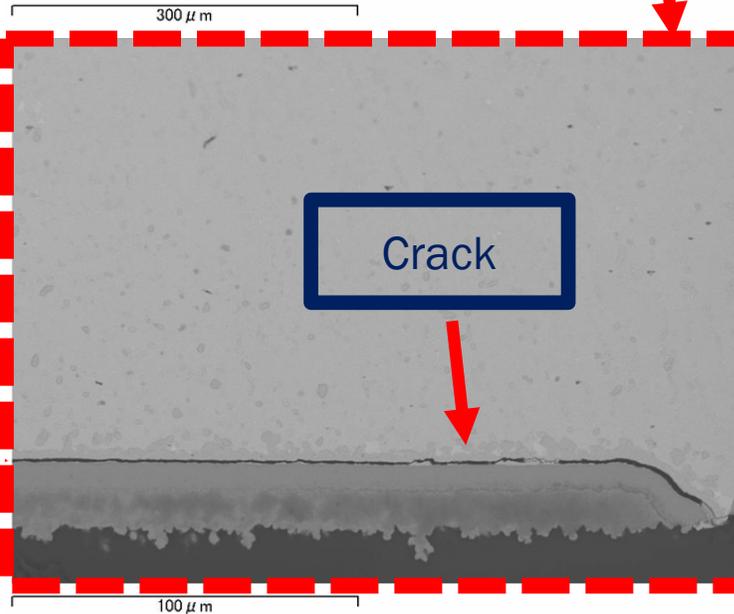
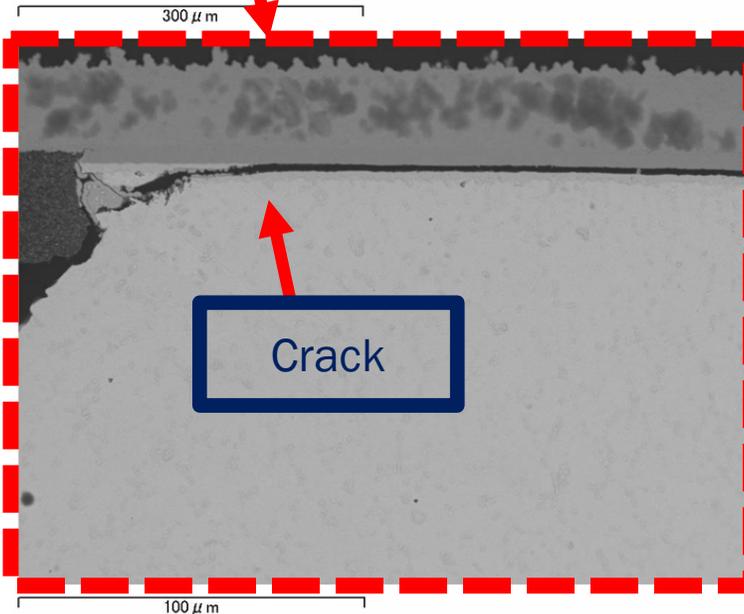
a) Failed SABIX alloy joint in drop test  
b) Failed SABIX alloy joint in drop test
