An Investigation into Lead-Free Low Silver Cored Solder Wire for Electronics Manufacturing Applications

Shantanu Joshi¹, Jasbir Bath¹, Kimiaki Mori², Kazuhiro Yukikata², Roberto Garcia¹, Takeshi Shirai²
¹Koki Solder America Inc., USA, ²Koki Company Ltd., Japan,

Abstract

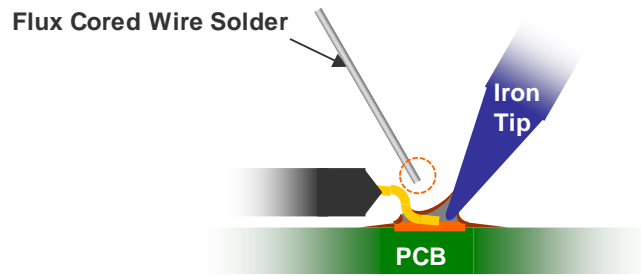
Figure 1: A Typical Solder Wire Application

Slide soldering is one of the soldering techniques useful to solder connectors to obtain high joint strength at a narrow location by selecting the appropriate rework wire diameter and solder iron tip size. Slide soldering by automation enables a large number of connector pins to be soldered in a single stretch; therefore, it is widely used at many manufacturing factories. To achieve both speed and quality using slide soldering, pins or leads must wet quickly and the solder must wrap around them very quickly.

For a quality solder joint with flux cored solder wire, the flux should remove all the oxidized layers on the component as well as printed circuit board pads. Also, care should be taken to apply the appropriate quantity of wire solder at an appropriate temperature at specific durations (Figure 1). These principals are common for both manual and automated soldering. Among these principals, maintaining appropriate temperature is difficult and is the main cause of the majority of the defects. When the tip temperature is low, solder fluidity starts to worsen and causes improper wetting of the pads. This may cause either bad solder fillet formation, insufficient through hole filling and/ or solder bridging.

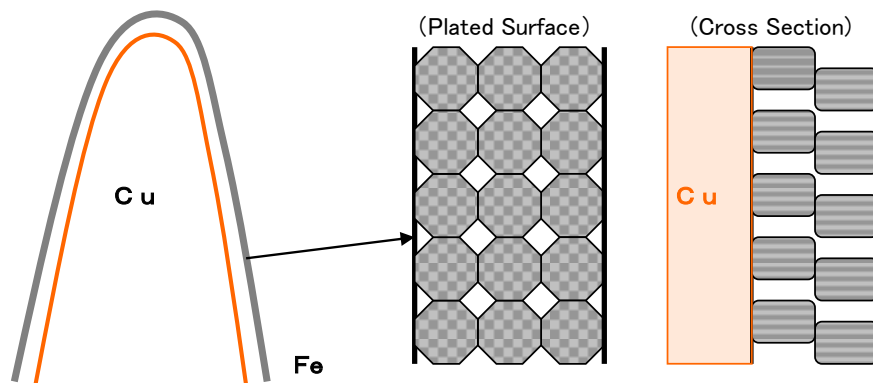
Figure 2: Soldering tip cross section

The conventional alloy composition of lead free rosin flux cored wires is typically by Sn3Ag0.5Cu (SAC305), which results in much higher tin content as compared to eutectic tin/lead solder alloy. Usually, the soldering tips are made up of copper and plated with iron to about 250 ~ 300 μm thickness. The micro-structure of the plated iron shows, crystal grains aligned in a direction perpendicular to the Cu material, and since they are porous crystals, there is a gap between the crystals as shown in Figure 2.

During soldering, iron-tin (Fe-Sn) intermetallic compounds are formed on the plated surface. Although this intermetallic compound has a melting temperature as high as $\sim 500^\circ\text{C}$, it does not melt and spread completely on the Fe plated surface due to high surface tension. As a result of which there is a partial barrier to protect the copper core of the tip. As soon as the soldering begins in full flow, tin in solder can penetrate through this gap dissolving the copper tip core in the process. The dissolved copper then flows outside of the core making the core thinner and disrupting the iron plating. This is a typical phenomenon by which the tip gets eroded causing to the replacement of the soldering iron tip which increases cost.

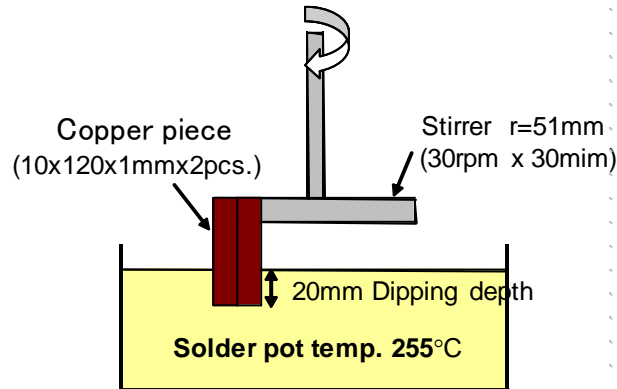
Figure 3: Copper Plate Erosion Test Schematic

The amount of eroded copper during soldering with different alloys (Sn3Ag0.5Cu, Sn0.7Cu, Sn0.3Ag0.7Cu, Sn0.3Ag0.7Cu0.04Co) was tested by attaching two copper piece test samples to a stirrer and applying a relatively aggressive no-clean soldering flux in a molten solder pot. After drying of the applied flux, the tips of the copper test pieces were dipped into the molten solder bath to a depth of 20mm. The test pieces were stirred for 30 minutes and the amount of Cu eroded into the solder was measured. The test equipment used is shown in Figure 3. The test piece was copper plate of 10×120 mm dimensions and 1mm thickness. The solder pot temperature was 255°C with an agitation speed of 30 rpm.

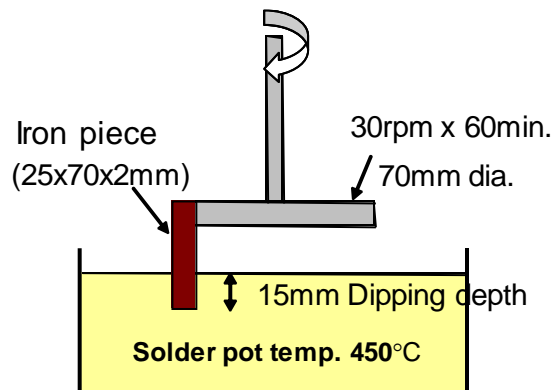
Figure 4: Iron Plate Erosion Test Schematic

The amount of eroded iron during solder with different alloys (Sn3Ag0.5Cu, Sn0.7Cu, Sn40Pb, Sn0.3Ag0.7Cu0.04Co) was tested by attaching an iron plate piece test samples to a stirrer and applying a relatively aggressive no-clean soldering flux in a molten solder pot. After drying of the applied flux, the tip of the iron test piece was dipped into the molten solder bath to a depth of 15mm. The test pieces were stirred for 60 minutes and the amount of Fe eroded into the solder was measured. The test equipment used is shown in Figure 4. The test piece was iron plate of 25×70mm dimensions and 2mm thickness. The solder pot temperature was 450°C with an agitation speed of 30 rpm.

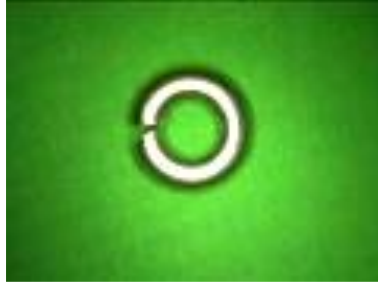
Figure 5: Solder ring for spreading test

Two lead-free alloys were tested in the solder spreading test, Sn3Ag0.5Cu and Sn0.3Ag0.7Cu0.04Co. To test the spreading of the solder on different surfaces, three different metal plates were used for the study. Copper, nickel and brass plates were used after cleaning / degreasing with organic solvent. One of the sides of the plate was polished with abrasive paper, then cleaned with alcohol and dried. Each resin flux cored solder wire of 0.8 mm ϕ was placed in a wound circular position condition (Ring inner diameter: 1.6 mm ϕ) at the center of the respective plate as shown in Figure 5. The same ROL0 no-clean flux in the rework wire was used for both lead-free alloys tested. The test vehicle was heated by keeping it floating in a solder bath kept at 300°C for 5 sec. The test vehicle was removed from the solder bath and allowed to cool down to room temperature. Flux residue was removed with a suitable solvent.

The height of the spread solder was measured by a micrometer. Using the measured value, the spreading ratio was calculated from Equation (1). This procedure was carried out on 5 test pieces for each solder alloy/ substrate combination and the mean value obtained as the spreading ratio of the specimen.

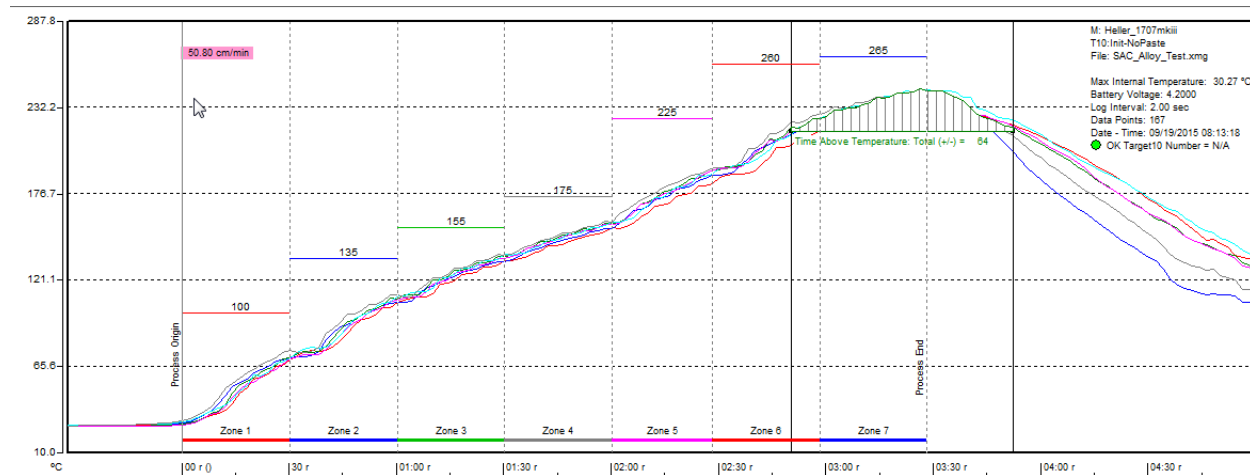
Figure 6: Reflow profile used to build lead-free boards.

Test vehicles were 1st pass reflow soldered in a forced convection oven under air atmosphere using Sn3Ag0.5Cu paste. The reflow profile was pre-heat for 50sec from 150°C to 200°C with a peak temperature of 244°C with Time over 217°C of 68 sec. as shown in Figure 6.

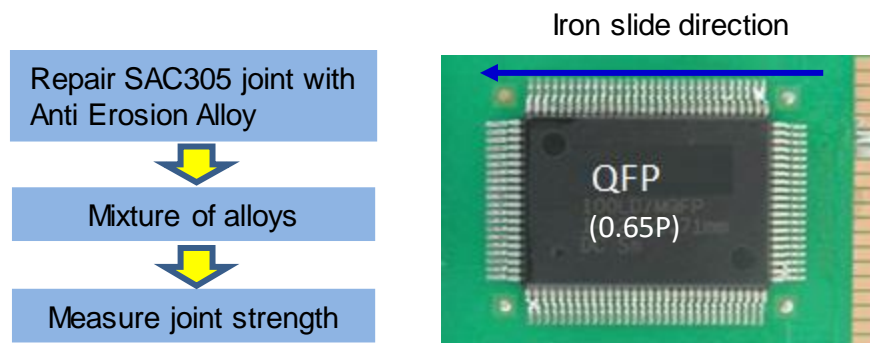
Figure 7: Test method

Soldered QFP component boards were then pull tested at the QFP leads at time zero and after up to 2,000 ATC cycles from -30C to +80C as indicated in Figure 7 and 8. 15 QFP leads were pull tested for each combination with the pull test results averaged for each combination.

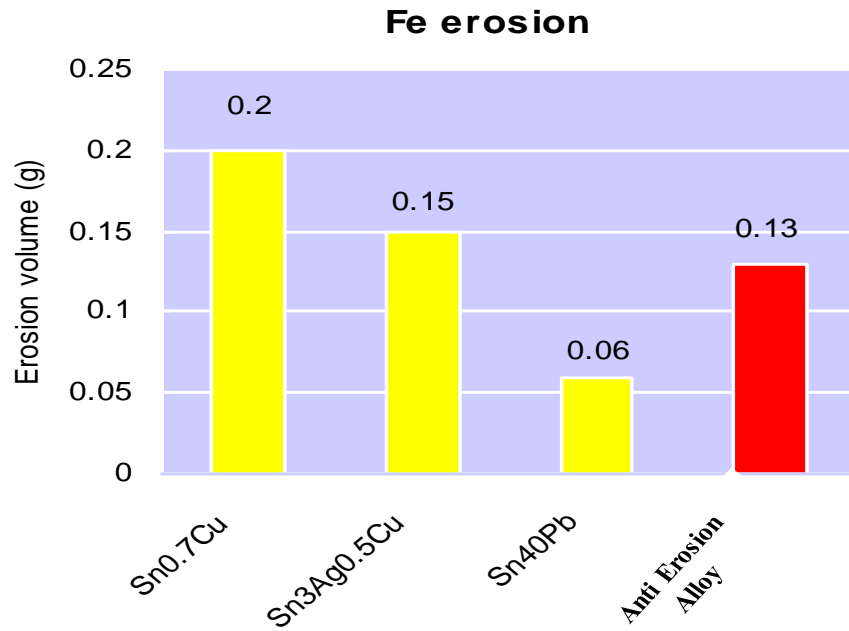
Figure 10: Erosion Results of Iron Plate on different alloys

The iron plate erosion test results are shown in Figure 10. Based on the results, the 60Sn40Pb tin-lead solder has less erosion than the anti-erosion lead-free alloy (Sn0.3Ag0.7Cu0.04Co) which has less erosion than Sn3Ag0.5Cu which has less than 99.3Sn0.7Cu. This shows the benefit of the cobalt addition to the lead-free solder to reduce iron erosion and indicates the iron erosion is more dependent on the tin content of the solder alloy with higher tin content giving higher iron erosion.

- Based on the results, the Sn40Pb solder has less erosion than the anti-erosion lead-free alloy (Sn0.3Ag0.7Cu0.04Co)
- This shows the benefit of the cobalt addition to the lead-free solder to reduce iron erosion.
- This indicates the iron erosion is more dependent on the tin content of the solder alloy with higher tin content giving higher iron erosion.

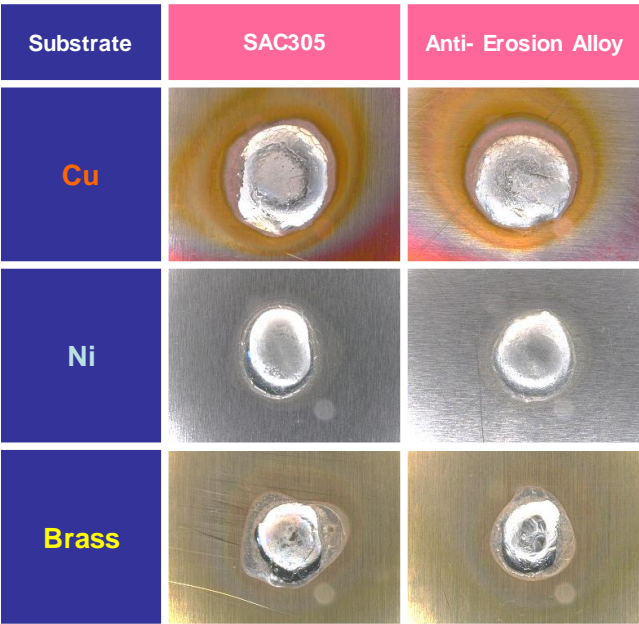
Figure 11: Wetting results of SAC305 and Sn0.3Ag0.7Cu0.04Co on different substrates (Copper, Nickel and Brass).

Both the Sn3Ag0.5Cu and Sn0.3Ag0.7Cu0.04Co alloys showed good wetting performance on different difficult to solder substrate including nickel as shown in Figure 11.

- Both the Sn3Ag0.5Cu and Sn0.3Ag0.7Cu0.04Co (Anti-Erosion) alloys showed good wetting performance on different difficult to solder substrate including nickel

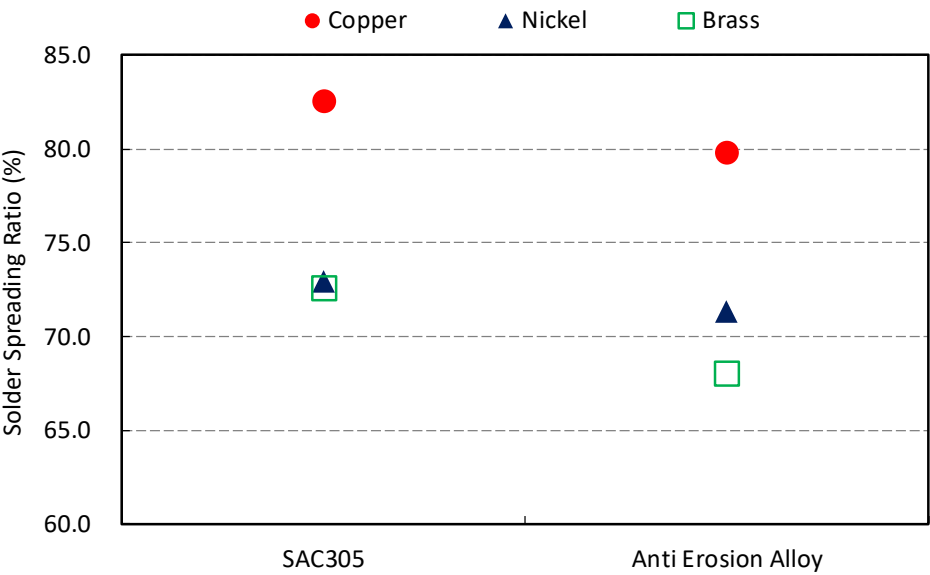
Figure 12: Solder Spreading Ratio on different substrates with the two lead-free solder alloys

The spreading ratio of Sn0.3Ag0.7Cu0.04Co anti-erosion solder wire on different substrates was found to be similar to Sn3Ag0.5Cu as shown in Figure 12.

- The spreading ratio of Sn0.3Ag0.7Cu0.04Co Anti-erosion solder wire on different substrates was found to be similar to Sn3Ag0.5Cu

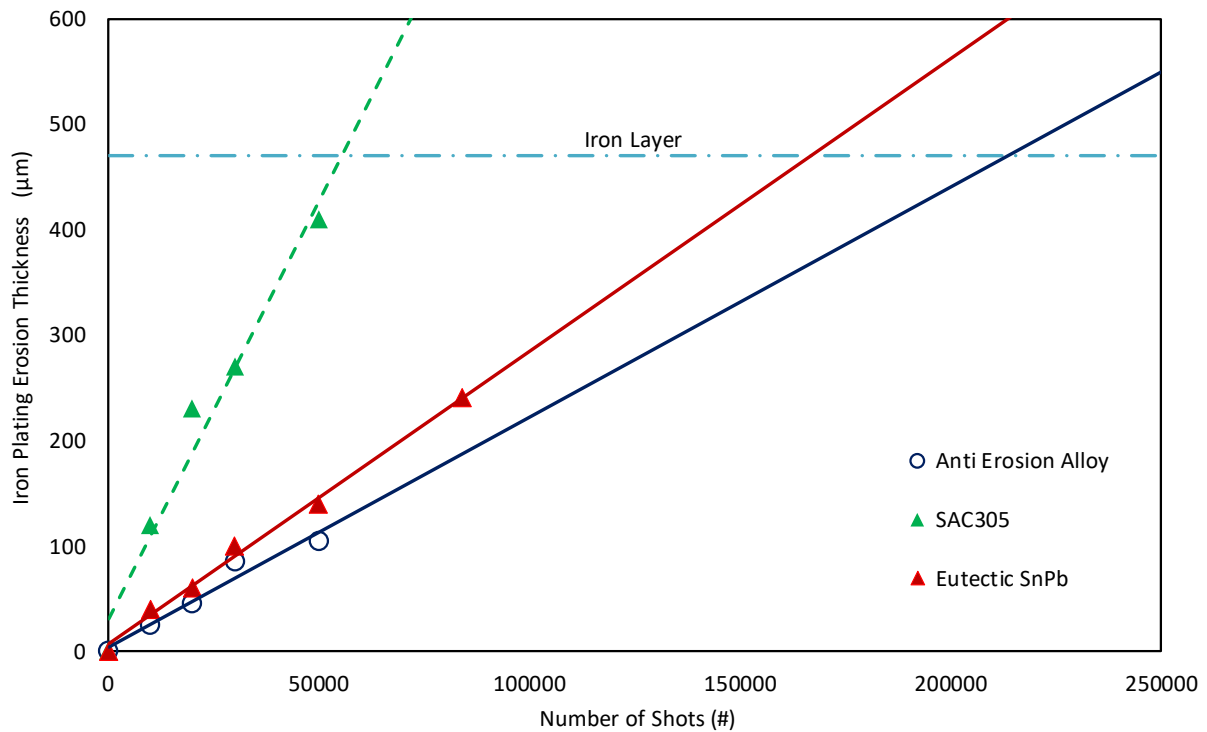
Figure 13: Iron Plating Erosion Thickness for different alloys.

The results of the soldering iron tip erosion test are shown in Figure 13 which indicates the Sn0.3Ag0.7Cu0.04Co solder alloy has much lower solder iron tip erosion than lead-free Sn3Ag0.5Cu alloy and is similar to Sn40Pb tin-lead solder.

- Anti Erosion alloy has lowest solder iron tip erosion.
- It can be seen that SnPb has in fact very similar iron tip erosion as Anti Erosion Alloy.

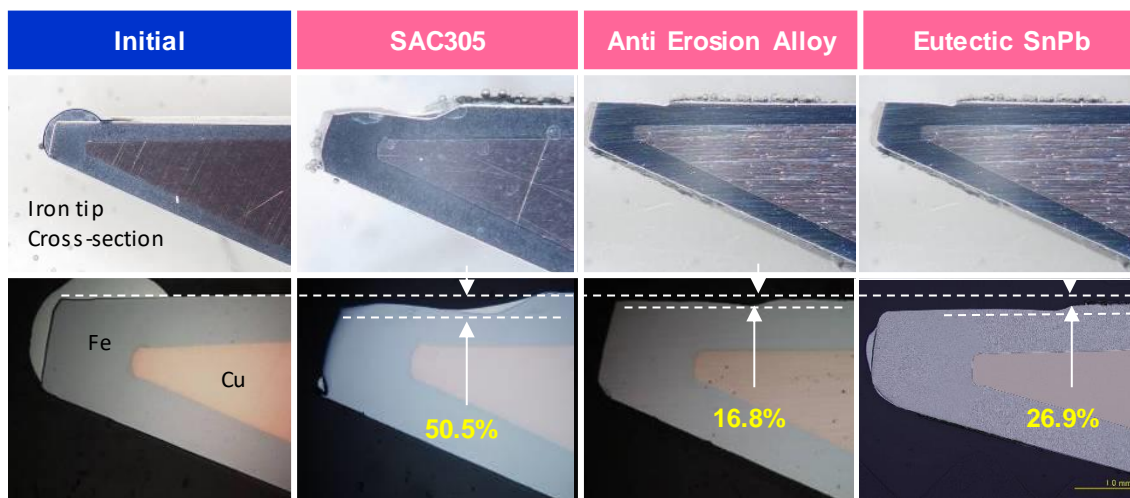
Figure 14: Cross Section of Iron Tips for different alloys (Sn3Ag0.5Cu, Sn0.3Ag0.7Cu0.04Co, Sn40Pb) after 10,000 shots (uses).

After 10,000 shots (uses), the soldering iron tips used with the three solder alloys were cross-sectioned as shown in Figure 14. Based on the results in Figure 14, solder iron tip erosion is large with Sn3Ag0.5Cu alloy but is reduced with the Sn0.3Ag0.7Cu0.04Co alloy which is similar or better than Sn40Pb tin-lead solder.

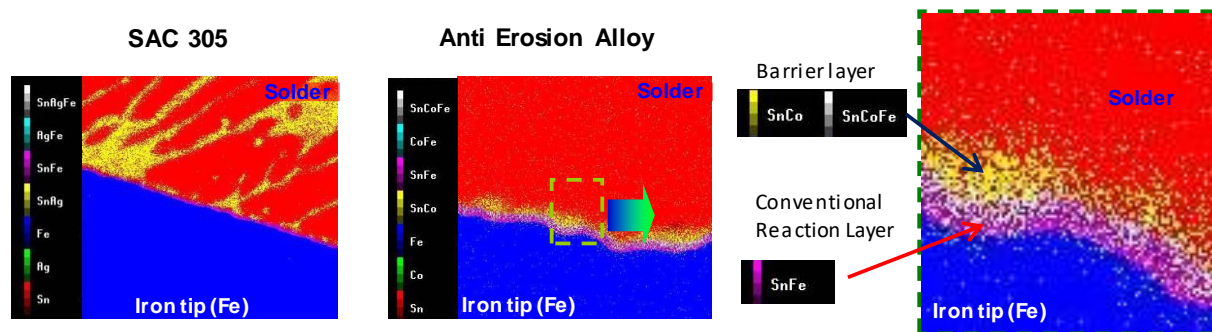
Figure 15: EPMA (Electron probe micro-analysis) of boundaries between solder and iron tip. (Sn3Ag0.5Cu compared with Sn0.3Ag0.7Cu0.04Co alloy)

Figure 15 shows elemental analysis of the soldering iron tips with a schematic view of the reaction between the solder iron tip and the melted solder shown in Figure 16. Based on these results, there is a barrier layer being formed of Sn-Co-Fe/ Sn-Co with the Sn0.3Ag0.7Cu0.04Co lead-free alloy which is helping to reduce the solder iron erosion.

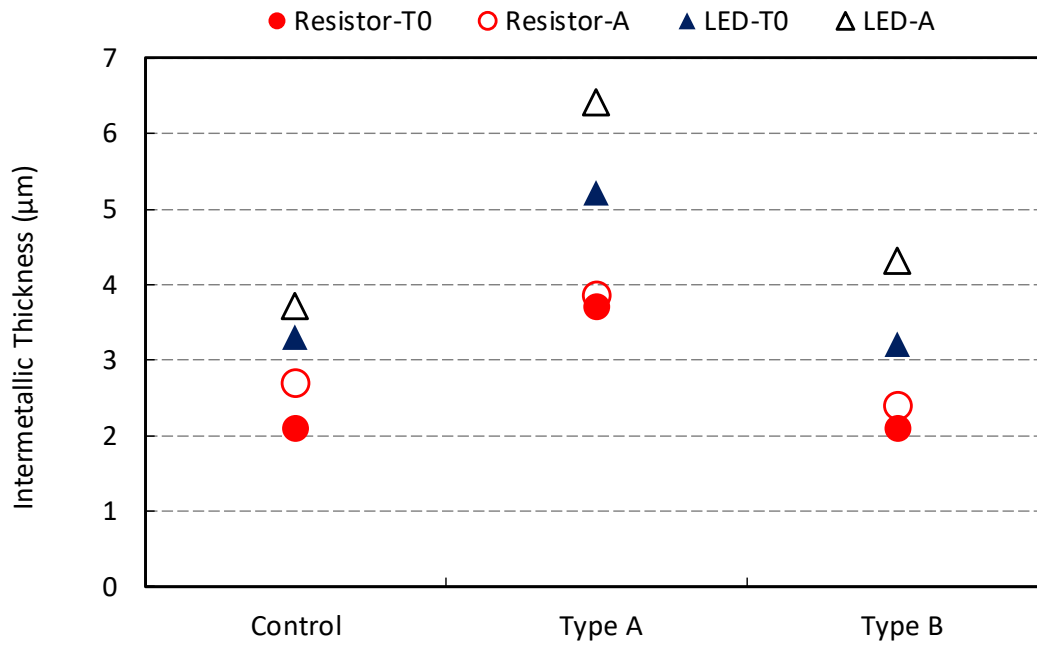
Figure 17: Board Side Intermetallic Thicknesses for different components (Resistor and LED) under different conditions (Control- SnAgCu 1st pass, A- SnAgCu 1st pass + SnAgCu rework, B- SnAgCu 1st pass + Sn0.3Ag0.7Cu0.04Co rework) before and after thermal cycling

Figure 17 shows the intermetallic thickness measurements for soldered chip resistor and LED components for the 3 combinations tested (Control- SnAgCu 1st pass, A- SnAgCu 1st pass + SnAgCu rework, B- SnAgCu 1st pass + Sn0.3Ag0.7Cu0.04Co rework) at time zero and after thermal cycling. The amount of IMC formed at the board side with the resistor component is less than the LED component at Time zero and after thermal cycling. IMC grows after thermal cycling for all combinations with the less amount for the SnAgCu 1st pass Control and Combination B test cells (SnAgCu 1st pass and Sn0.3Ag0.7Cu0.04Co rework). As combination B is reworked with the Sn0.3Ag0.7Cu0.04Co rework alloy this is a good indication of reduced IMC growth with this alloy. Previous work with a similar alloy (Sn0.1Ag0.7Cu0.04Co) showed reduced IMC growth on copper at 250C compared with Sn3Ag0.5Cu, Sn0.3Ag0.7Cu and Sn0.7Cu0.05Ni lead-free alloys [1].

- Control: FPY SAC 305, No Rework
- Type A: Reworked with SAC305 wire
- Type B: Reworked with Anti Erosion Wire
- Amount of IMC with Type B is significantly smaller than that of Type A

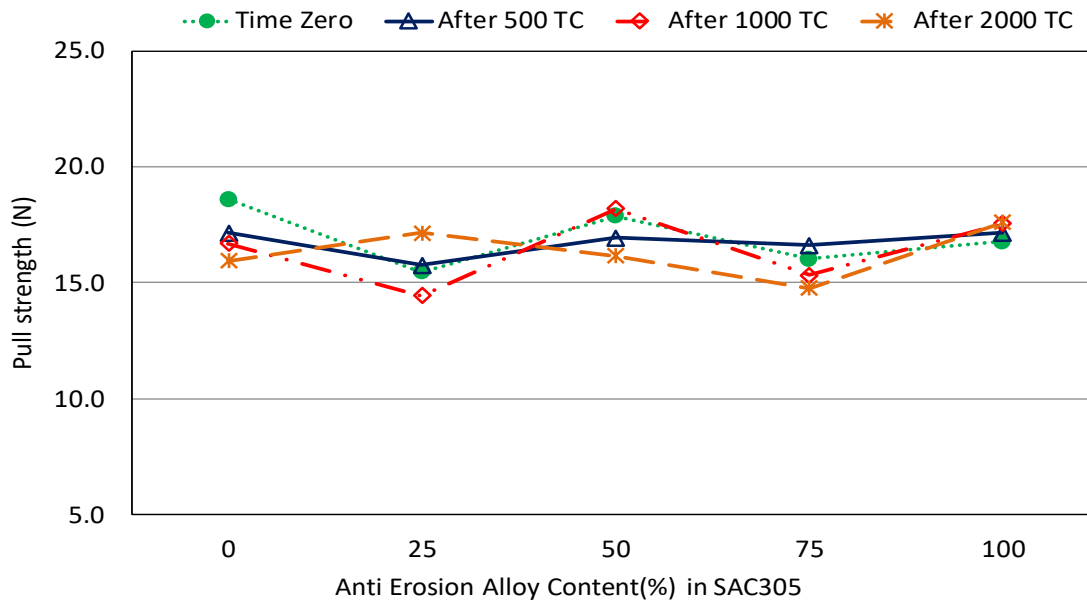
Figure 18: QFP Pull Strengths Results for different solder joint alloy combinations (Cell 1 (Sn3Ag0.5Cu) , Cell 2: 25% Sn0.3Ag0.7Cu0.04Co- 75% Sn3Ag0.5Cu , Cell 3: 50% Sn0.3Ag0.7Cu0.04Co - 50% Sn3Ag0.5Cu, Cell 4: 75% Sn0.3Ag0.7Cu0.04Co - 25% Sn3Ag0.5Cu, Cell 5: Sn0.3Ag0.7Cu0.04Co)

Figure 18 shows the QFP lead pull test results for the soldered QFP components at time zero and after up to 2,000 ATC cycles from -30C to +80C. Comparing Test Cell 1 (Sn3Ag0.5Cu) with the other test cells (Cell 2: 25% Sn0.3Ag0.7Cu0.04Co- 75% Sn3Ag0.5Cu, Cell 3: 50% Sn0.3Ag0.7Cu0.04Co - 50% Sn3Ag0.5Cu, Cell 4: 75% Sn0.3Ag0.7Cu0.04Co - 25% Sn3Ag0.5Cu, Cell 5: Sn0.3Ag0.7Cu0.04Co) at time zero and up to 2,000 ATC cycles there is little difference between the pull test force results. This indicates mixed Sn3Ag0.5Cu/ Sn0.3Ag0.7Cu0.04Co solder joints have good reliability.

- From Time Zero up to 2,000 ATC cycles there is very little difference between the pull test force results.
- This indicates mixed Sn3Ag0.5Cu/Sn0.3Ag0.7Cu0.04 Co solder joints have good reliability.

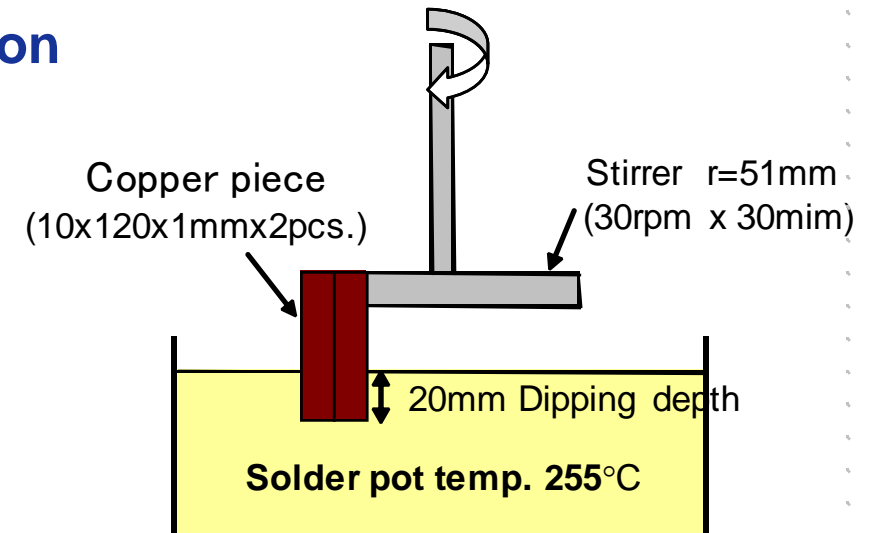
a. Copper Erosion

- Relatively aggressive no-clean soldering flux was applied in a molten solder pot.
- After drying of the applied flux, the tips of the copper test pieces were dipped into the molten solder bath to a depth of 20mm.
- The test pieces were stirred for 30 minutes and the amount of Cu eroded into the solder was measured.

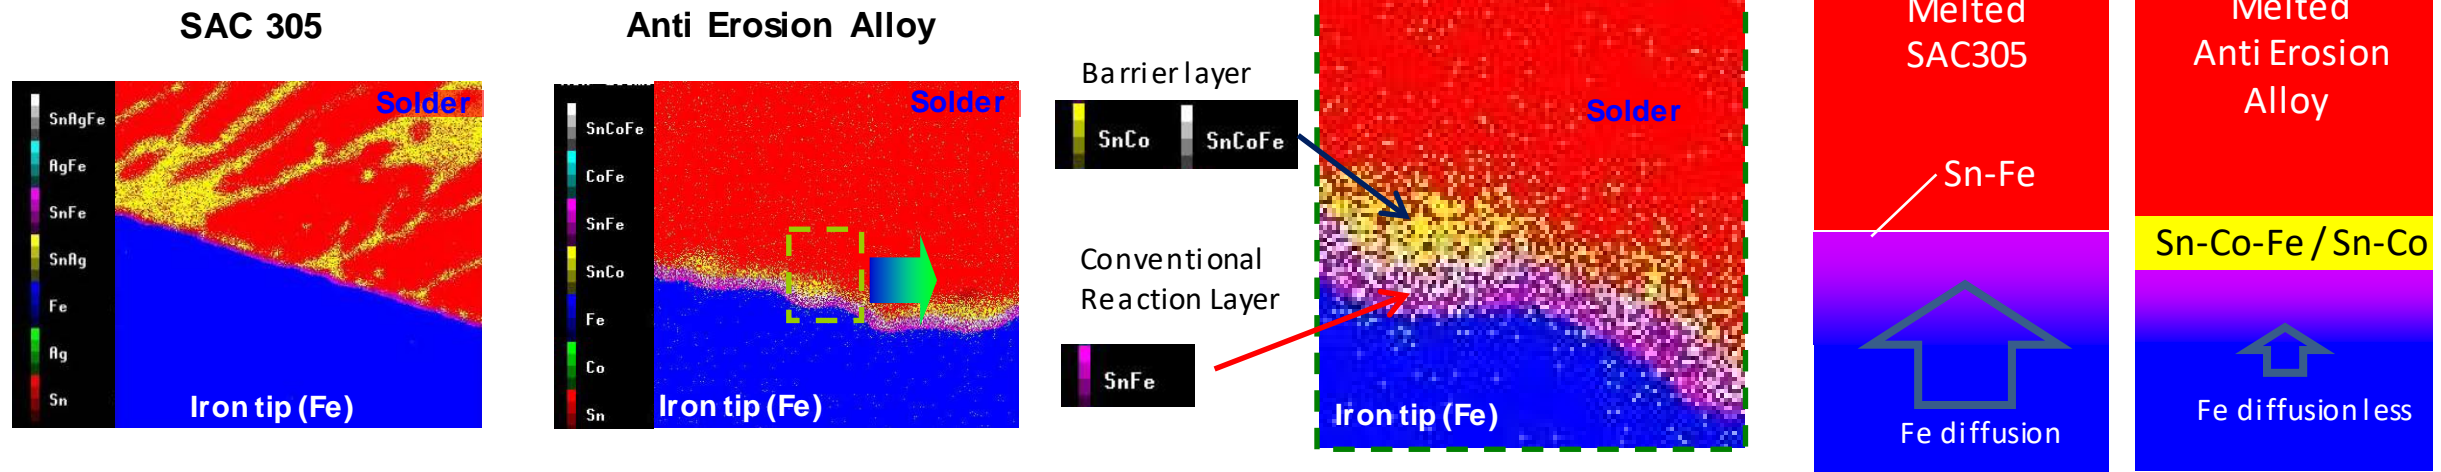
Mechanism of Anti Erosion

- The barrier layer being formed of Sn-Co-Fe/ Sn-Co with the Sn_{0.3}Ag_{0.7}Cu_{0.04}Co lead-free alloy helps to reduce the solder iron erosion.
