# Influence of Pd Thickness on Micro Void Formation of Solder Joints in ENEPIG Surface Finish

Dong-Won Shin, Jin-Woo Heo, Yeonseop Yu, Jong-Soo Yoo, Pyoung-Woo Cheon, Seon-Hee Lee  
Samsung Electro-Mechanics Co., Ltd.  
Daejeon, Republic of Korea

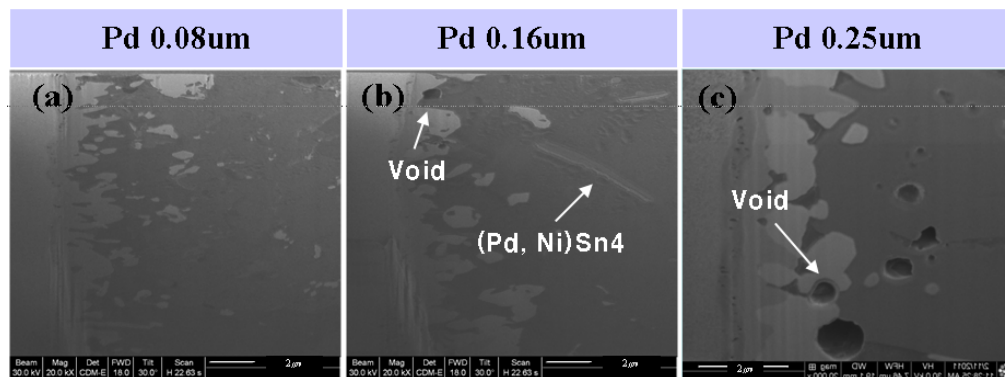
Cross-sectional FIB micrographs also indicates that there are micro-voids right above the  $(\text{Cu}, \text{Ni})_6\text{Sn}_5$  phase as shown in Figure 4(c). The micro-voids appear when the Pd thickness is greater than 0.16  $\mu\text{m}$ . The size of the micro-voids was less than 1  $\mu\text{m}$  when the Pd thickness was 0.25  $\mu\text{m}$ . Another important change in the morphology as the Pd thickness increases is the occurrence of another phase above  $(\text{Cu}, \text{Ni})_6\text{Sn}_5$  layer.

**Figure 4 - Cross-sectional FIB micrographs obtained from (a) specimen ‘A’ after precon+TC 100 cycles, (b) specimen ‘B’ after precon+TC 100 cycles, (c) specimen ‘C’ after precon.**

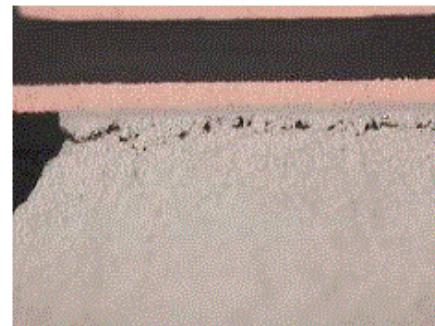
Crack w/ champagne Voids
