Addressing the Challenge of Head-In-Pillow Defects in Electronics Assembly

Mario Scalzo
Senior Technical Support Engineer
CSMTPE, Six-Sigma Black Belt

Solder Sphere Head-In-Pillow

Causes & Solutions

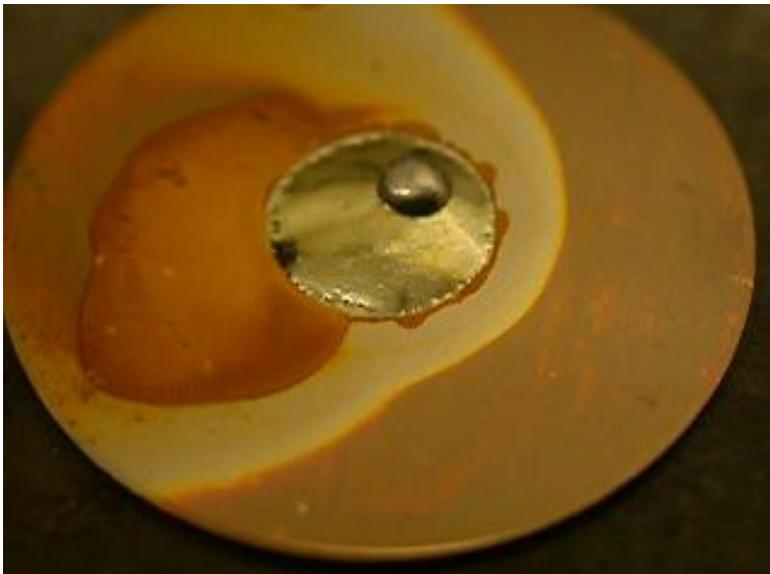
- 90s Time above liquidus (TAL)
- 25°C above liquidus
- Sn/Pb and SAC alloy
- SAC sphere

Poor Oxidation Barrier

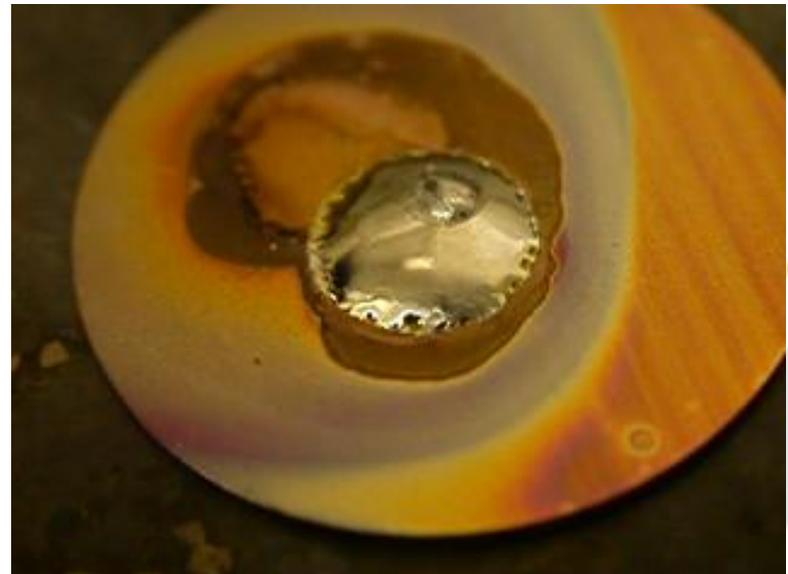
Good Oxidation Barrier

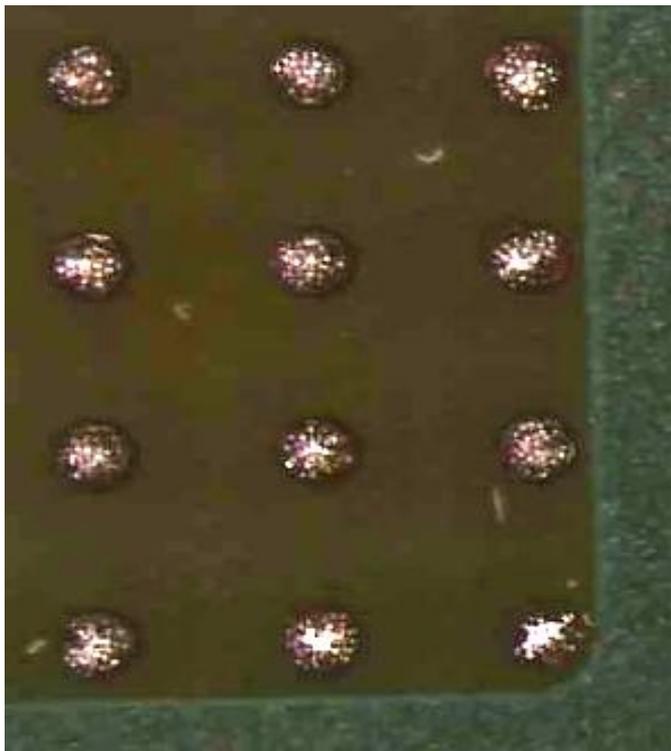
Graping

Poor Oxidation Barrier
