# Solder Paste Residue Corrosivity Assessment: Bono Test

Céline Puechagut, Anne-Marie Laügt, Emmanuelle Guéné, Richard Anisko  
Inventec Performance Chemicals  
Bry sur Marne, France

## Abstract

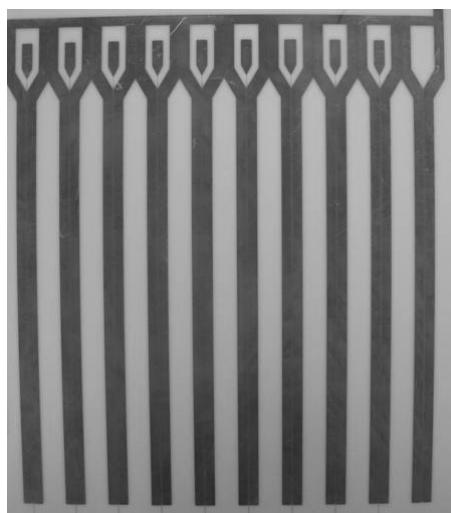
Figure 1: Bono Test Board

This method is based on an existing test which assesses the liquid soldering flux residue corrosivity after wave soldering. The test board has been modified to measure the solder paste residue corrosivity<sup>1</sup> (Figure 1) and is different from the one used in the SIR and ECM tests. It is composed of 10 electrolytic cells and is made of an FR4 epoxy substrate with a single copper layer, having a very thin anode between two cathodes.

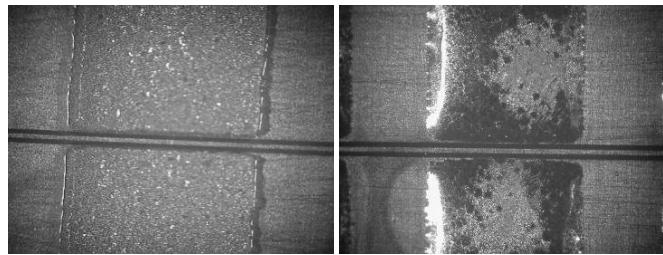
**Figure 2: Solder Paste a) after printing and b) after reflow**

The solder paste is printed on cathodes through a 120µm thickness stencil and reflowed according to the desired profile<sup>2</sup> (Figure 2). The thermal profile used for the tests is described below (Figure 3).

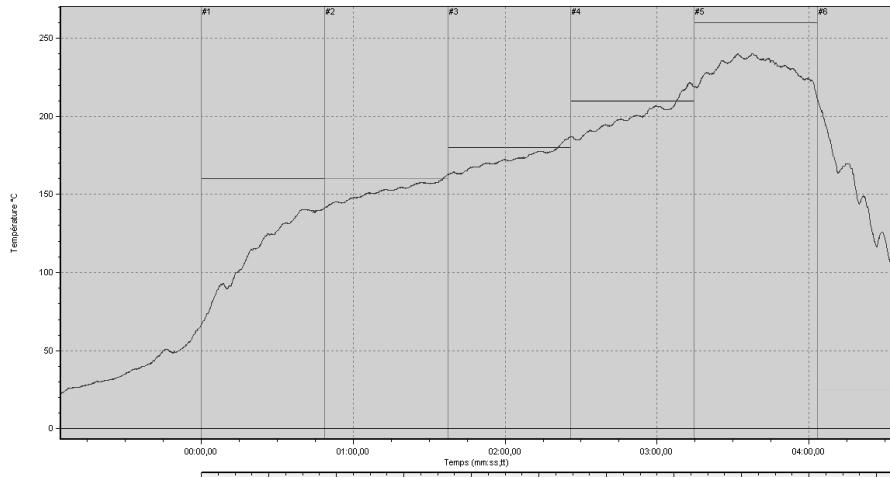
**Figure 3: Thermal Profile for boards reflow (Profile 1)**

Time above liquidus: 50sec; Peak Temperature: 240°C; Time from 25°C to 240°C: 270sec

In this experiment, a different profile is tested with solder pastes A and C. Profile 1 is the one described in Figure 3. Profile 2 is shorter, considered as easier and is described in Figure 7 in comparison with Profile 1.

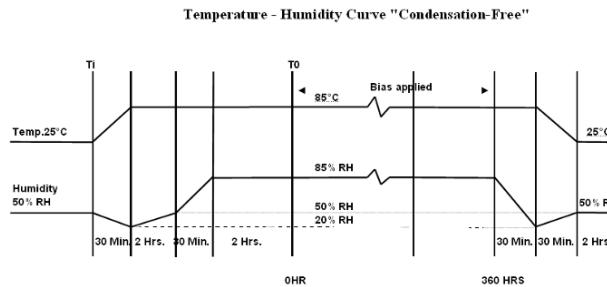
**Figure 4: Temperature – Humidity Curve**

Twenty-four (24) hours after reflow, the boards are submitted to ageing conditions; the samples must be then placed in a vertical position in the climatic chamber according to the temperature/humidity curve below (Figure 4). This is necessary to avoid any condensation on the test boards.

The samples are conditioned for 16 hours 85°C/85% RH. Initial measurements ( $T_0$ ) are then taken. All measurements are made under temperature/humidity exposure, at a test potential of 12 VDC. The chamber is set at 85°C/85% RH for a total exposure time of 360 hours (15 days), with 20 VDC bias voltage applied to all samples. Resistance measurements of the anode are taken daily and the corrosion factor (Fc) is calculated according to the equation below:

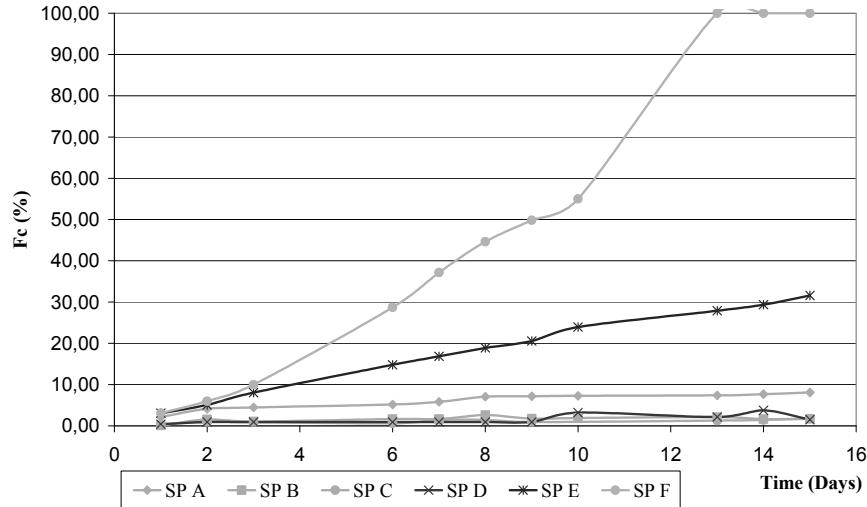
**Figure 5: Solder Paste Influence**

Three other no clean, lead-free pastes were tested in addition to the three solder pastes presented previously to assess their corrosive nature. The curve Time-Fc (Figure 5) shows the corrosion factor for each solder paste.

The curve of data points shows that solder pastes A, E, and F exhibit a very high Fc value, and the three other solder pastes have low Fc values. Moreover, a visual inspection has been conducted (Table 3) to observe 1) whether or not mousebites are present, and 2) the actual appearance of the residue (color, spread, etc.).

This experiment showed that 1) even if the Fc value is low, copper dissolution may appear (solder pastes B and D): since there are no short circuits between anodes and cathodes, the Fc value can be low; 2) a high Fc value does not necessarily lead to mousebites (solder paste A). Since the residue can be conductive, the leakage current can then be measured through the Fc value. Residue spreading could also be a root cause for high Fc values; 3) halogen in the solder paste flux caused mousebites (Solder paste B); 4) some no clean solder pastes lead to a very high level of corrosion (solder pastes E and F).

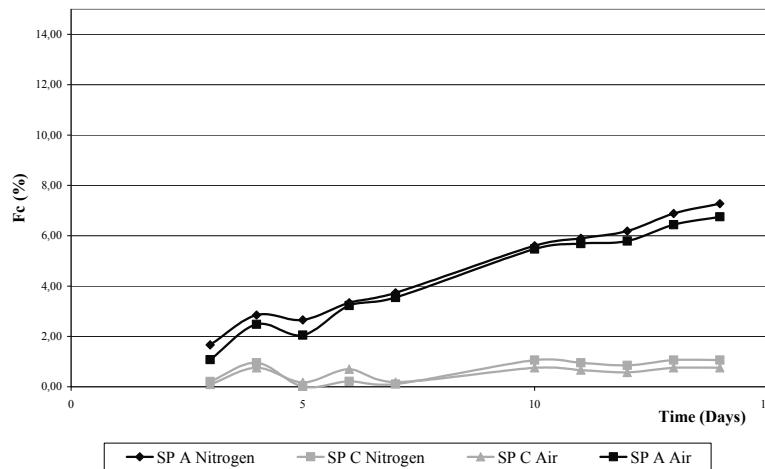
Figure 6: Bono test, Reflow under Nitrogen

In this experience, two solder pastes have been selected for reflow under nitrogen: solder paste A and C<sup>9</sup>. The results are given in Figure 6 and Table 4.

The first experiment (solder paste influence) seemed to show that the more the residue spreads, the higher the corrosion factor is. In spite of the fact that reflow under nitrogen leads to residue spreading, the corrosion factor is not affected compared to air reflow. In conclusion, residue spreading is only a cosmetic parameter which does not necessarily lead to a corrosion effect.

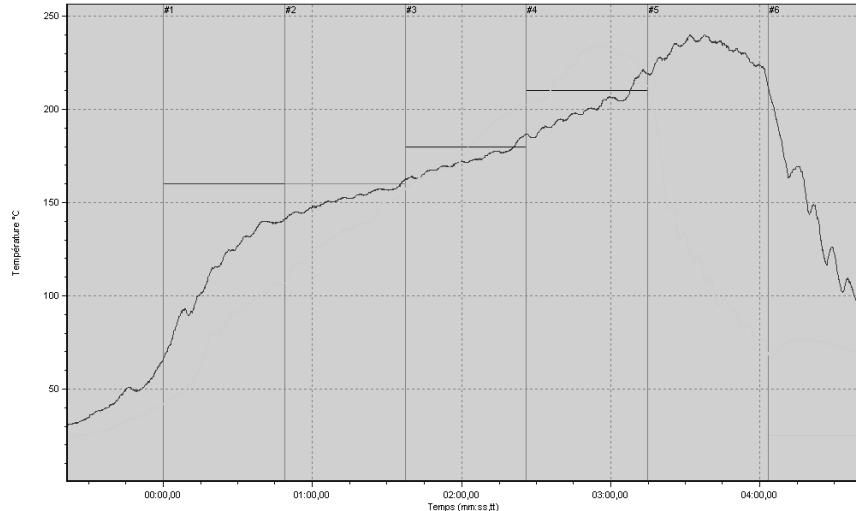
**Figure 7: Profile 1 (red) and 2 (green) on the same graph**

Profile 1: Time above liquidus: 50sec; Peak Temperature: 240°C; Time from 25°C to 240°C: 270sec  
 Profile 2: Time above liquidus: 35sec; Peak Temperature: 235°C; Time from 25°C to 240°C: 230sec

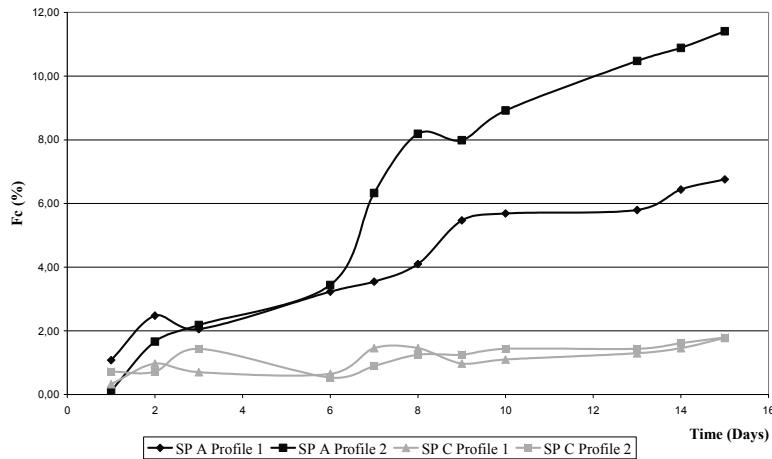
**Figure 8: Thermal profile influence on solder paste**

This experiment showed that the thermal profile seemed to have an influence on solder paste A but not on solder paste C. Solder paste C is not corrosive at all, regardless of the thermal profile used. Solder paste A is more corrosive if the thermal profile is shorter (Fc=6.7% for Profile 1 and 11.5% for Profile 2). This can be explained by the fact that some activators remained on the board after reflow due to the shorter thermal profile. Thus a higher corrosion factor is observed for solder paste A.

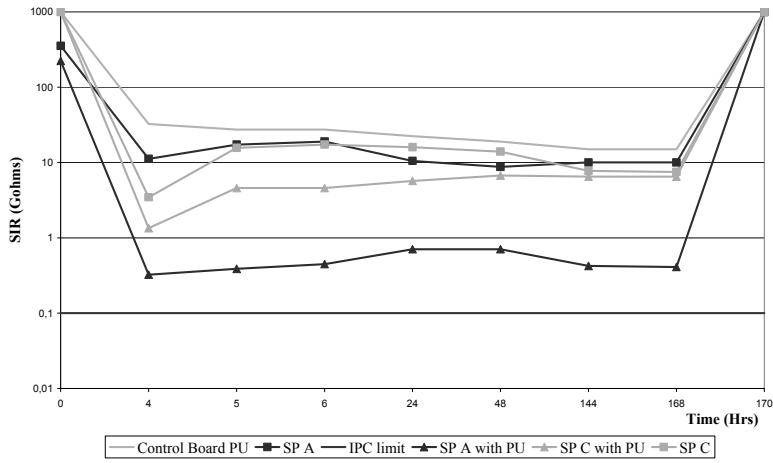
**Figure 9: SIR results for solder pastes A and C with and without PU conformal coating**

To protect the boards from environmental conditions (temperature, humidity), conformal coating is sometimes required. The Bono test is a very good technique for assessing the compatibility between the solder paste and the conformal coating. Solder pastes A and C were once again selected and reflowed according to the profile 1; the conformal coating used for this study is a polyurethane (PU), cured according to its Product Data Sheet. The SIR tests (IPC TM 650 method 2.6.3.3) passed for both solder pastes: the SIR values were above  $10^8\Omega$  and no dendritic growth was observed. However, the solder paste A with the PU conformal coating gave the lower SIR value (Figure 9).

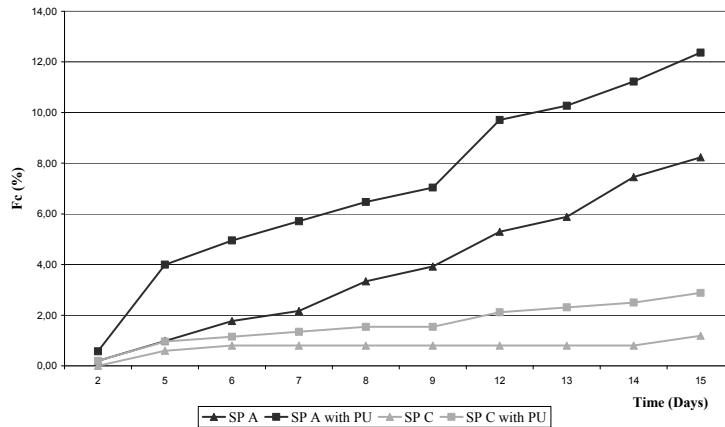
**Figure 10: Bono results for pastes A and C with and without PU conformal coating**

The Bono test was then applied to the same solder pastes. Both solder pastes exhibited a higher Fc value when the conformal coating was applied (Figure 10). The corrosion factor for solder paste A increased more than the one for solder paste C, meaning that the solder paste A residue and the PU conformal coating were not totally compatible, even though the IPC SIR test passed. No mousebites were observed in either case.

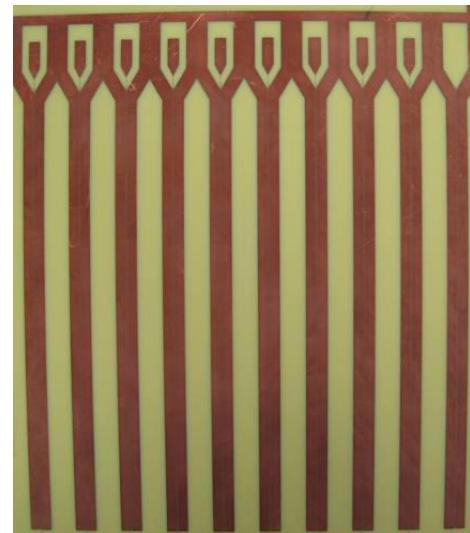
- Board:
  - Adapted from wave soldering flux Bono test board
  - FR4 epoxy single layer copper
  - 10 electrolytic cells:  
very thin anode between two cathodes

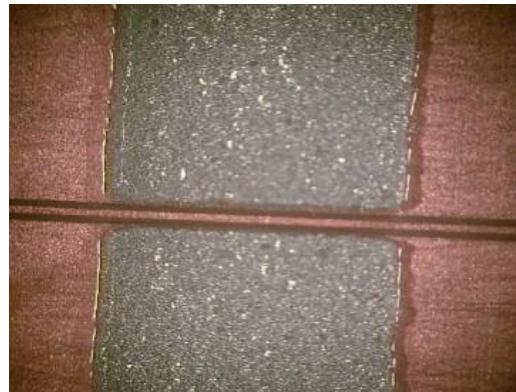
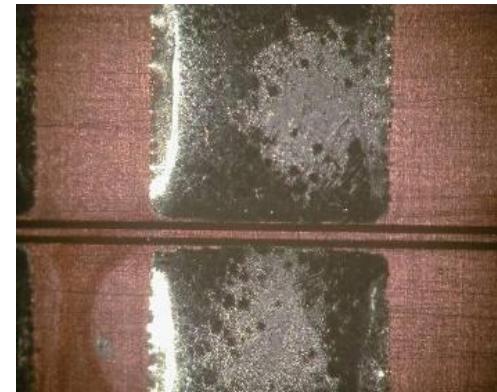
- Solder Paste Printing and Reflow
  - Printed on cathodes
  - $120\mu$  stencil thick
  - Reworked according to the desired profile

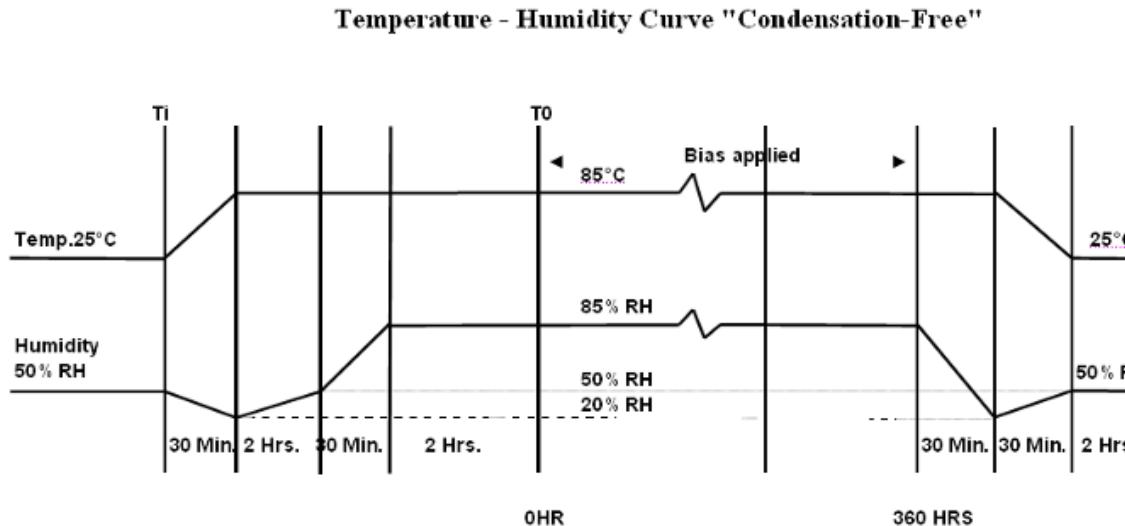
- Climatic Conditions
  - 24hrs after reflow, start of ageing
  - Vertical position
  - 85° C/85%RH during 15 days

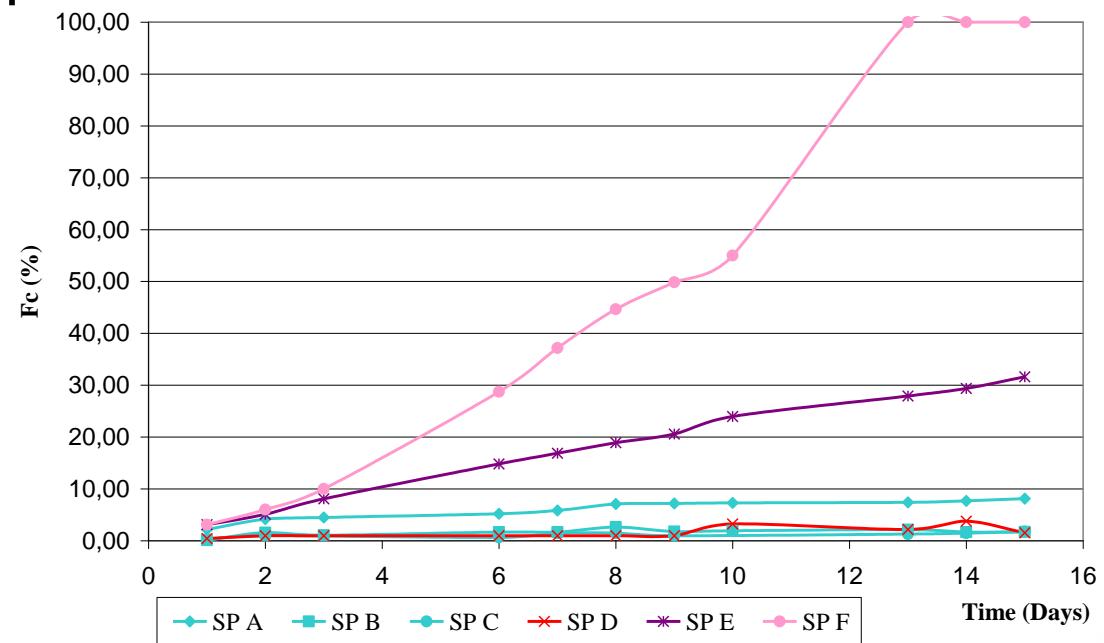
- Fc analyse: curves OK
- Short circuits over 9 tracks: All tracks for F and 2 tracks for E

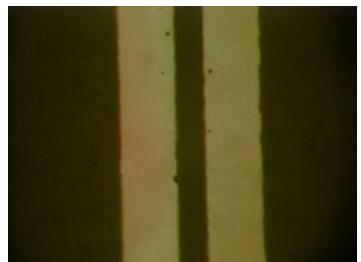
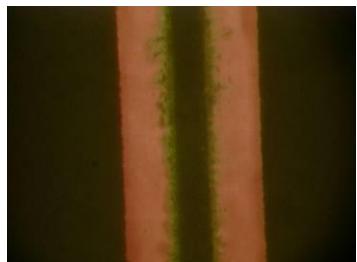
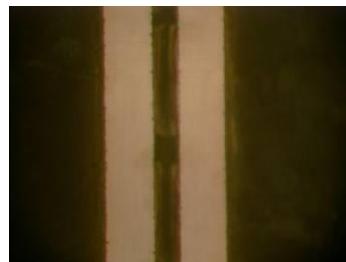
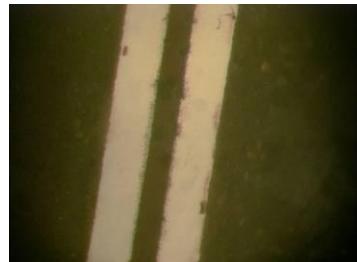
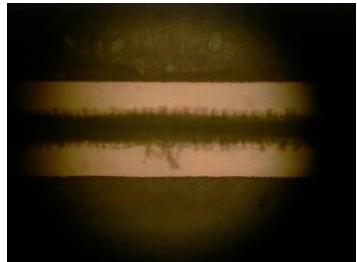
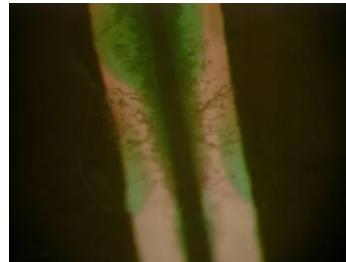
- Visual Obs.: mousebites, copper dissolution, residue aspect

- Low Fc value: copper dissolution may appear
- High Fc value: does not necessarily lead to mousebites
- Halogen caused mousebites
- Some no-clean solder pastes can cause a very high corrosion

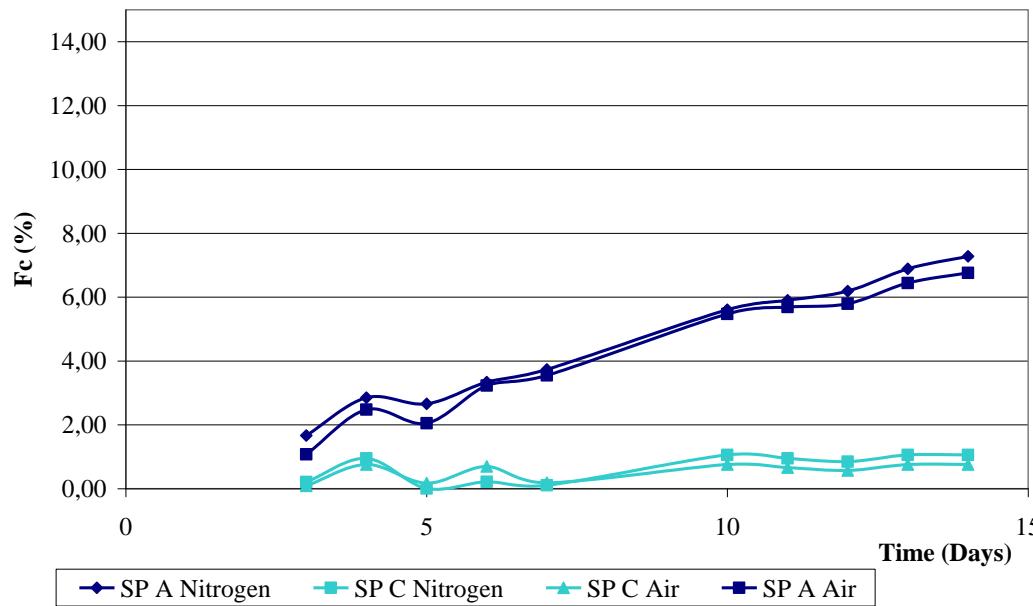
- Fc analyse: curves OK
- Short circuits over 9 tracks: No

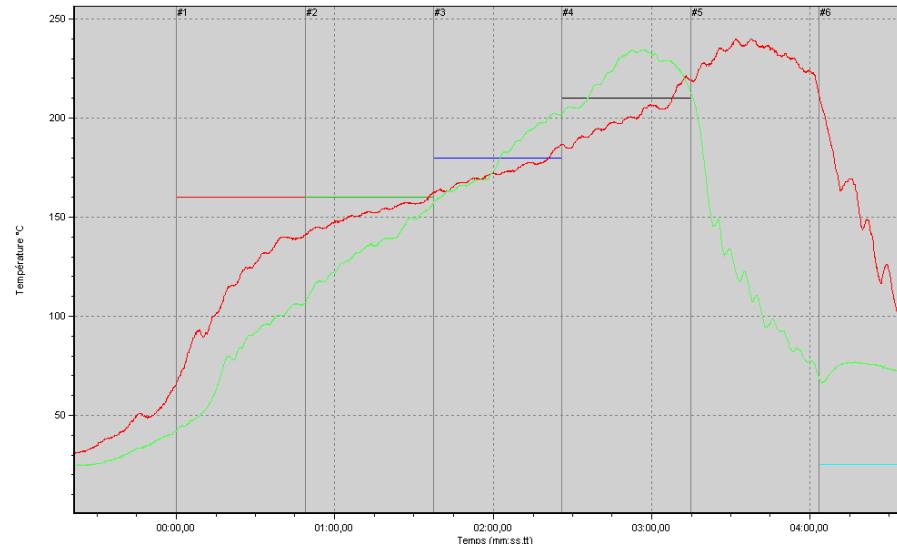
- Profile 1: TAL: 50sec; Peak T: 240° C; Time: 270sec
- Profile 2: Shorter, TAL: 35sec; Peak T: 235° C; 230sec

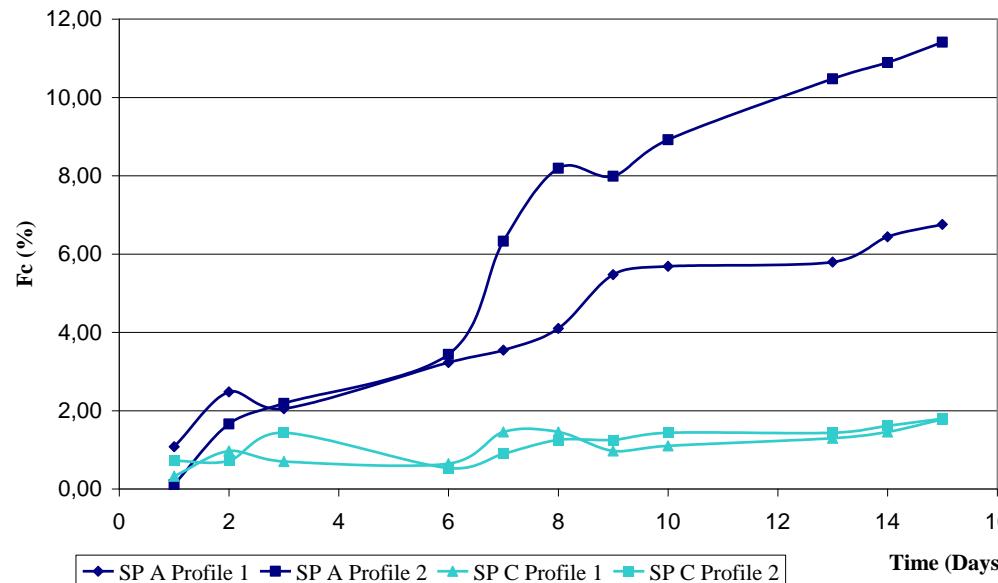
- Fc curves OK, No short-circuits
- Visual inspection: no mousebites, no copper dissolution

- SP A: Fc value increase
- SP C: Fc value stable

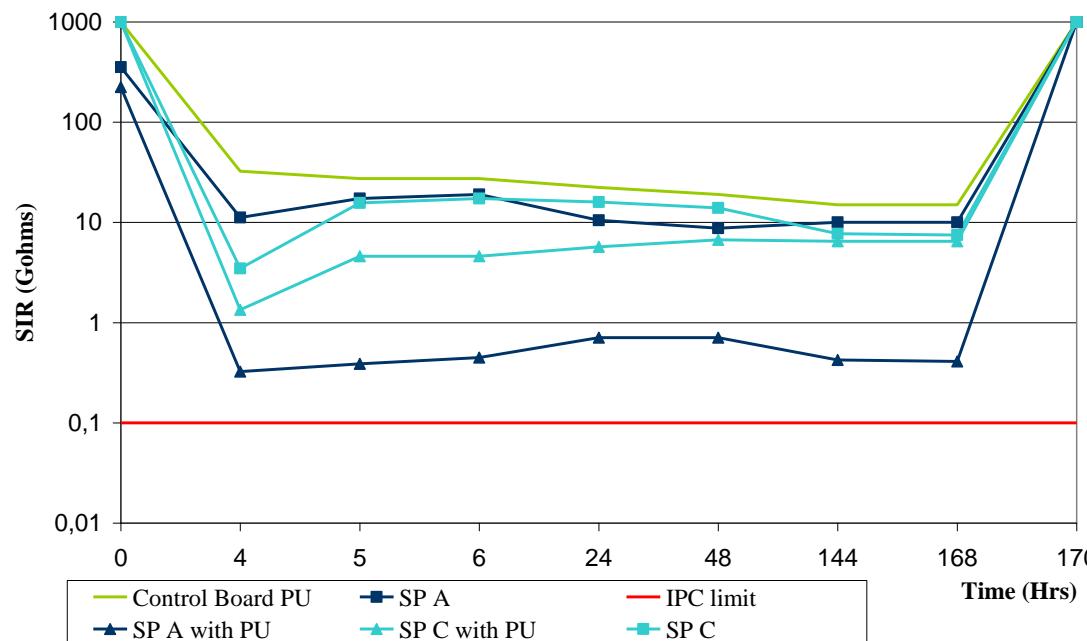
- SIR according to IPC TM 650, 2.6.3.3
- SP A and C with a PU conformal coating

- SIR >  $1.10^8 \Omega$
- No dendrites

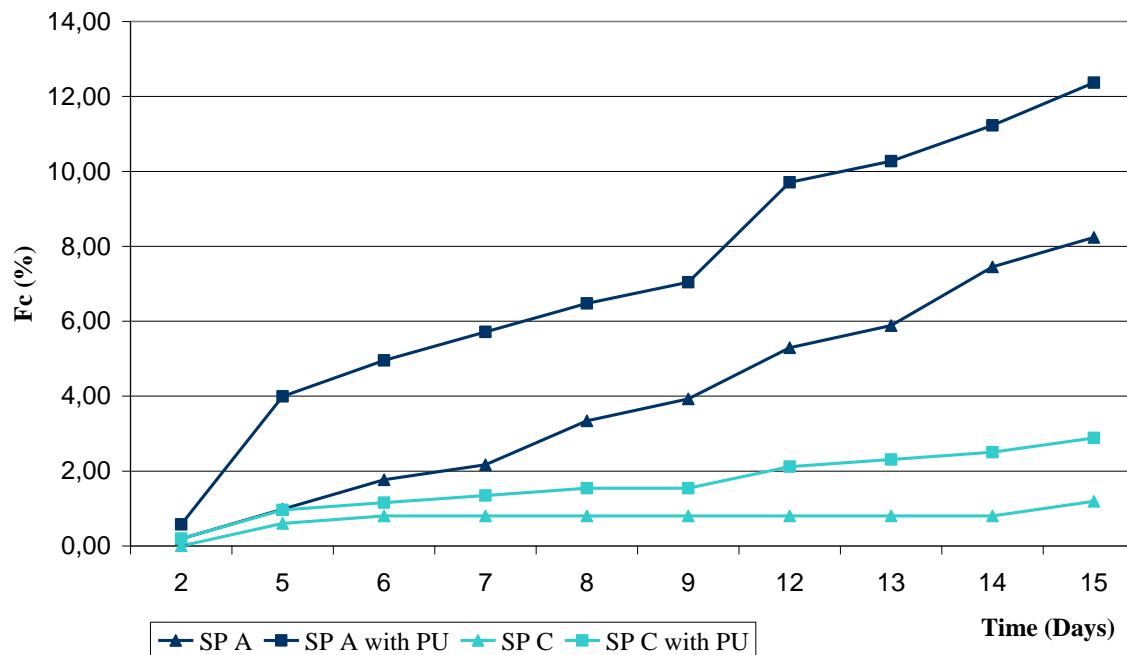
- Bono Test with the same parameters

- For both solder pastes:
  - No copper dissolution, no mousebites
  - Fc value increase
