Reliability Evaluation of One-Pass and Two-Pass Techniques of Assembly for Package on Packages under Torsion Loads

Vikram Srinivas, Michael Osterman
Center for Advance Life Cycle Engineering, Department of Mechanical Engineering,
1103 Engineering Lab Building, University of Maryland,
College Park, MD 20742-9121

Reliability Evaluation Of One-pass and Two-pass Techniques of Assembly for Package on Packages Under Torsion Loads

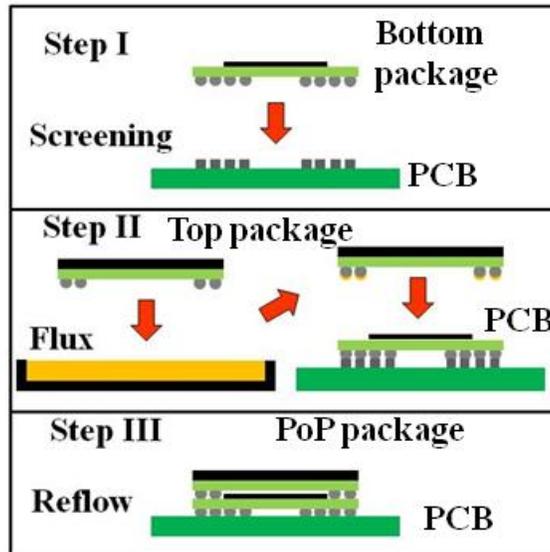
Figure 2: One pass assembly technique

Package on packages can be assembled using two techniques, one pass technique and two pass technique. The one pass technique involves screen printing the printed wiring assembly (PWA) and then placing the bottom BGA package. This is followed by dipping the top BGA package and stacking on the bottom BGA package. Then, using a single reflow, the package is assembled. A schematic of this process is shown in **Error! Reference source not found.**. This method has an advantage that the memory and logic chip can be used exclusively and provides more logistic flexibility [5].

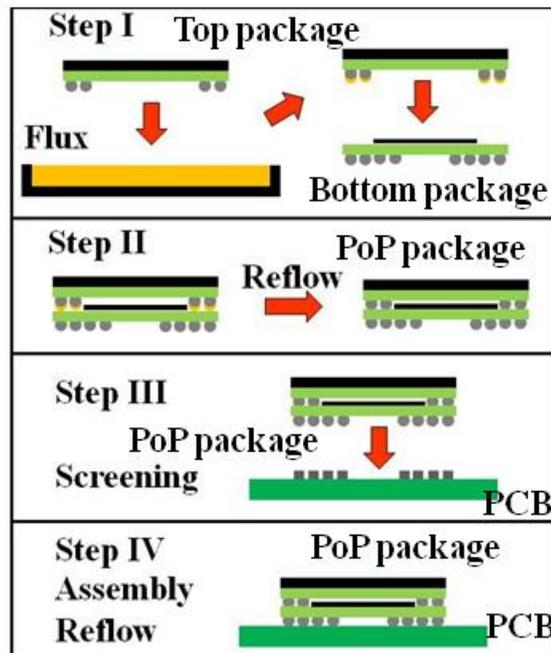
Figure 3: Two pass assembly technique

The two pass technique involves dipping the top package in flux and stacking on the bottom package on the carrier tray. At this point the package is reflowed once to make the solder connections between the top and bottom package. This is followed by screen printing the PWA and placing the stacked package on package followed by the second reflow process to make the solder interconnects between board and package. A schematic representation of this process is shown in **Error! Reference source not found.**

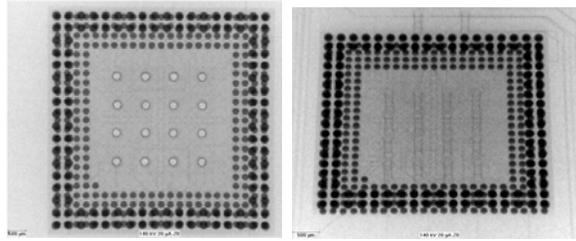
Figure 5: X-Ray of PoP technology

This technique allows us to introduce another quality control check after stacking of packages using non-destructive test methods such as X-ray. An example of such non-destructive testing using X-Ray is shown in **Error! Reference source not found.** This ensures better board yields since defects in interconnect between top and bottom BGA can be screened before final assembly on the PWA [6].

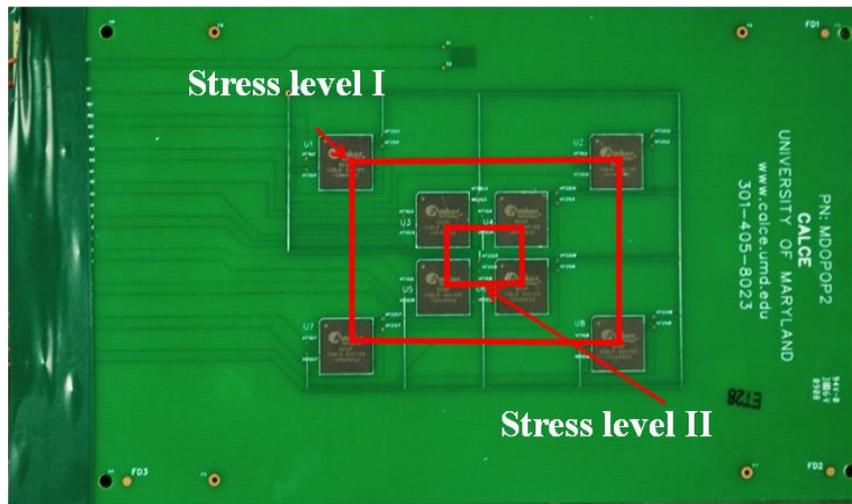
Figure 6: Test Vehicle

The test vehicle used in this study consists of PWA of the dimension, $8'' \times 4.5'' \times 62$ mils. The PWA cards were built using Polyclad 370HR board laminate with OSP board finish. Eight PoP packages were assembled into two clusters with quarter board symmetry. Package dimensions of 12×12 mm were selected with package laminate of 0.21 mm. The top package in the configuration consisted of a peripheral BGA package of 0.65 mm pitch with 128 pads in a 18×18 ball matrix. The bottom package used a peripheral BGA package with 0.5 mm pitch and 305 pads in a 23×23 ball matrix. The packages in the outer cluster are referred to as stress level I and the inner cluster as stress level II. The strains observed at stress level II are marginally higher than stress level I and hence one can expect components placed at stress level I to last longer than components at stress level II. The test vehicle with the stress levels marked is shown in **Error! Reference source not found.**

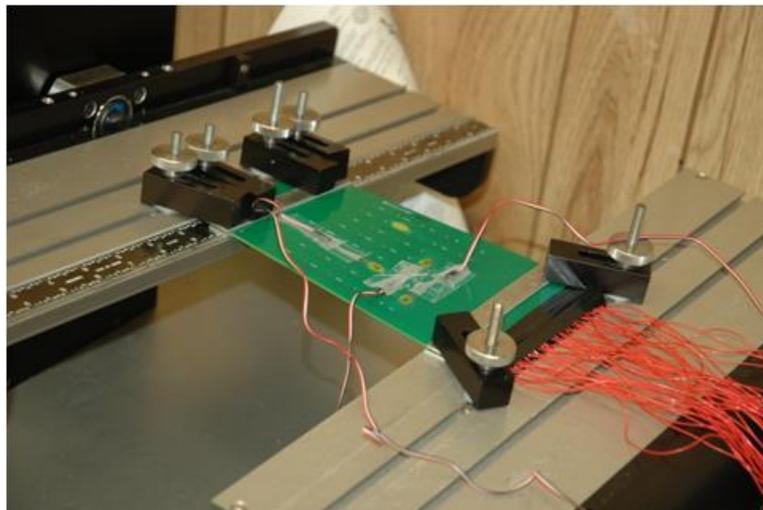
Figure 7: Test setup

The test setup involves use of a static platform and rotary platform to introduce torsion loads on the PWA. The rotary platform has controlled rotary displacement with ability to define angular displacement, angular velocity and angular acceleration with feedback. The thickness of the PWA is also taken into consideration and necessary changes are made to ensure that the axis of rotation passes through the center of the PWA. This allows us to control peak-to-peak board strain and average strain rate. An angular deflection of 4.5° full cyclic load was selected at angular velocity of 1°/s and angular acceleration of 1°/s². This approximately translates into board shear strain of 1000 μstrain units at an average strain rate of 50 μstrain units/sec. Preliminary finite element analysis work performed on the test setup has been explained in previous work [24].

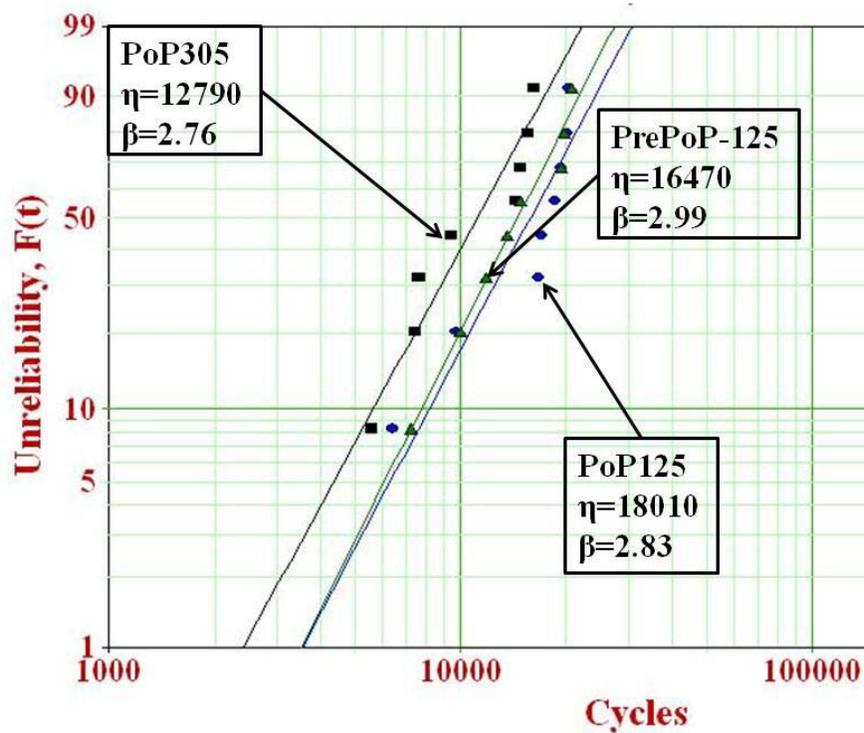
Figure 8: Weibull Analysis- Stress Level I

The resistances of all the daisy chain nets were monitored and cycles to failure data was obtained. The failure data was then plotted assuming a Weibull 2-parameter distribution. Data was grouped based on the placement (stress level) of the packages. Test results at stress level I are shown in **Error! Reference source not found.** ANOVA analysis was performed on the test results and no statistically significant difference was observable between the one pass and two pass assembly techniques. Also no difference in performance was observable between the PoP components assembled with SAC125 and SAC305 solder pastes for the bottom package. This suggests that the increased stiffness due to stacking of the packages has increased the solder strain on the bottom package. This will be confirmed using finite element analysis. The trends are consistent at stress level II too as seen in **Error! Reference source not found.**

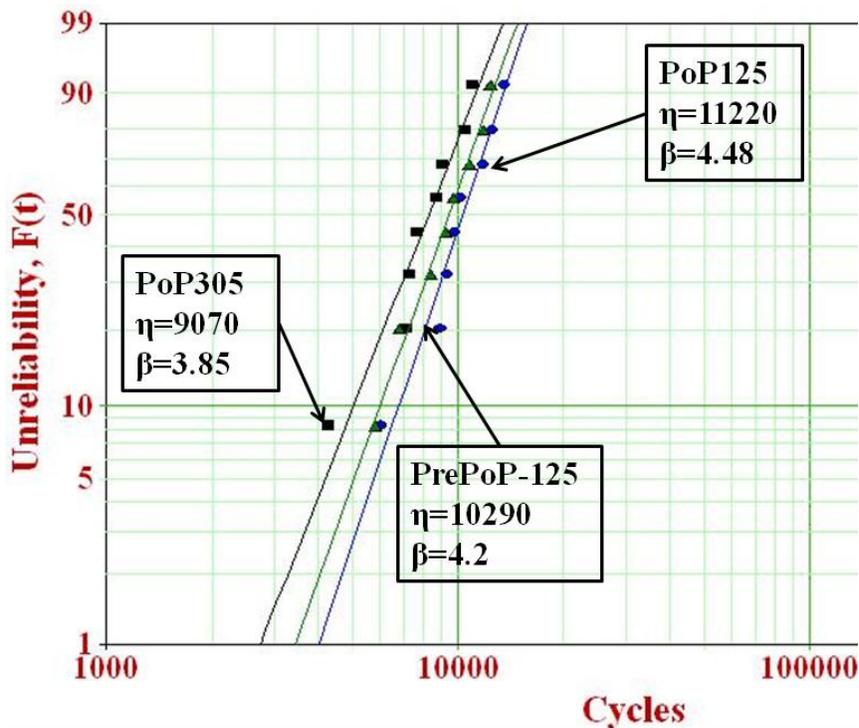
Figure 9: Weibull Analysis- Stress Level II

Another interesting observation was that all the first failures on the packages were observed on the daisy chain net of the bottom package. This suggests that the solder strain is maximum at the solder joints on the bottom packages.

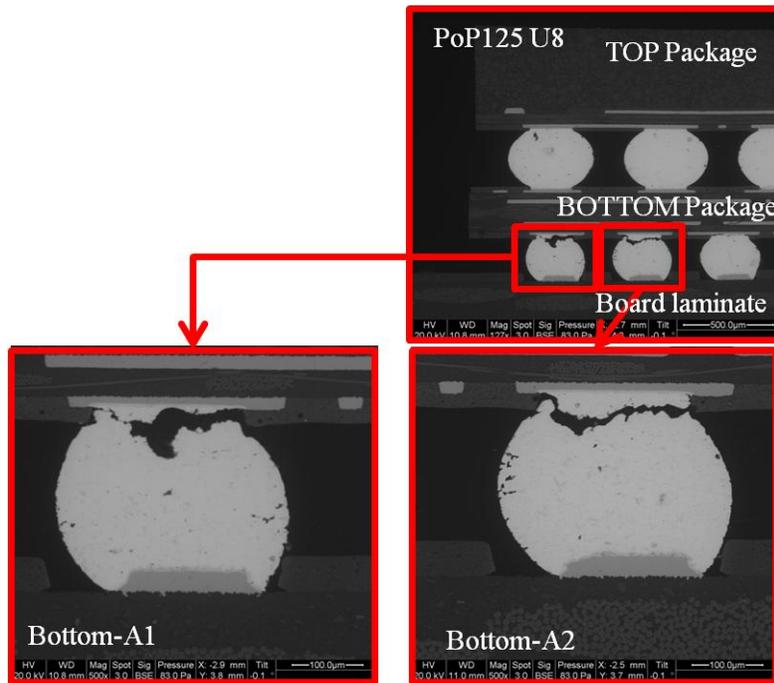
Figure 10: E-SEM image of cross sections of PoP125

The resistance monitoring showed that the first failures were on the bottom packages. Destructive failure analysis was performed to determine the failure site and compare between test vehicles. **Error! Reference source not found.** shows an E-SEM image of a PoP125 component from stress level I.

The test vehicle was tested for 18200 cycles and the package shown in **Error! Reference source not found.** failed at 6399 cycles. All interconnect failures were observed on the bottom package's second level interconnects. Cracks were located on the package-solder interface. Also, several instances of pad cratering were observed. Similar observations were made in the PoP305 package at stress level I. An instance of pad cratering observed under E-SEM has been shown in **Error! Reference source not found.**. Similar observations were made on the PrePoP-125 package.

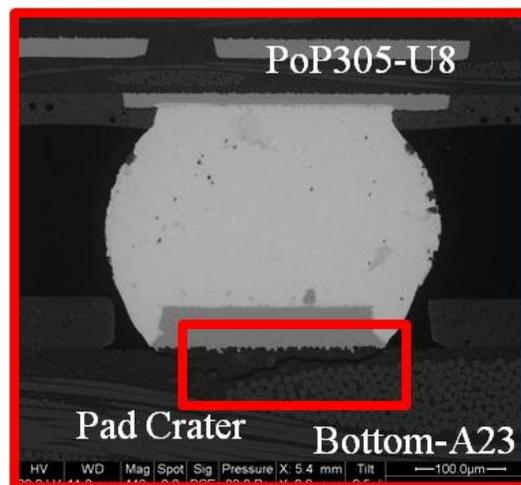
Figure 11: E-SEM image of pad cratering observed in PoP305 at stress level I

Pad cratering is defined as cracking in the thin resin rich region underneath the copper pads and traces [26]. Literature classifies the crack mechanisms commonly observed into the following two categories, cohesive failure and adhesive failure. Fracture that occurs along the resin region alone is referred to as cohesive failure, while fracture between the resin and glass fiber bundles is called adhesive failure. All instances of pad cratering in this study were cohesive failures. Pad cratering by itself does not refer to an electrical failure of solder joints or the loss of functionality of package. However, the crack in the resin may result in failures on the connecting trace on the PWA, and thus cause an electrical open. However, even if the trace is not severed, or the pad is non-functional, a crack in the underlying laminate is a source of reliability concern [27]. Use of underfill is suggested as a mitigation technique [28].

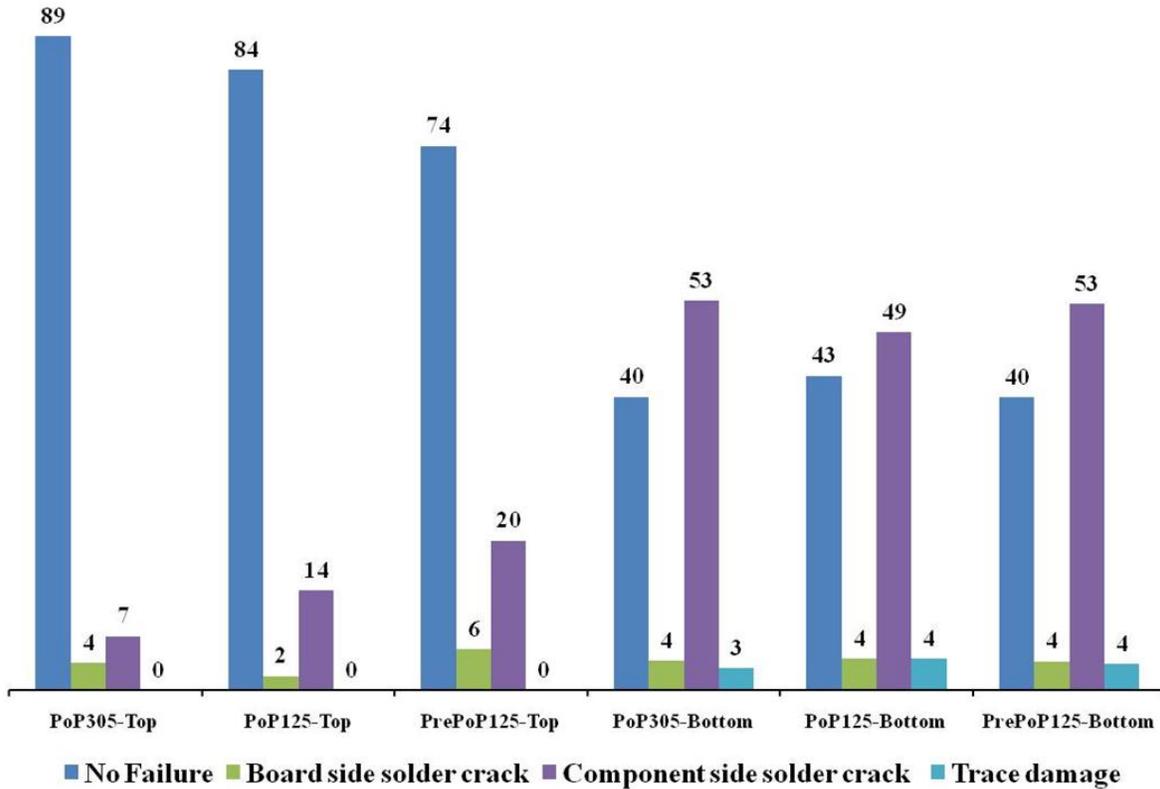
Figure 12: Dye & Pry Results, Stress Level I (Normalized)

Results from this study are shown in **Error! Reference source not found.** and **Error! Reference source not found.**. It is clear that no statistically significant change in distribution occurs with change in assembly techniques. Also, change in solder paste does not impact the failure site either. Since the components were tested to first failure of the three nets, the number of balls on the top package in PoP assembly with no failure is high. We also do not observe any instances of pad cratering or trace failure on the intermediate laminate but instead only the PWA. Component- solder interface is the most common failure site observed on all samples.

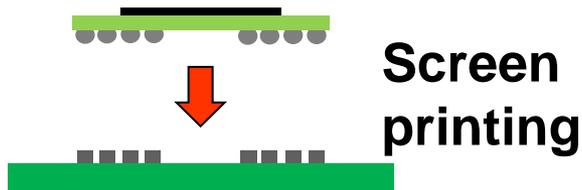
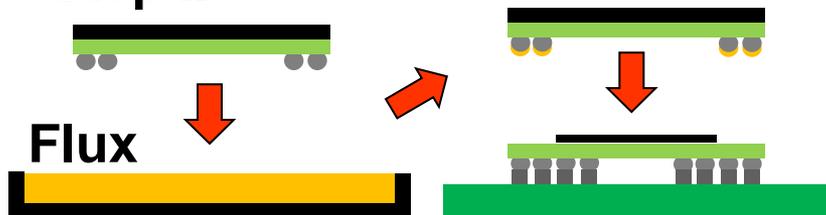
Package on Package: One-pass assembly Technique [2]

- This process involves screen printing the board, then placement of the bottom package of any stacked devices on the PWB.
- The top package(s) of any stacked devices are then picked and dipped in either flux (or solder paste), then placed on top of the bottom package.
- The entire assembly is then reflowed, forming both layers of joints in one reflow pass.
- It also allows logistic flexibility in which top and bottom package can be changed until the PWB is assembled.

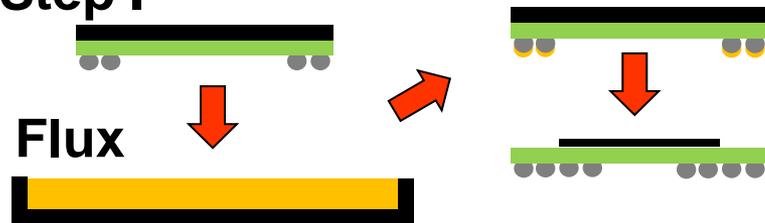
Two-pass assembly Technique^[3]

- The pre-stacking process involves placing the lower packages in a carrier, then dipping the upper package(s) in flux or solder paste, and placing them on top of the lower packages.
- The pre-stacked components are then reflowed in the carrier.
- During assembly of the main circuit board, the pre-stacked components are picked out of the carrier and placed onto the circuit board, which has been screened with solder paste.
- The entire assembly is then reflowed to complete the process.

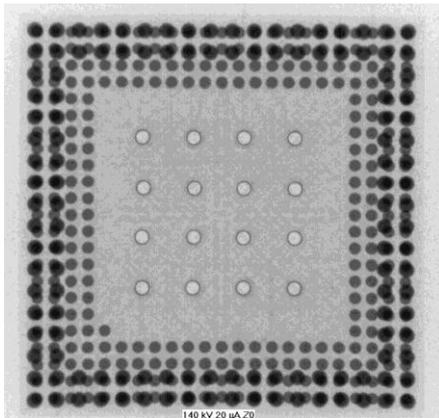
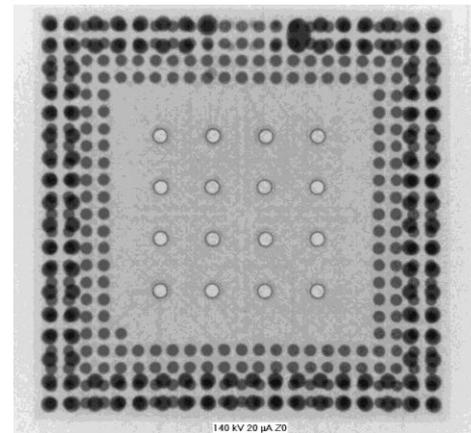
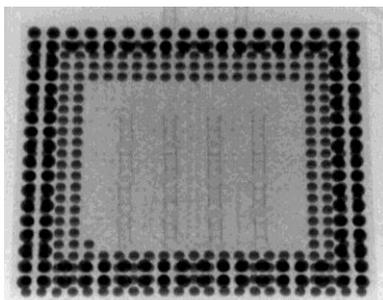
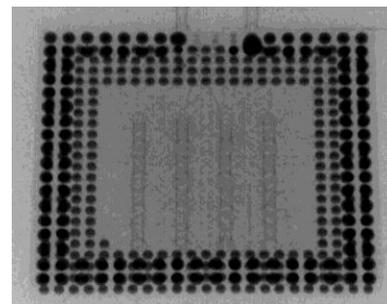
Post Assembly Inspection: X-Ray

Several PoP assemblies with SAC125 solder balls were found to have missing or enlarged solder spheres.

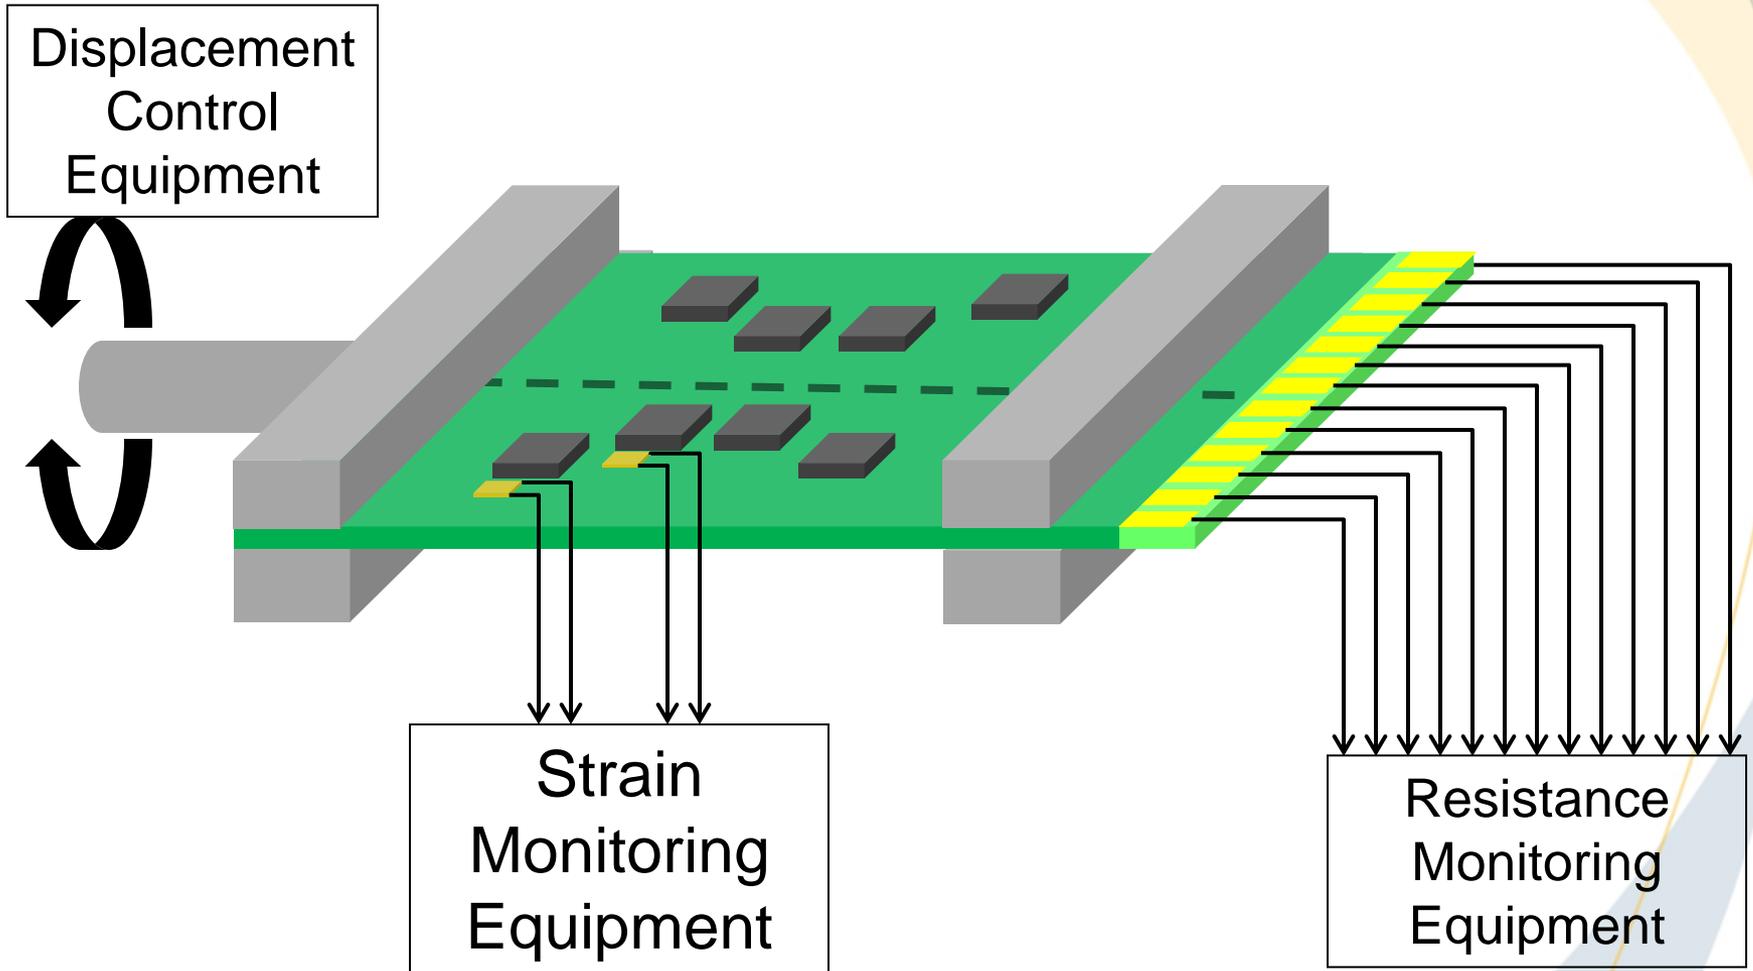
Torsion Test Setup

Angle and rate of displacement should be considered

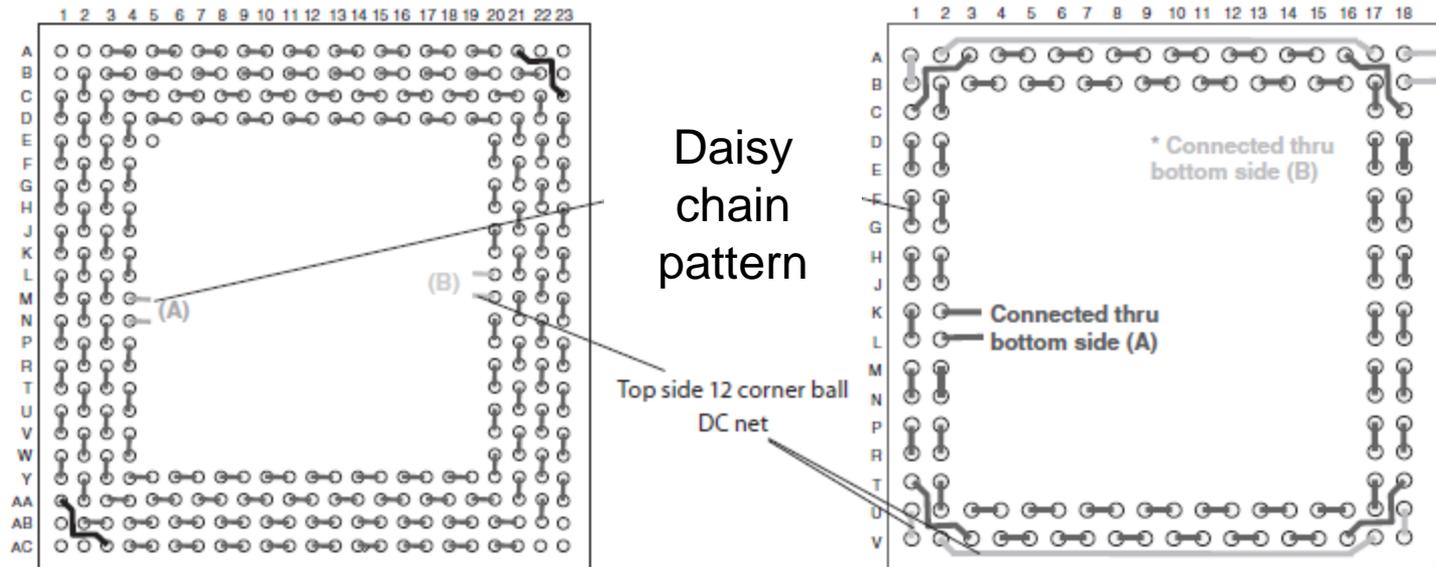
Three net monitoring PoP package

- Three daisy-chain nets were used to monitor the resistance for easy location of first failure site.
- A package was considered a failure even if one of the nets failed.
- A failure criterion was 20% increase in nominal resistance over 5 successive cycles was used as per IPC-9701.

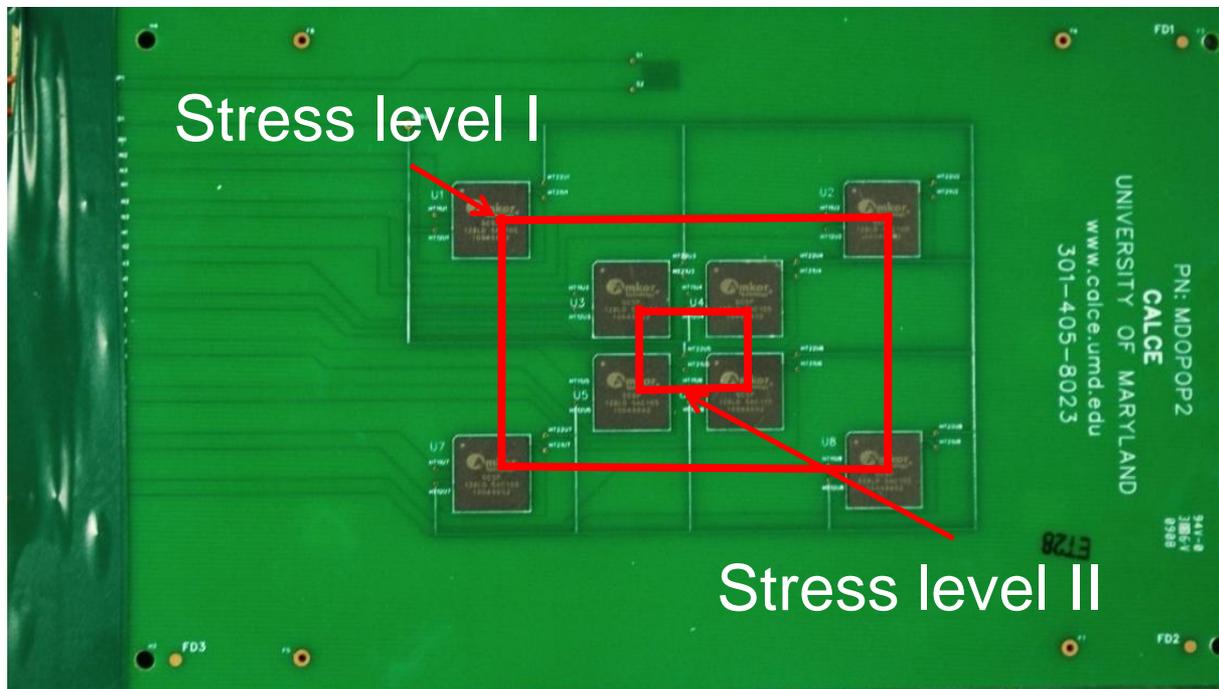
Test Vehicle

- 8" × 4.5" × 62 mils, Polyclad 370HR board laminate, OSP Board Finish
- Eight PoP packages; Package size: 12 × 12 mm; Package laminate: 0.21 mm
- Top package: 0.65 mm pitch, 128 pads, 18 × 18 ball matrix
- Bottom package: 0.5 mm pitch, 305 pads, 23 × 23 ball matrix
- Arranged in two clusters symmetrically about the center of the PWB

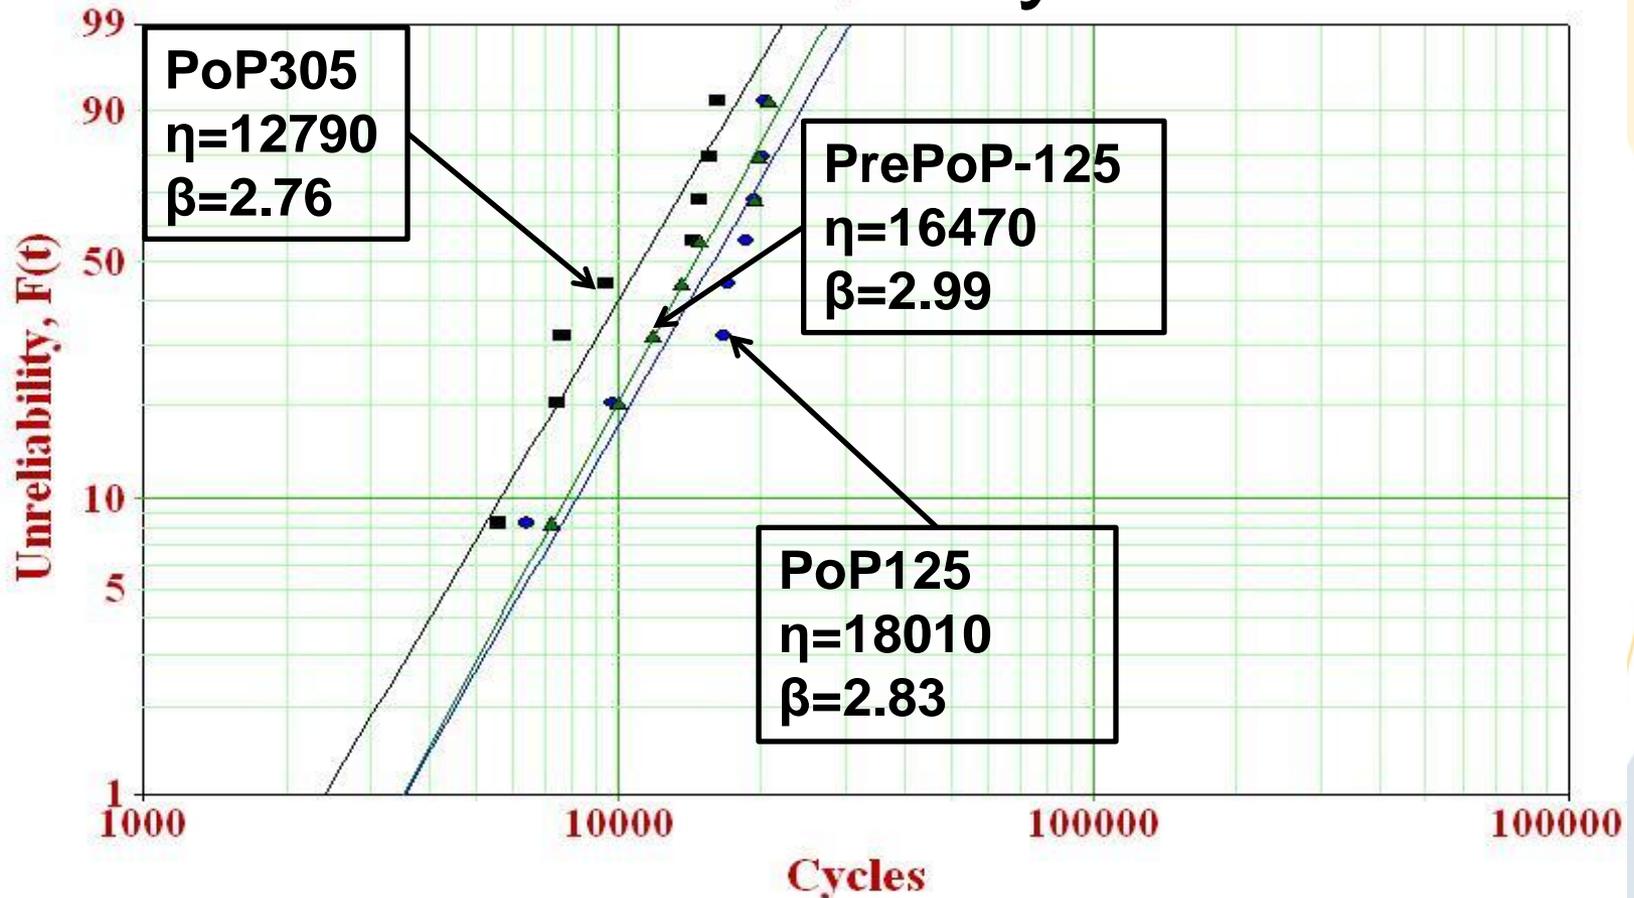
Stress Level I- Weibull Analysis

No statistical difference found using ANOVA between POP305, POP125 and PrePoP125 for both stress levels.

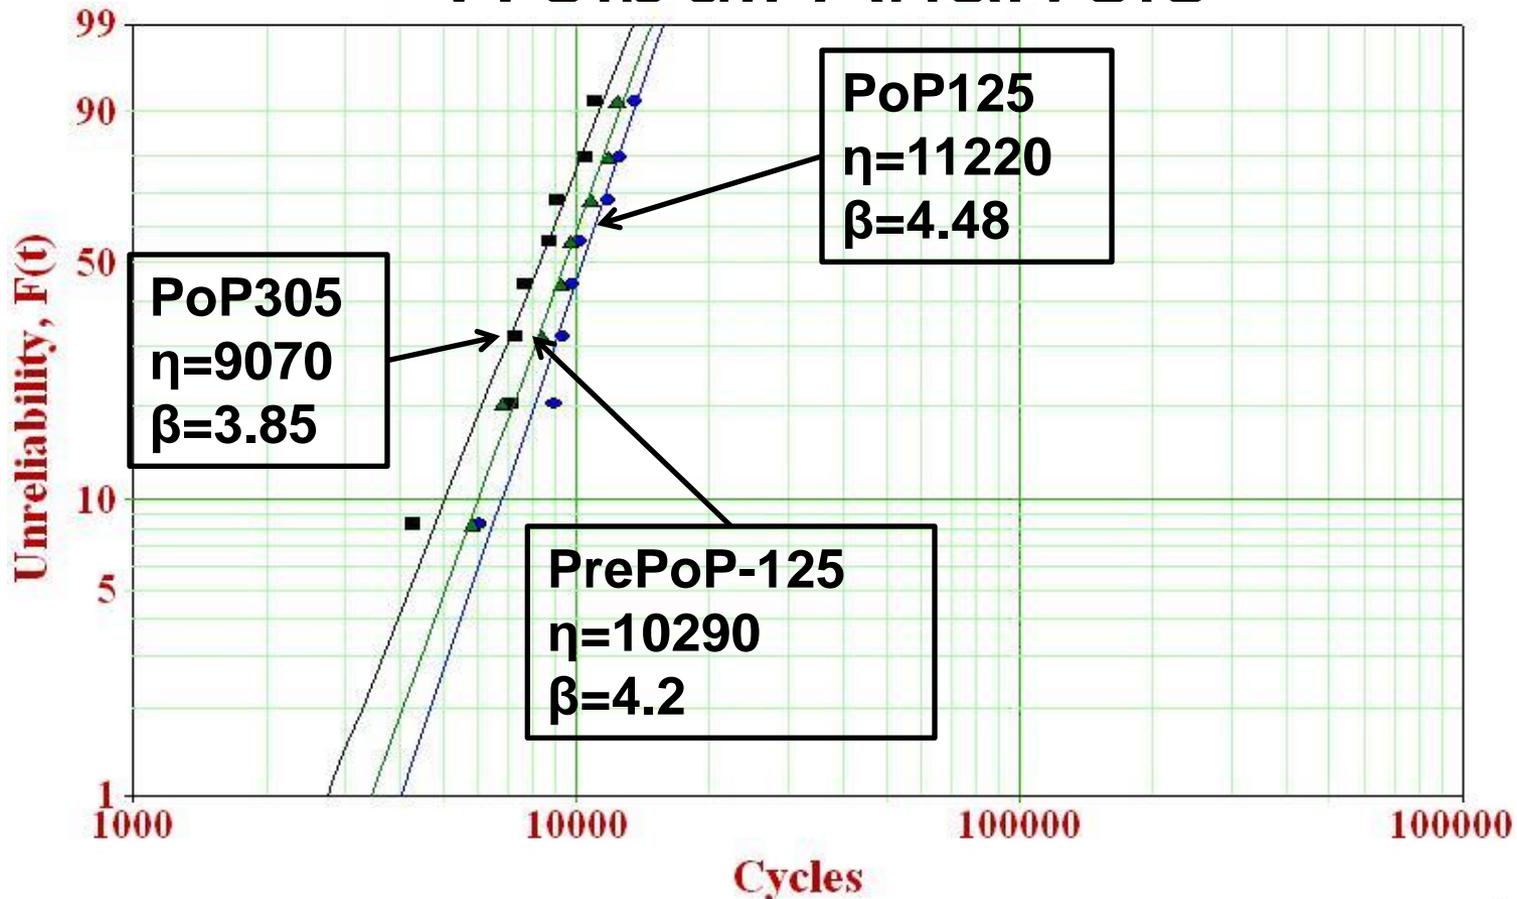
Stress Level II- Weibull Analysis

Bottom net is observed to fail first on PoP components irrespective of solder paste or assembly technique.

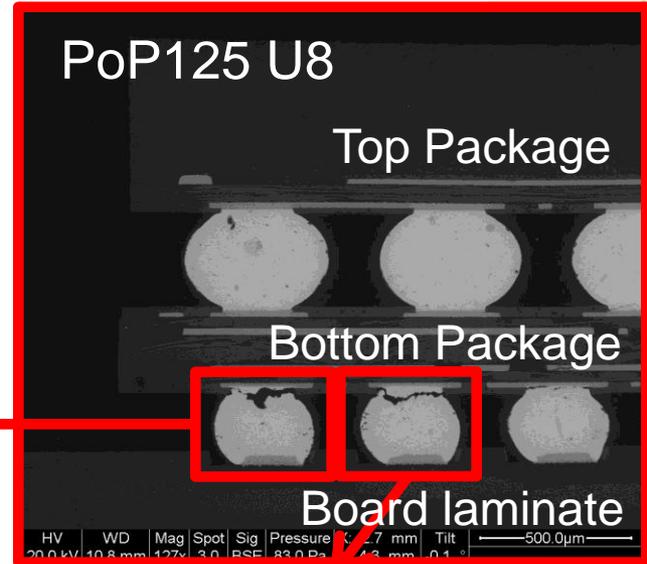
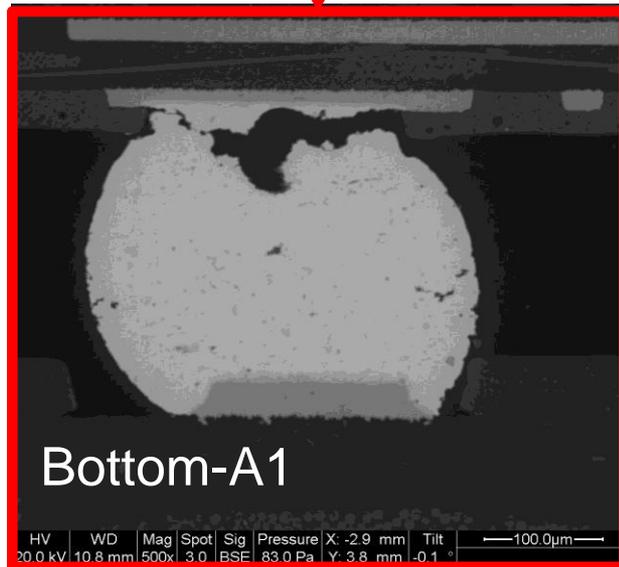
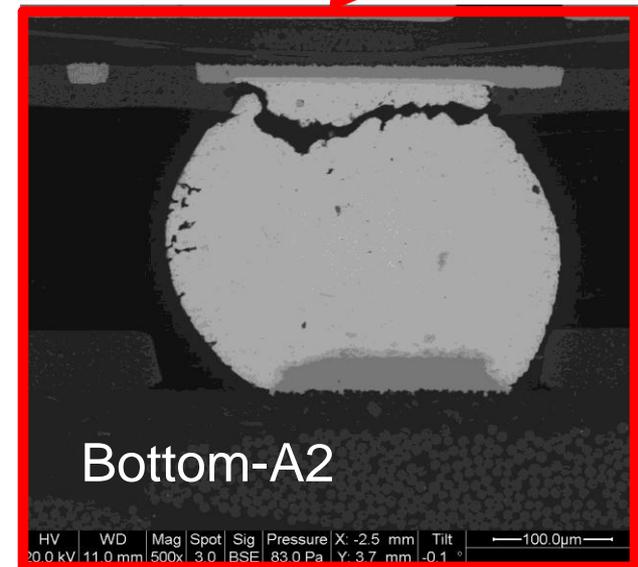
Failure Analysis: PoP125

All interconnect failures were observed on the Bottom package second level interconnects. Cracks were located on the package-solder interface. Instances of pad cratering were observed.

6399

18200

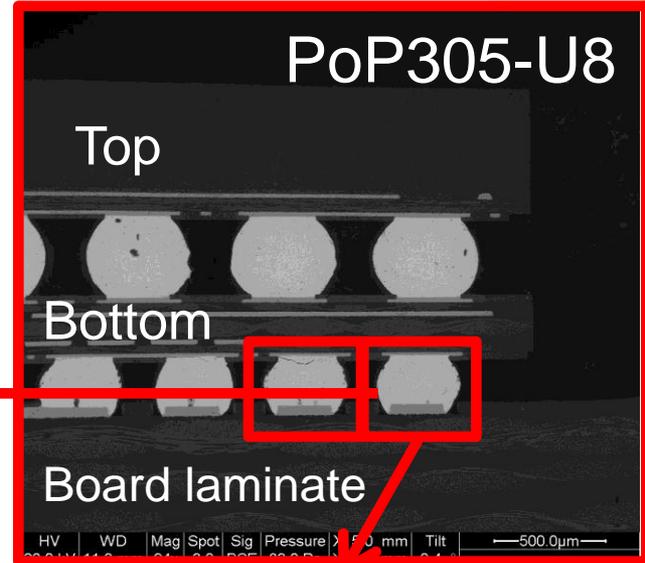
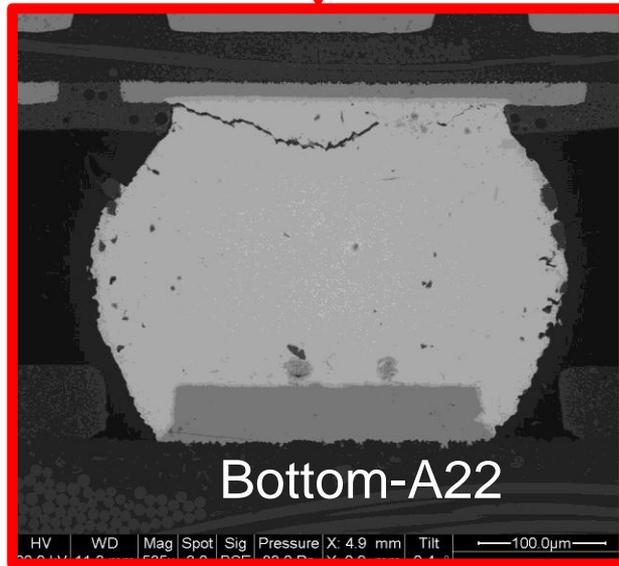
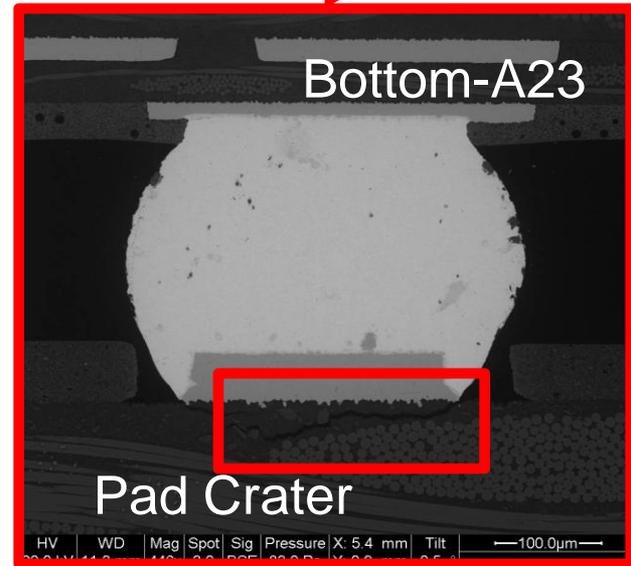
Failure Analysis: PoP305

Nature of failures were similar irrespective of solder paste used to assemble the packages.

Package first CTF : 5565
Cycles on board: 11980

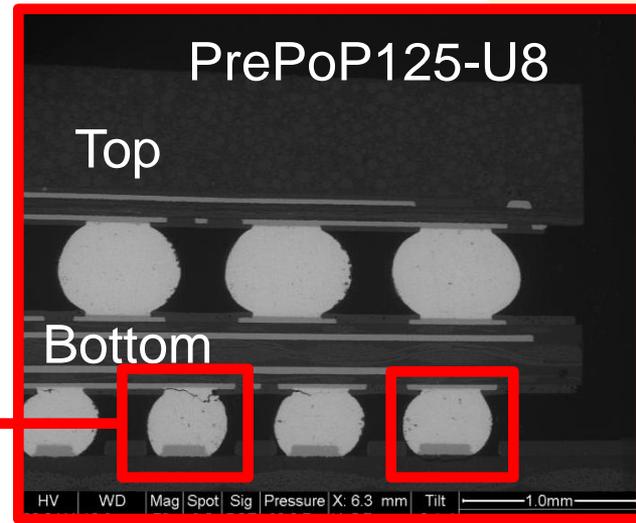
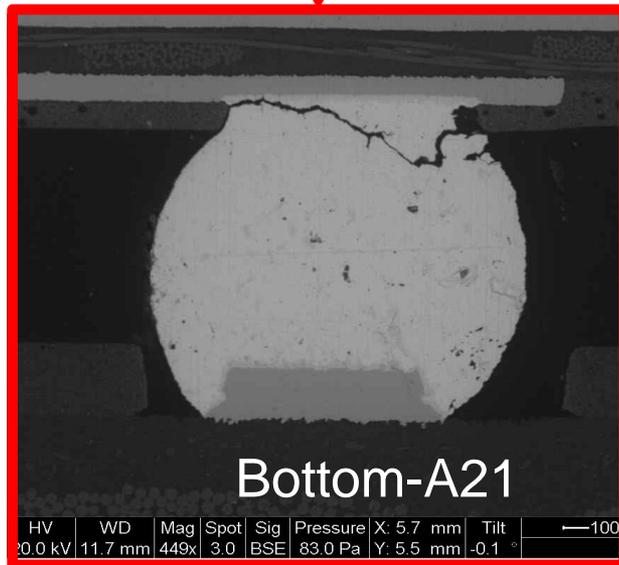
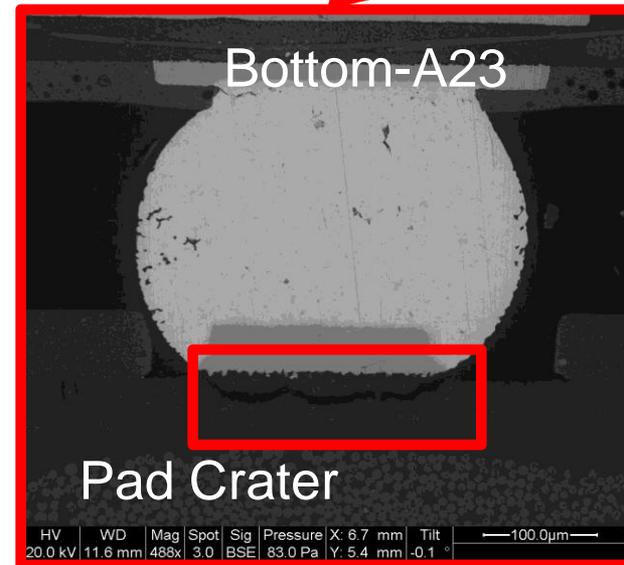
Failure Analysis: Pre-PoP125

Nature of failures were similar irrespective of assembly technique used to assemble the packages.

Package First CTF : 11817
Cycles on Board: 22350

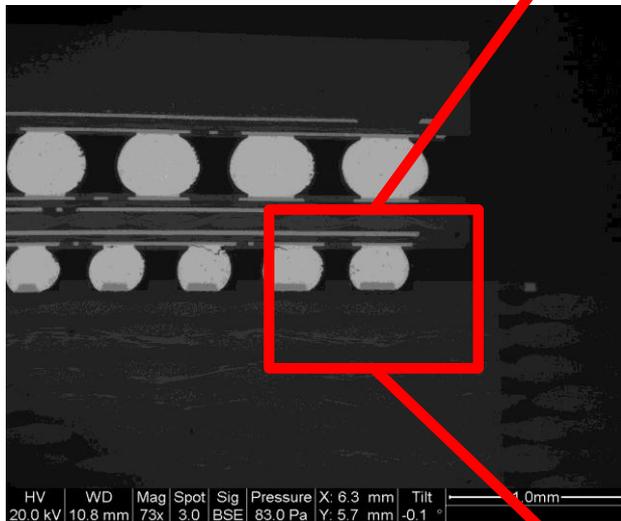
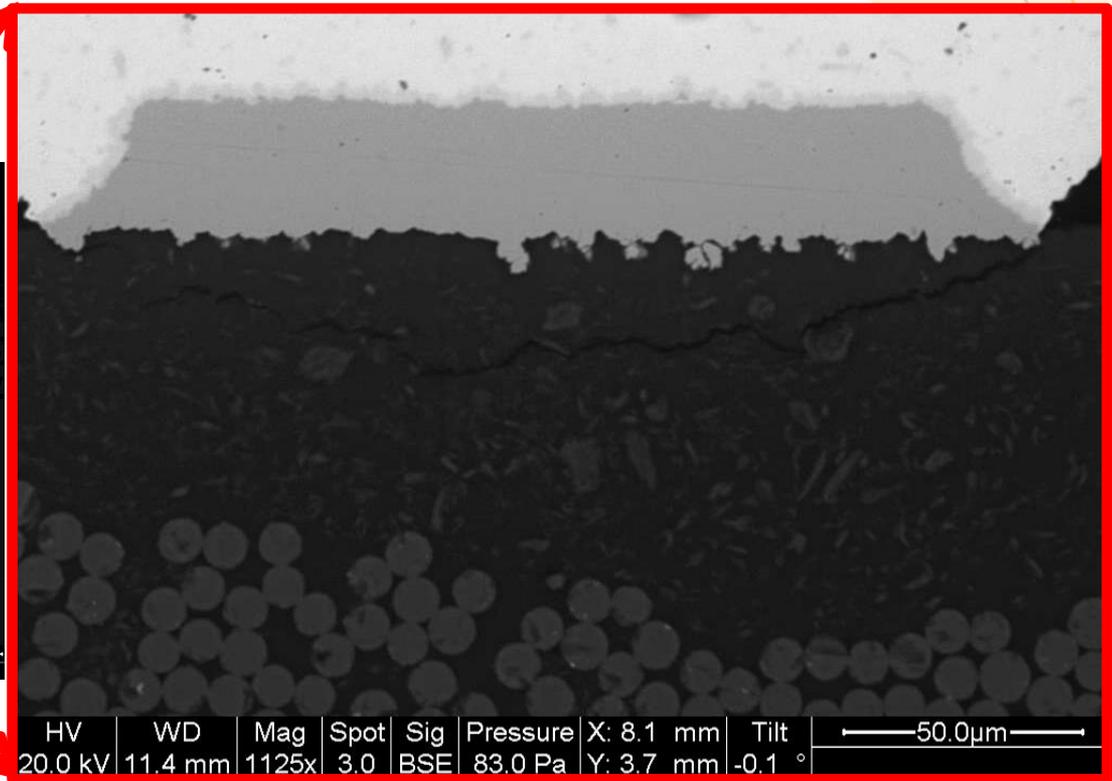
Pad Cratering

- Pad cratering was observed on PoP assemblies for all assembly techniques.
- Pad cratering was observed on board laminate Polyclad 370HR.
- Cohesive failure mechanism of the resin was observed in the failed samples.

- Pad cratering is defined as cracking in the thin resin rich region underneath the copper pads and traces [12].
- Two crack mechanisms are commonly observed [13]:
 - Cohesive failure : Fracture along the resin rich region.
 - Adhesive failure : Fracture between the resin and glass fiber bundles.
- Pad cratering does not necessarily lead to electrical failure of solder joints.
- The crack in resin may cause failures in connecting trace, and thus cause an electrical open. Therefore, pad cratering does not directly cause electrical discontinuity.
- Even if the trace is not severed, or the pad in question is non-functional, a crack in the underlying laminate is a reliability concern.

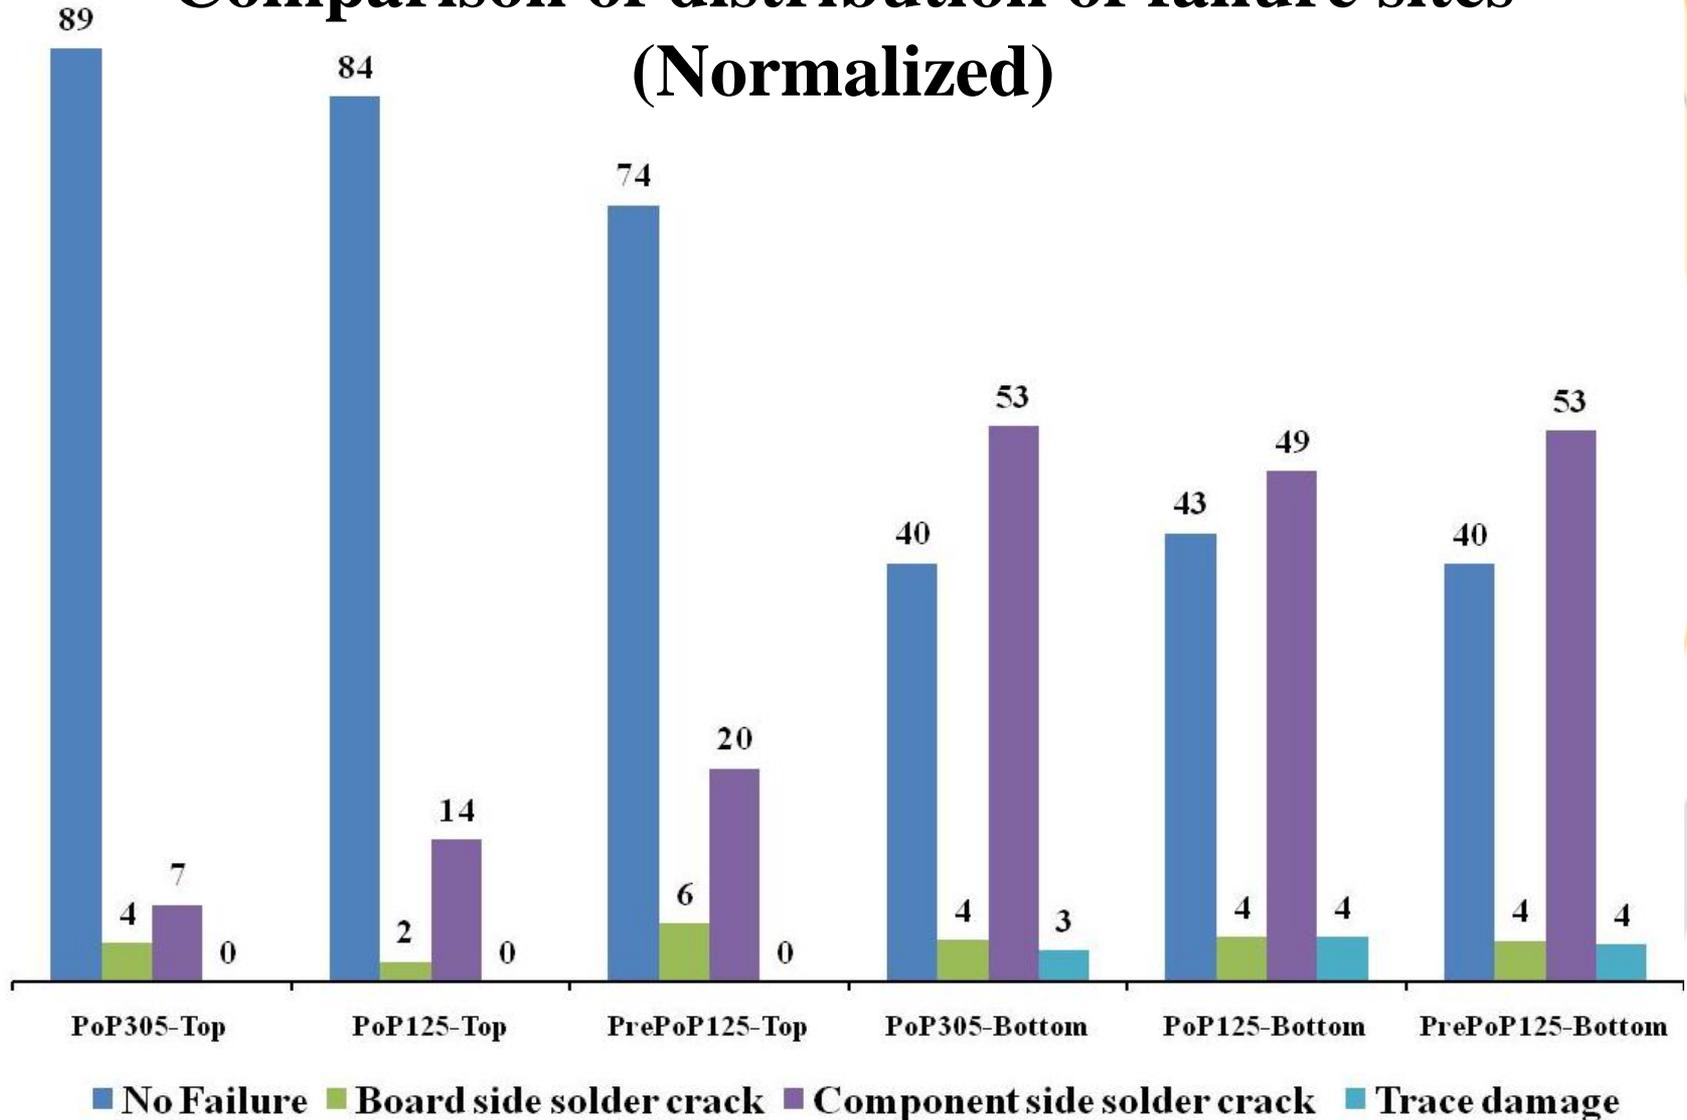
Dye & Pry Results: Stress Level I

Comparison of distribution of failure sites (Normalized)
