Reliability Evaluation of One-Pass and Two-Pass Techniques of Assembly for Package on Packages under Torsion Loads

Vikram Srinivas, Michael Osterman
Center for Advance Life Cycle Engineering, Department of Mechanical Engineering,
1103 Engineering Lab Building, University of Maryland,
College Park, MD 20742-9121

Reliability Evaluation Of One-pass and Two-pass Techniques of Assembly for Package on Packages Under Torsion Loads

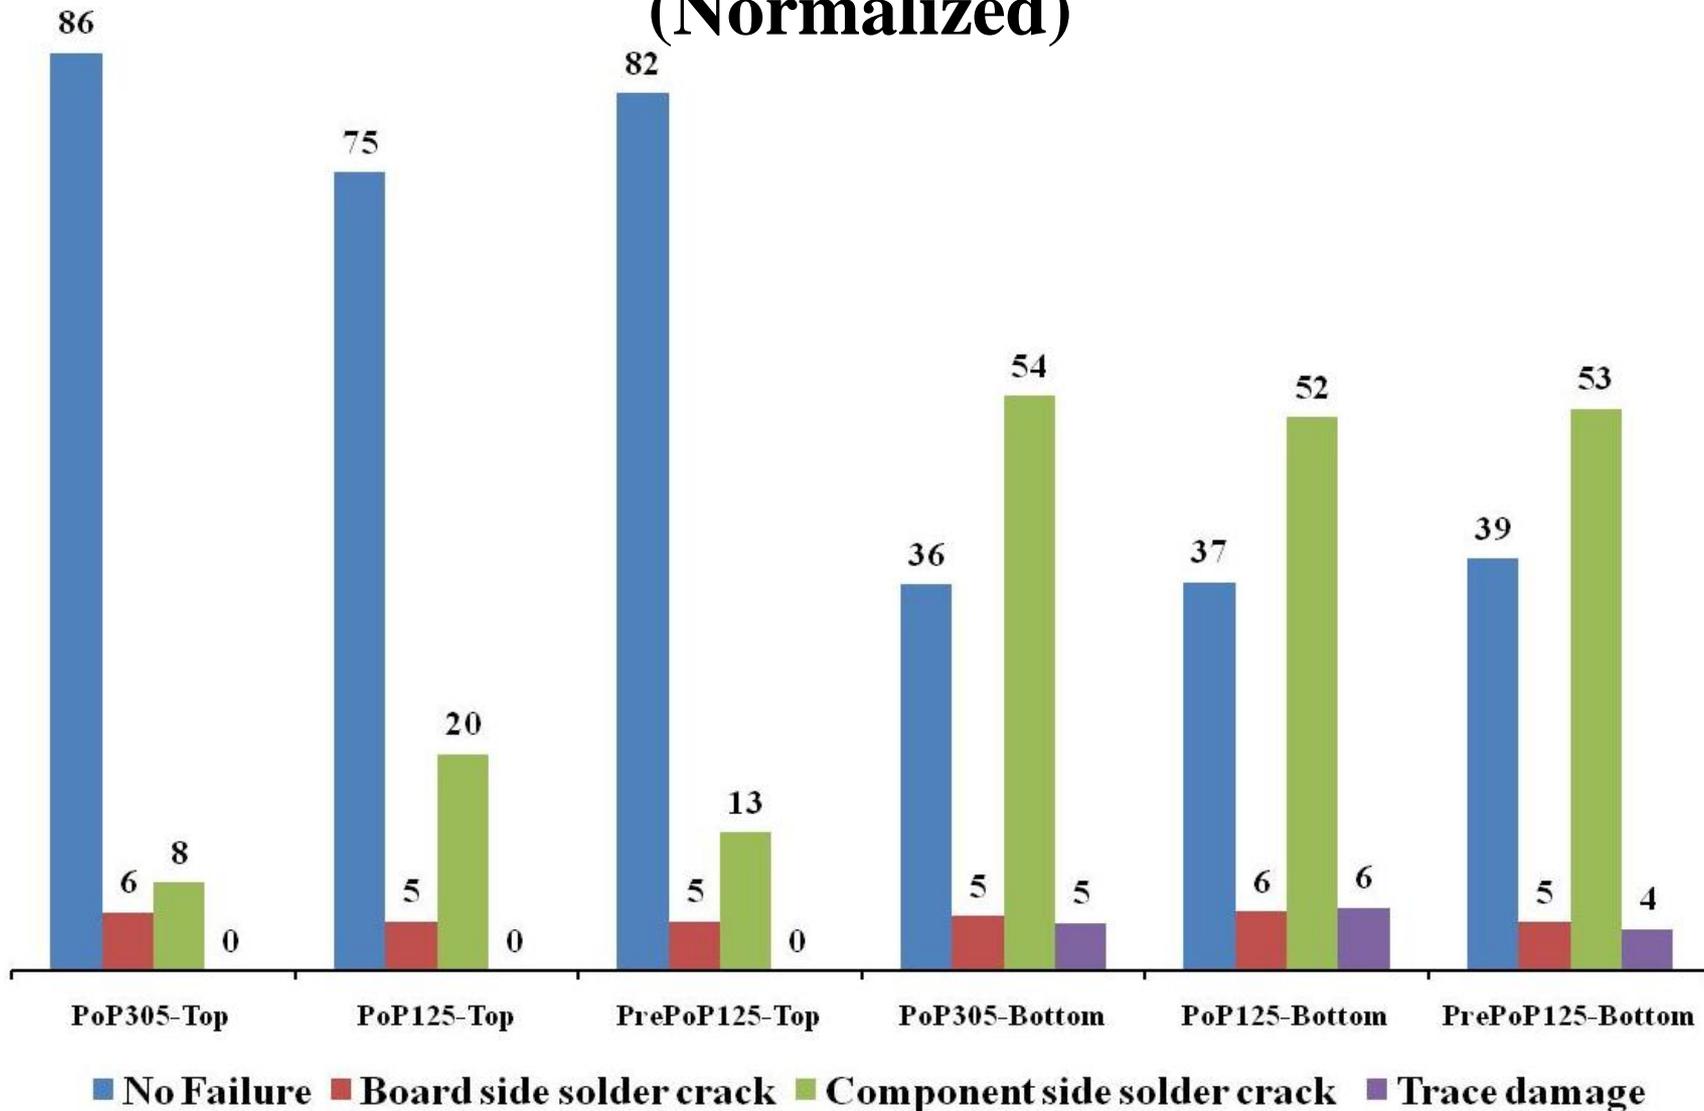
Dye & Pry Results: Stress Level II

Comparison of distribution of failure sites in PoP (Normalized)
