Changing the Paradigm For Optical and X-Ray Inspection of Backplanes and Large PCB Assemblies

Ian J Brown PhD
RoBAT Ltd
Manchester, UK

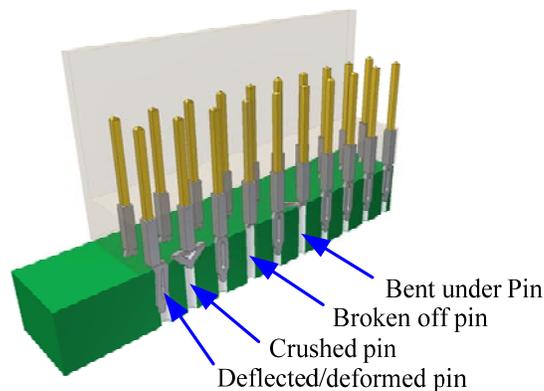
Figure 1 - Press fit connector assembly defects

Meeting the combined challenges of high speed serial data communication, and high channel density interconnection, has dramatically changed backplane connectors from relatively sturdy 2mm pitch assemblies to fragile 1.2mm and smaller pitch assemblies. These modern connector types have proven to be more susceptible to pressing defects such as those illustrated in figure 1. Many of these errors are not reliably detected by the existing electrical ATE techniques applied to backplane test ⁶.

Press-fit pin defect detection is a known and existing problem on all back plane assemblies as recognised in the iNEMA manufacturing report 2009⁶. As the requirement for higher data rates in backplane designs increases then these problems will also grow in frequency. This is particularly recognised as a problem for mid-plane systems where via barrels are shared between connectors on both sides of the board. It is no longer sufficient to perform electrical tests to evaluate continuity, isolation, and even functional tests to validate the performance of backplanes and other large PCBA samples. In the same way that BGA assemblies are routinely tested by X-ray inspection, it is crucially important to know what is going on underneath, as well as inside, the signal interconnects. The iNEMA 2009 report proposes the development of a scalable X-ray or vision methodology that is capable of doing 100% inspection of pins pressed into the same via barrel on the largest of

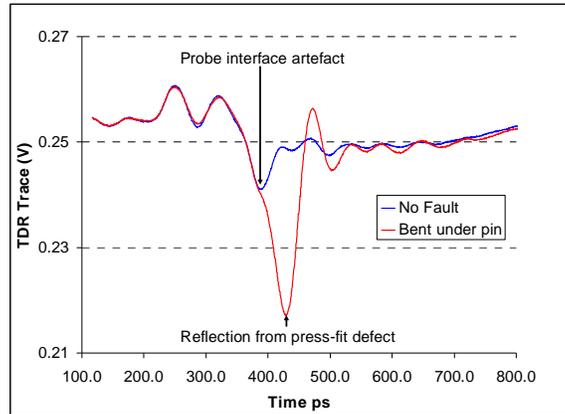
Figure 2 - TDR trace of typical press-fit defect

Figure 2 shows the start of a TDR trace of a high Gbps (Giga bit per second) backplane circuit with and without a bent under pin defect. This defect was not evident in ATE tests as contact continuity was maintained. The effect of the defect is obvious, and the result on the circuit bandwidth profound. Similar deficiencies in a backplane that passes ATE test may not be discovered until full system integration. Worse still is that a backplane that performs adequately at today’s data transmission rates may not work at all if the system daughter boards are upgraded in the future to meet the demands of higher communication rates. Interconnect systems for 10Gbps Ethernet are already widely available. Future interconnect systems utilising both press-fit technology and SMT mounting techniques that quote data rates exceeding 20Gbps are already openly discussed in the literature₁. These high data rate systems utilise interconnect systems that are increasingly susceptible to pressing problems of this type.

A largely unrecognised side effect of pressing defects is their impact on signal integrity. The effect of standing wave resonances on the signal integrity of interconnect circuit trace features is well established (see 1, 2, 3, 4 for example). These resonances exacerbate cross talk and insertion loss at frequencies between 2.5GHz and 5GHz. This is a critical frequency range for contemporary serial data transmission rates. The PCBA design strategies (via size, stub length, anti pad size and shape) to essentially “tune” any resonances on the backplane interconnect away from critical frequency bands are also well established. Each of the common press fit defects is itself an un-tuned circuit resonance feature, (similar to an un-tuned via) and they will detrimentally affect interconnect losses by as much as 30dB₄ and dramatically reduce the data transmission bandwidth.

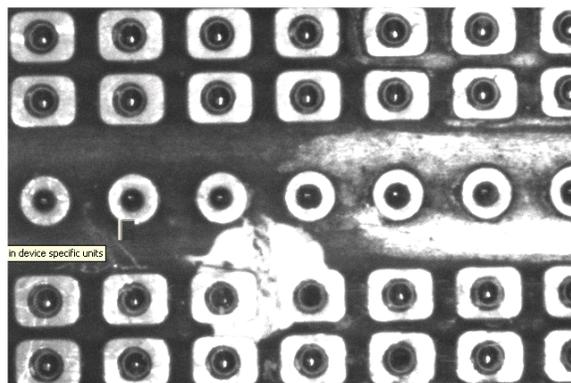
Figure 3 - Pin in hole image of a 10mm thick PCBA

In figure 3 there are two pins that are not visible in the vias. In this example the pins had been deliberately removed from the connector. This is a particularly easy example where the compliant pins are quite large and the via holes are 0.6mm in diameter. Still there are many occasions when the pin tip is simply not visible down the hole even though it is present. This leads to false alarms on testing. Using axial illumination methods (diffuse and otherwise) reduces the number false alarms but the issue remains for production volume testing. For most modern high density connectors the via diameters may be even smaller. The narrow aspect ratio offered by the via hole (that the compliant pin is pressed into) limits the visibility of the pin tip. Particularly for thicker backplanes, or where a variable diameter via's have been used to tune the interconnect resonances. This situation will not be significantly improved by the use of transparent materials for the fabrication of the connector housings. Simple geometry is the enemy. This dictates why this technique is unreliable as a primary production test. Pin in hole is not possible at all for mid-plane systems where the via barrel is often shared by compliant pins from connectors on both sides of the board.

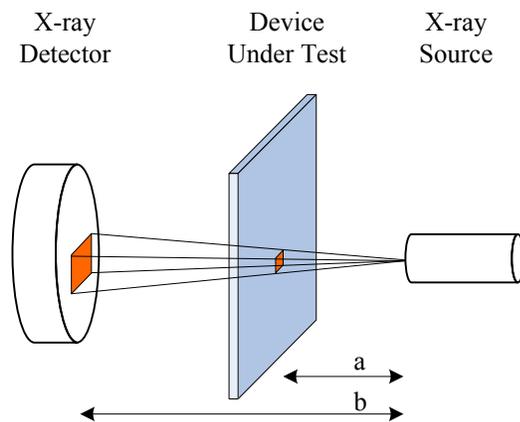
Figure 4 - Anatomy of an X-ray system

The X-ray imaging process is a “shadow” technique based on the classic design of the “pin-hole camera” as shown in figure 4.

The source of the X-rays is a micro focus X-ray tube. This can be considered as a point source of X-rays (typically less than 100µm across). The X-rays spread out as a cone to illuminate the test object. At the test object some of the X-rays are absorbed and the remainder continue to form a shadow of the test object on the flat surface of the X-ray detector. Any object within the analysed sample that has material of higher density than the surroundings will absorb more of the x-ray beam and so cast a shadow on the detector (see figure 4). In this way, solder and copper tracks appear dark compared with the laminated circuit board in a PCBA, for example. The shadow image is magnified due to the diverging cone of X-rays that emerge from the source as is shown in figure 4. The shadow image is magnified by the ratio of the distances “b/a” in the figure. This is known as the geometric magnification.

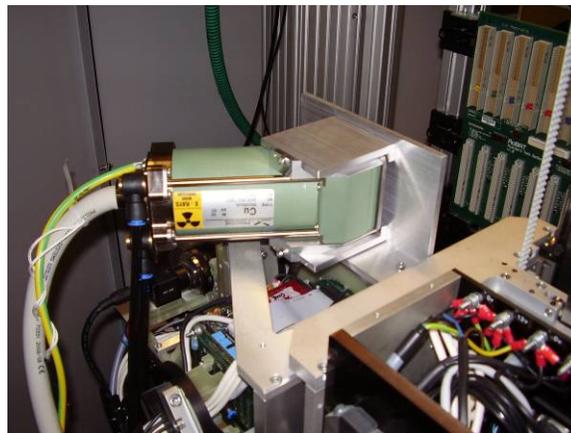
Figure 5- Source mounted in the test system

Figures 5 and 6 show the practical arrangement we used for mounting X-ray source and detector mounted on opposite robotic heads of our development prototype system. The detector utilised was a 35mm field of view 4 megapixel camera. The DUT shown in figure 6 was one of the many backplane and larger PCBA samples we tested. In this case the backplane was a small (550mm wide by 700mm high) mid plane system with press fit connectors on both sides of the backplane sharing via barrels. The source can just be seen in figure 6 on the opposite side of the DUT.

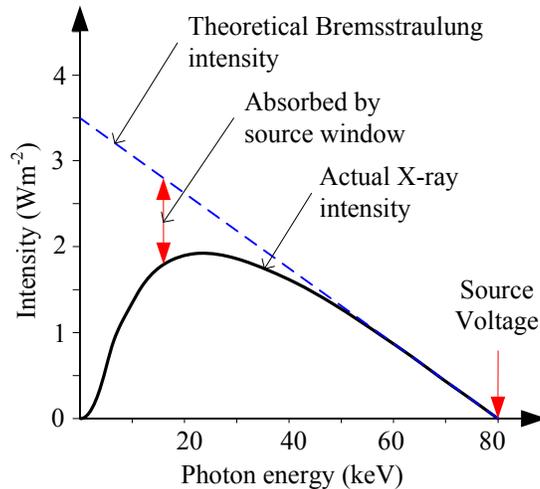
Figure 7 - Typical X-ray source energy spectrum

The principal parameter for any AXI system is the source energy. The value quoted is usually specified in kV (Kilo Volts) or keV (Kilo Electron Volts) and is actually the voltage that is applied to accelerate the electron beam that is focussed on the source anode. Typical values quoted are in the range 30-160kV. This then defines the upper limit of the energy of the X-ray photons produced. The principal process for generating X-rays for imaging is known as Bremsstrahlung (or breaking radiation). The theoretical relationship between the intensity of the Bremsstrahlung X-rays with reducing energy is for practical purposes a straight line (see figure 7) whose intersection is at the source voltage. Any very low energy photons are absorbed by the source window (usually made from beryllium) and never get to the DUT. This gives a very broad energy spectrum of useful X-rays. A system quoted as having a 160kV source does not mean that all of the X-rays used for the image are at that level. The energy spread of the X-rays will be over a range from a few kV up to a theoretical maximum of 160kV. The modal value (the energy with the highest intensity) will typically be in the range 20kV to 40kV depending on the thickness and transmission properties of the exit window of the source. Typically for a source operating at 100kV, most of the X-ray photons produced would have an energy of less than 50kV.

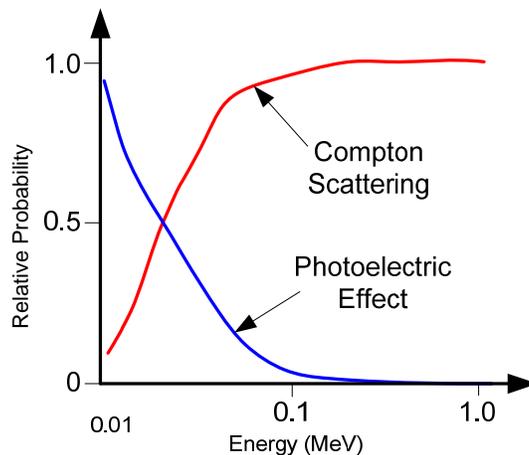
Figure 8 - X-ray absorption and scattering in materials

A simple rule of thumb that can be learned from any medical diagnostic X-ray technician is that the higher the energy of the X-rays, the higher the penetration power, and the lower the contrast in the image. To understand how this effects the detection of press fit defects we do need to delve briefly into the fundamental physics of the two physical process involved in the absorption of soft X-rays₇ (see figure 8). This is the photoelectric effect, and Compton Scattering.

The principal beneficial process to creating contrast in an X-ray image is the photoelectric effect. Here the X-ray photon interacts with the electrons in the atoms of the material resulting in the emission of a photoelectron and the absorption of the X-ray photon. The probability of this occurring depends on the atomic number of the atoms in the material and the energy of the X-ray photon. The higher the atomic number of the material (or the denser the material) the more likely the X-ray will be absorbed. The higher the energy the less likely the X-ray will be absorbed. This is the physical process that gives rise to all of the contrast in an X-ray image. At low energy there is a very high probability of photon absorption so the image contrast is very good. At high energies most of the X-rays go straight through and image contrast is reduced.

The physical process that is responsible for the majority of the noise in an X-ray image is Compton scattering. In Compton scattering the X-ray photon interacts with the electrons in the atoms of the material but is deflected, and slowed down, rather than being absorbed. The probability of Compton scattering occurring is independent of the atomic number of the material and increases dramatically as the photon energy is increased. The visual effect of this is that the contrast in the image is worse and edges become blurred.

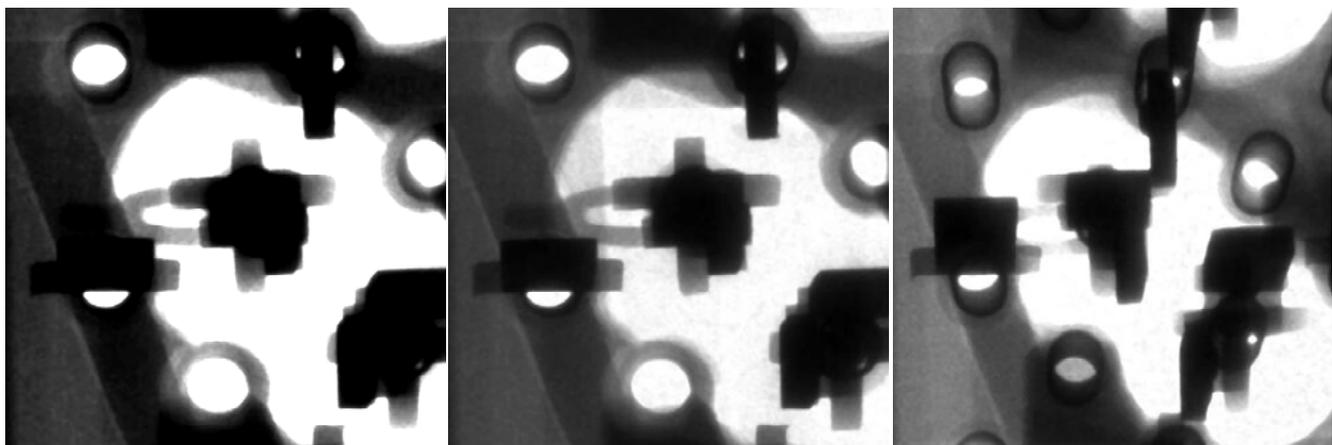
Figure 9 - Effect of source voltage on image contrast

Figure 9 shows images of a mid plane sample fitted with FCI Airmax connectors. The images show a bent under compliant pin on a signal trace. At source energies above 80 kV it was difficult to image the defect artefact at all due to further loss of contrast in the image. The higher the source energy, the more narrow the tolerance window on exposure time. In this case the ideal energy to image the artefacts was 60kV. Repeating this process for a variety of backplane configurations 50-60kV appears the ideal energy for most backplane test applications. Utilising a source energy of between 50 and 60 kV produced optimum results in terms of clarity of images, insensitivity to precise exposure timing, and low test times. The remainder of sample images in this paper were all obtained at 60kV source energy.

40keV source, 3.4s exposure

60keV source, 1s exposure

80keV source, 0.5s exposure

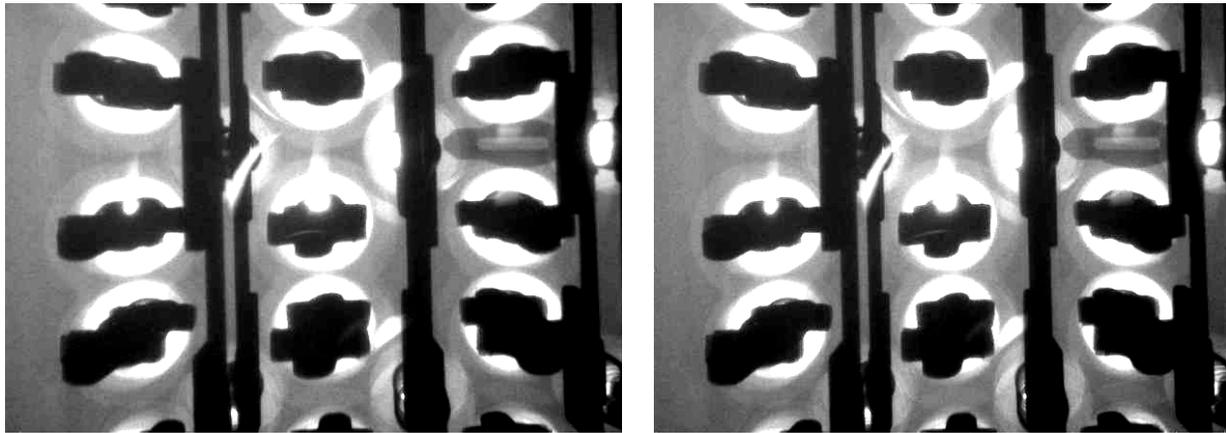
Figure 10 – Effect of focal spot diameter on backplane images

The second key parameter is the focal spot diameter of the source. This is the diameter of the focussed beam of electrons that strikes the anode of the source to produce the X-rays. This is hence the same as the size of the point source of the X-rays used to create the image. The smaller the focal spot diameter the sharper the images produced (and the more expensive the source). 95% of the energy of the electrons in the source is converted to heat in the anode. The smaller the focal spot means that the heat generated is confined within a smaller area. There is a limit to the power density that can be dissipated by the anode without melting. So this means the smaller the focal spot, the lower the maximum luminescence (brightness) of the source. Many systems quote a large range of focal spot diameters from as little as 0.1µm to as much as 100µm. But how small a focal spot do you need to reliably detect the assembly defect features we have been discussing. Figure 10 show images taken with our system of a 10mm thick, 32 layer mid plane PCBA with back to back connectors sharing the via barrels of the PCBA. The only difference between the images is the focal spot diameter that was used. The bent under pin on a ground bar is clearly visible on both images. Examining the pixel by pixel grey levels at the sharp edges does confirm the relative focal spot sizes. Full scale and full resolution images show that the 20µm image appears marginally “sharper” but there is very little visible difference and images obtained using a 50µm focal spot size system will automatically detect all of the backplane assembly errors discussed. The added system benefit (other than the cost of the source) of operating the source with a 50µm focal spot is that it can be operated at up to 6 times the intensity than the 20µm diameter spot source without causing damage to the anode. This results in shorter test times.

Focal Spot Diameter 50 μ m

Focal Spot Diameter 20 μ m

These images were acquired with a geometric magnification of approximately 2. This is the maximum geometric magnification factor that is practically required for the detection of any of the backplane faults expected. But is this suitable for all X-ray inspection tasks? Figure 11 shows an oblique image through a Raid controller IC on a PC motherboard. The separation of the individual pins of the 128 QFP package is 0.5mm.

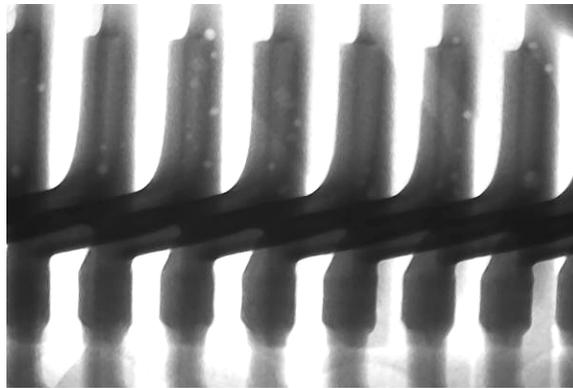
Figure 11 – Higher geometric magnification image with 20 μ m focal spot

The geometric magnification used for this image was 9. The blurring on the image edges due to the focal spot diameter in the source is slightly more obvious but the image quality is still highly acceptable and easily capable of displaying the texture on the surface of the IC pins and the integrity of the solder joints themselves. The white “bubbles” visible in the image are voids in the solder joint. These images are average samples from the many we have obtained on a wide variety of boards and image targets. All confirm that a source with a focal spot size that is controllable in the range 20 to 50 μ m is adequate for all of the needs of our application.

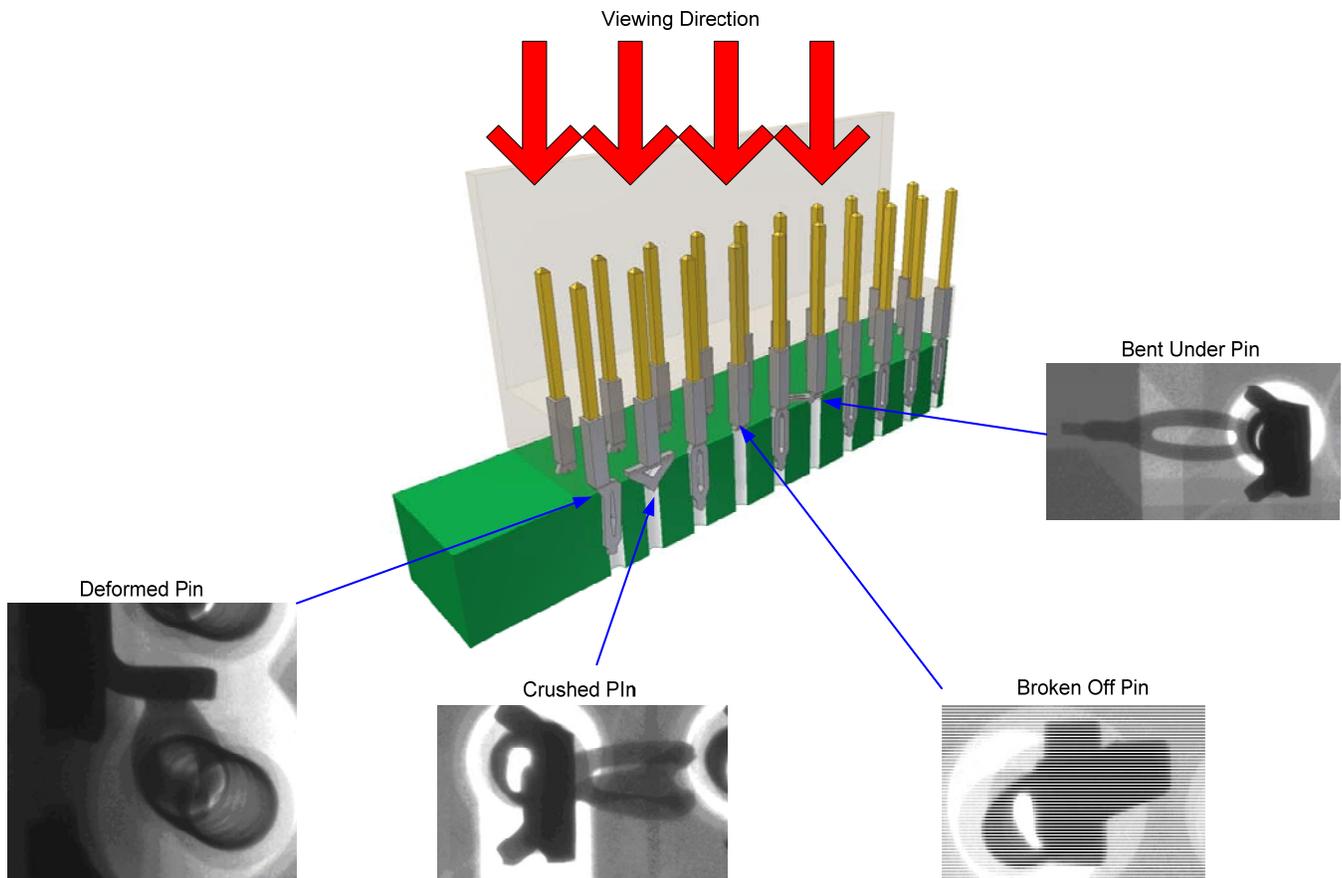
Figure 12 - Sample images of press fit connector assembly faults

Figure 12 shows example images of each of the types of faults that are commonly experienced in press fit connectors. The geometric magnification used to acquire the images was between 1 and 2. So in each case the source is far enough above the DUT to eliminate parallax issues from clouding the detail on the images. The detail and sharpness of the images of the fault defects is superb. The broken off pin image in figure 12 is a good example of the use of oblique imaging to confirm the presence of the fault. This is common technique where the image is obtained at an angle through the board rather than perpendicular to the board's surface.

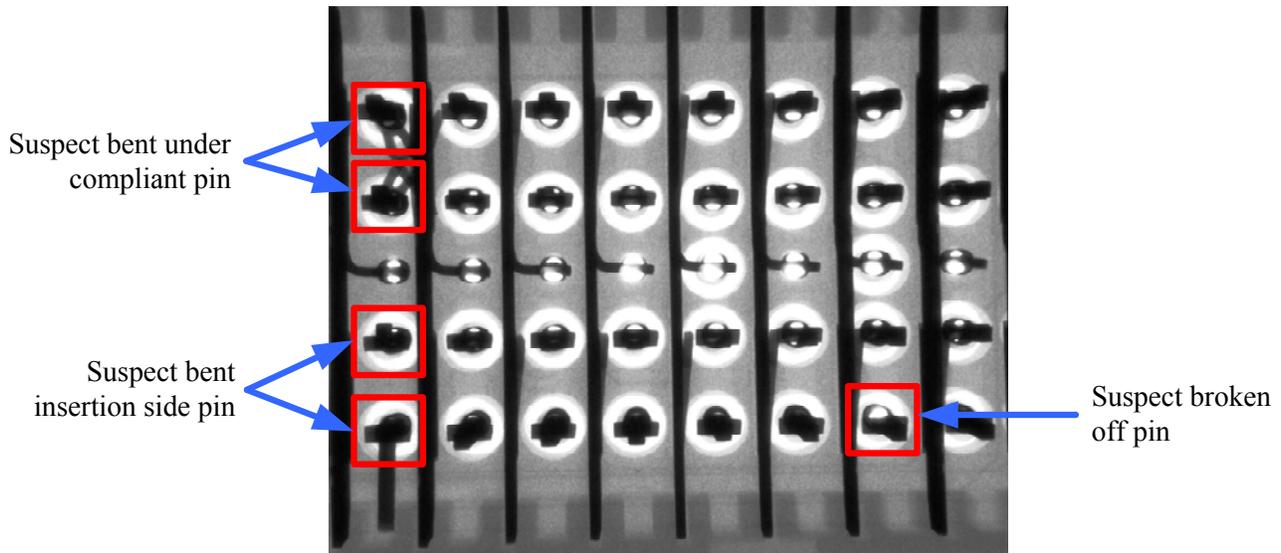
Figure 13- Example exploratory image

In the RXI system we utilize a multi scan approach to X-ray inspection. Firstly an exploratory image at low magnification is obtained and analysed by the computer to identify any suspect faults (see figure 13). This scan is performed at very low geometric magnification, 50µm focal spot diameter and high source brightness. In the image in figure 13 the computer has identified 5 suspect areas on the connector. Any suspect faults are then analysed in detail, at higher magnification, and using a small focal spot size and even a different X-ray energy. The broken pin image in figure 12 is one of these detail images. This image clearly shows that the compliant pin has broken off completely at the point where it clears the connector housing. This is a very subtle fault that would be missed by many systems.

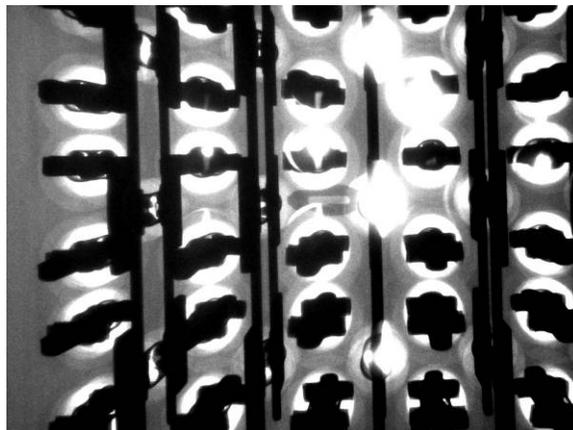
Figure 14 - Effect of parallax on image

Image parallax is a common problem encountered when inspecting press-fit connector defects using systems optimised for normal PCBA AXI. The problem is caused by the high aspect ratio of a connector compared with a typical electronic component. The typical procedure in standard PCBA X-ray inspection is to acquire the image with the source as close as practical to the sample under test. This minimises the exposure time and maximises the available geometric magnification. Inspecting backplane samples is very different! In effect we are viewing the base of the connector through the gap between the pins. As the viewing point gets closer and closer to the top of the connector, more and more of the PCBA surface becomes occluded by the bodies of the pins themselves. The effect is that only a small area of the connector base is sufficiently visible to clearly view any defect artefacts that may be present. Figure 14 is an image acquired with the X-ray source 75mm above the unit under test. Although the pressing defect is still visible in the image the impact of the parallax in the image means that only 50% of the detector field of view is useful. Determining the ideal source height for a given field of view, and a given connector height, is a matter of simple geometry.

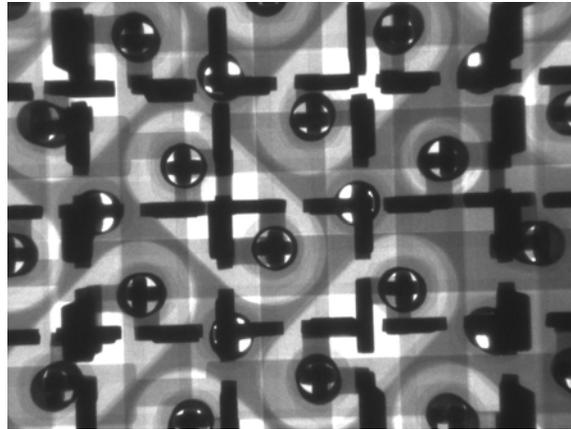
Figure 15 - Back to back FCI Zipline connectors sharing via barrels

Figure 15 is an image of an 11mm thick backplane board fitted with 210 FCI Zipline connectors. The connectors are mounted back to back on the board with 105 individual connectors on each side of the board. The connectors on the rear of the board are mounted orthogonally to the connectors on the front. Hence the “crosses” on each of the via holes (the

compliant pins are at right angles to each other. This image is obtained using a geometric magnification of 1.5. This image is presented to highlight the importance of automatic computer inspection rather than manual inspection. At this magnification there will be 4 images obtained for each connector giving over 420 images to inspect the Zipline connectors on the board alone. These are very detailed images which would be physically impossible for a human operator to inspect thoroughly. The only realistic expectation is to confirm the presence of a fault already localised by other means.

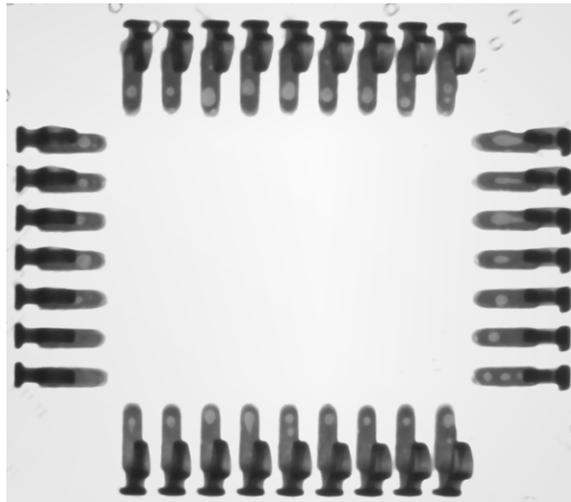
Figure 16 - Solder voids on a PLLMC surface mount IC socket

Figure 16 shows an image of a PLLMC surface mount socket on a PC motherboard. Here the solder joints are all physically underneath the housing packaging and hence impossible to inspect using any other technique but X-ray inspection. The voids in the solder joints appear as bubbles underneath each of the solder pads. In this case every pin has some evidence of solder voids. In some cases more than 60% of the pad area is voided. In automatic inspection the computer analyses these joints by measuring the percentage of the pad area that is covered by the void. When this area exceeds a given percentage then a fault is flagged.

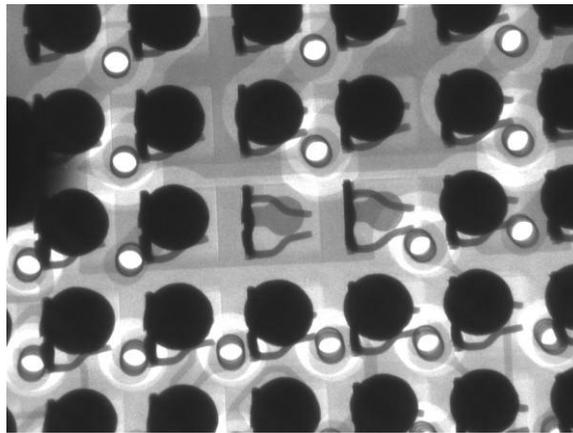
Figure 17 - Missing "Balls" on a FLGA connector

No paper on X-ray inspection would be complete without an image of a BGA joint. This is one of ours. Figure 17 is of a FLGA processor socket on a PC motherboard. The diameter of the BGA balls is $500\mu\text{m}$ and the pitch is $800\mu\text{m}$. The image is slightly more complicated in that the pin contacts in the housing body overlay the BGA balls. Still the absence of the two balls in the array is clearly obvious. BGA assemblies with ball diameters down to $200\mu\text{m}$ are also straightforward to detect. As with a majority of AXI systems our system software detects discrepancies in ball diameter, position, and shape.

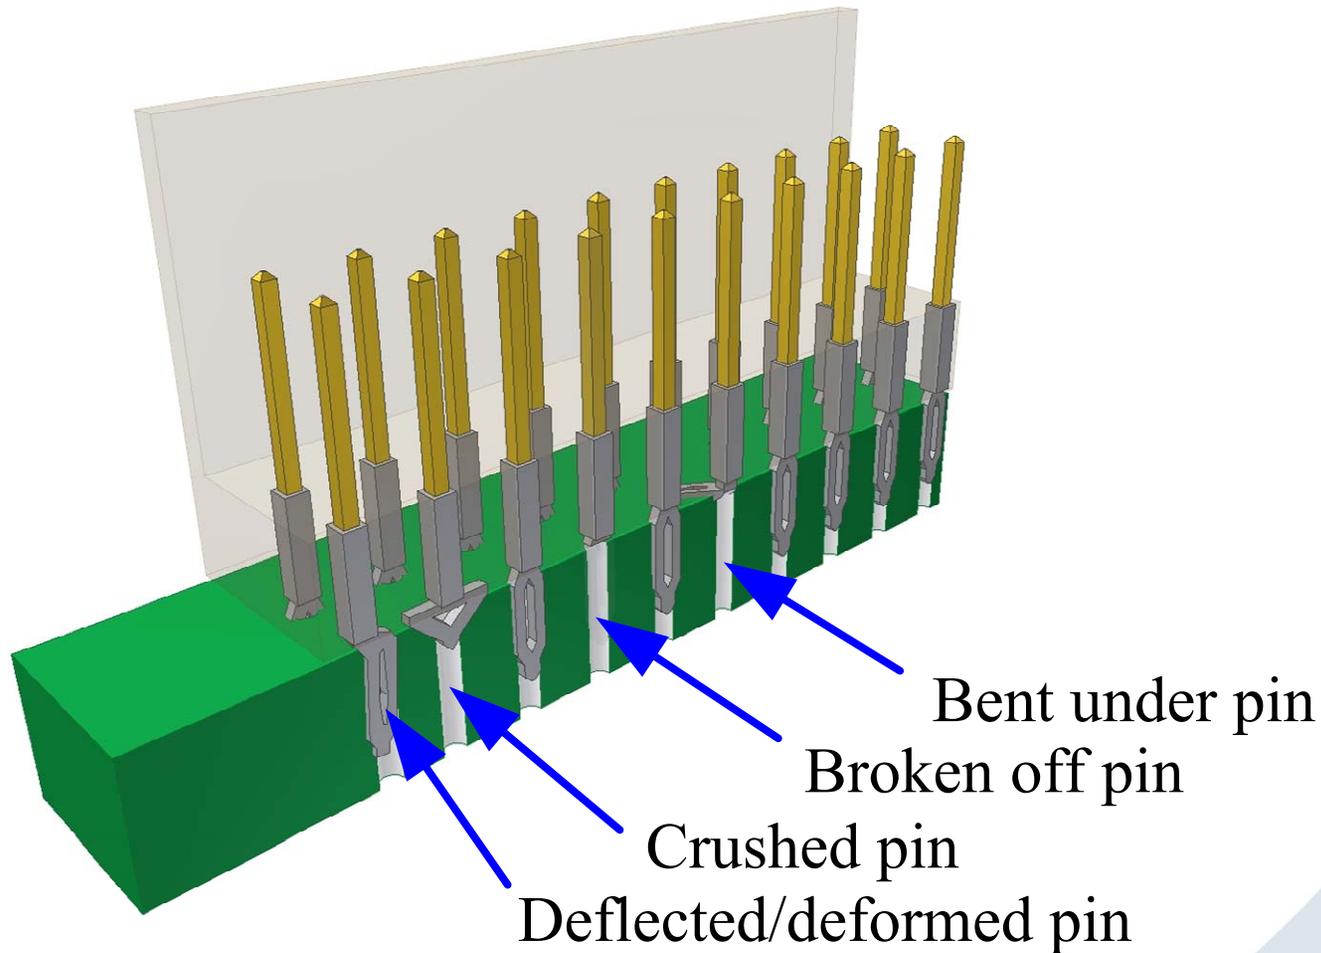
Press fit assembly defects

- Are a known and existing problem on all backplane assemblies.
- High channel density/ high speed interconnects are more susceptible to pressing defects.
- May not be detected by existing ATE testing methods.

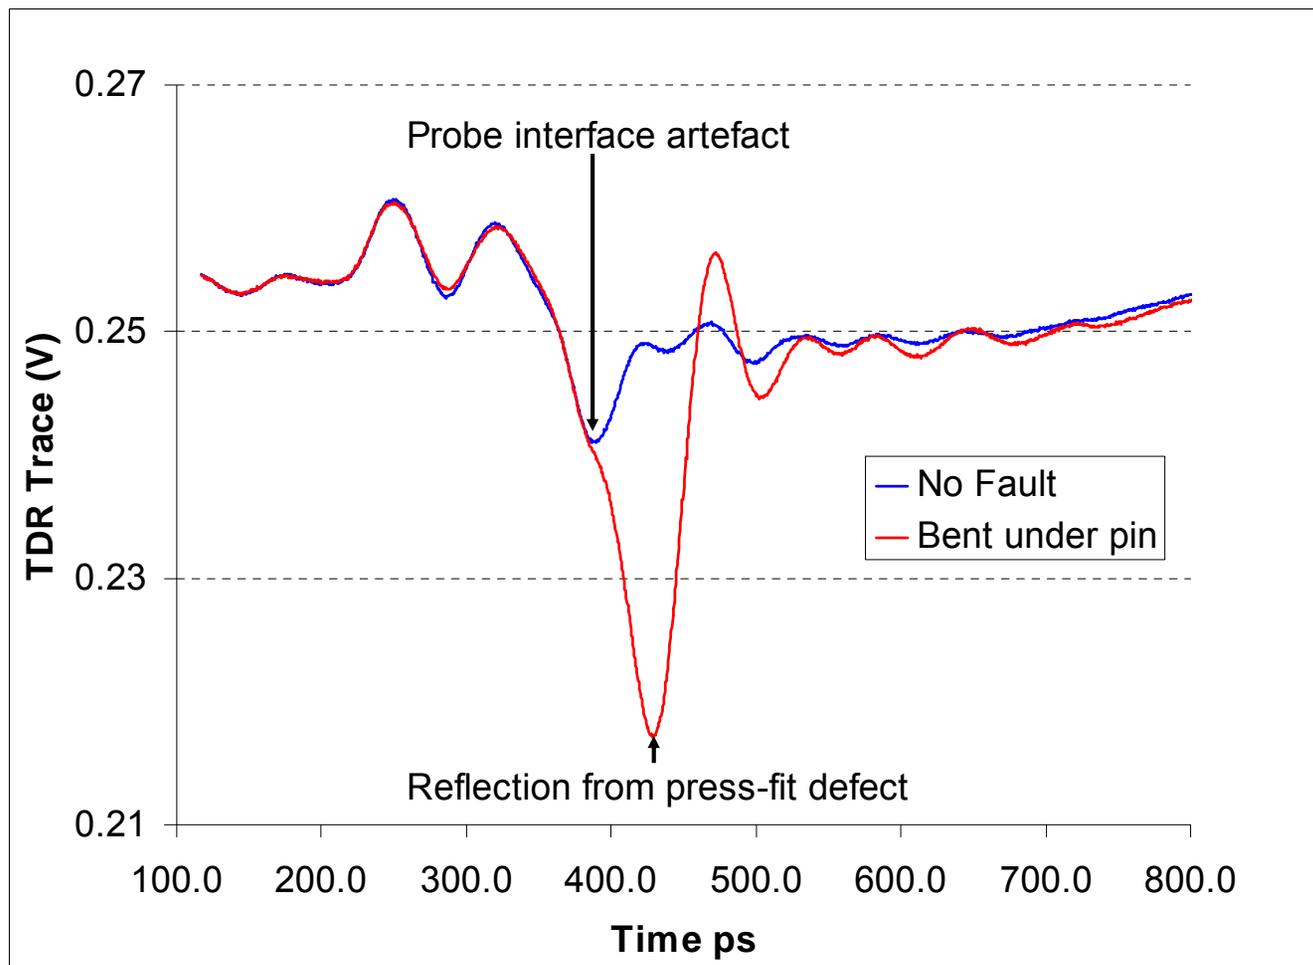
Impact of press fit defects on high speed signal integrity

- Press fit defects behave like un-tuned circuit features producing standing wave resonances in the 2-5GHz range.
- They can detrimentally effect interconnect losses by as much as 30dB.

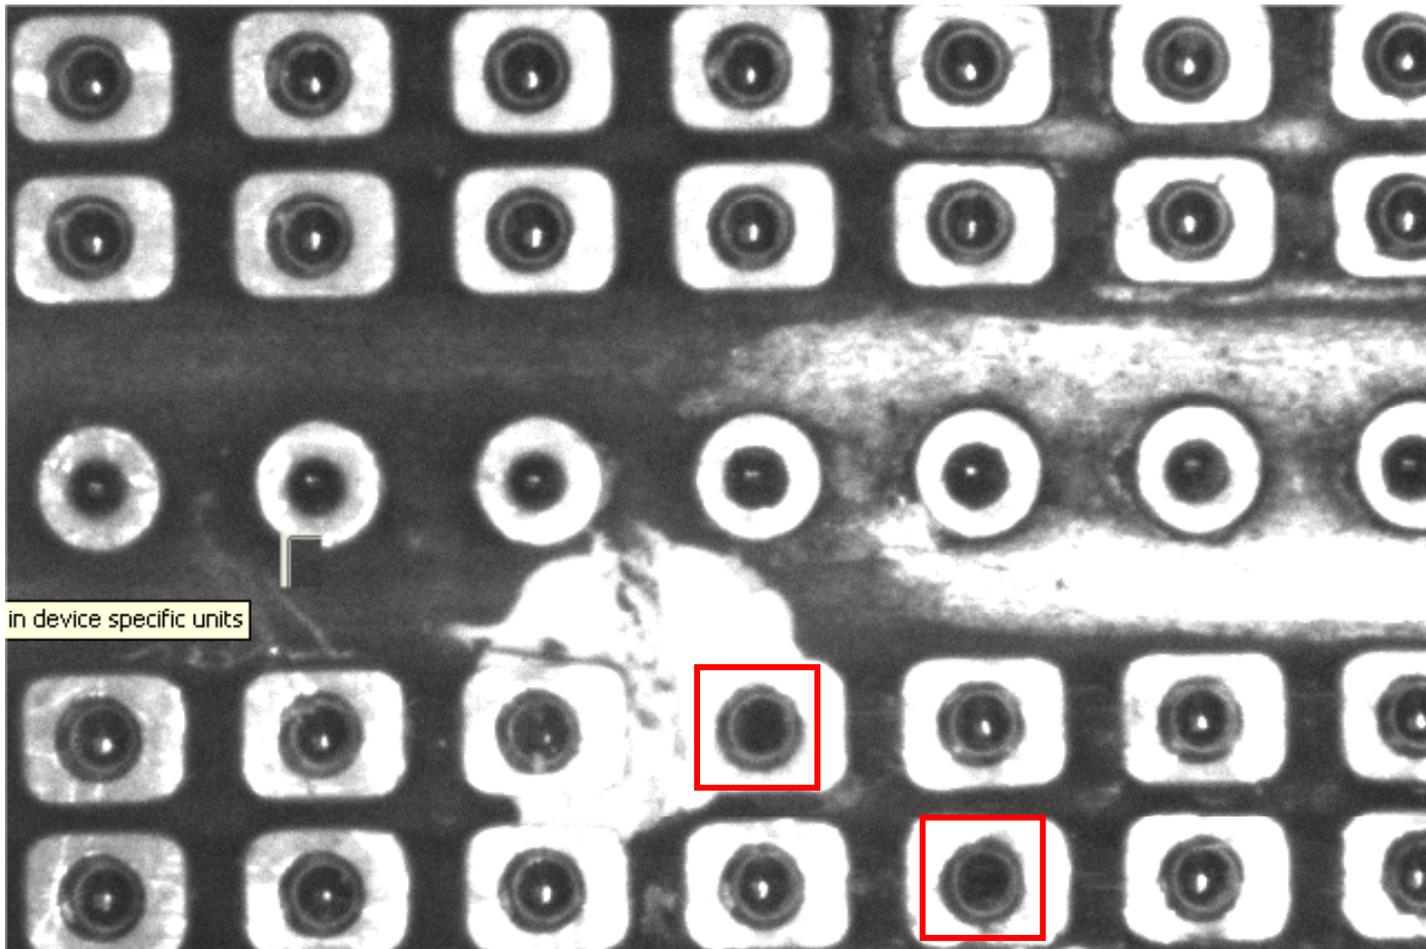
Geometric limits to pin-in-hole testing

- For given PCBA dimension there is a minimum camera height for a given field of view size.
- For this board and a 20mm FOV the minimum camera height is 360mm!

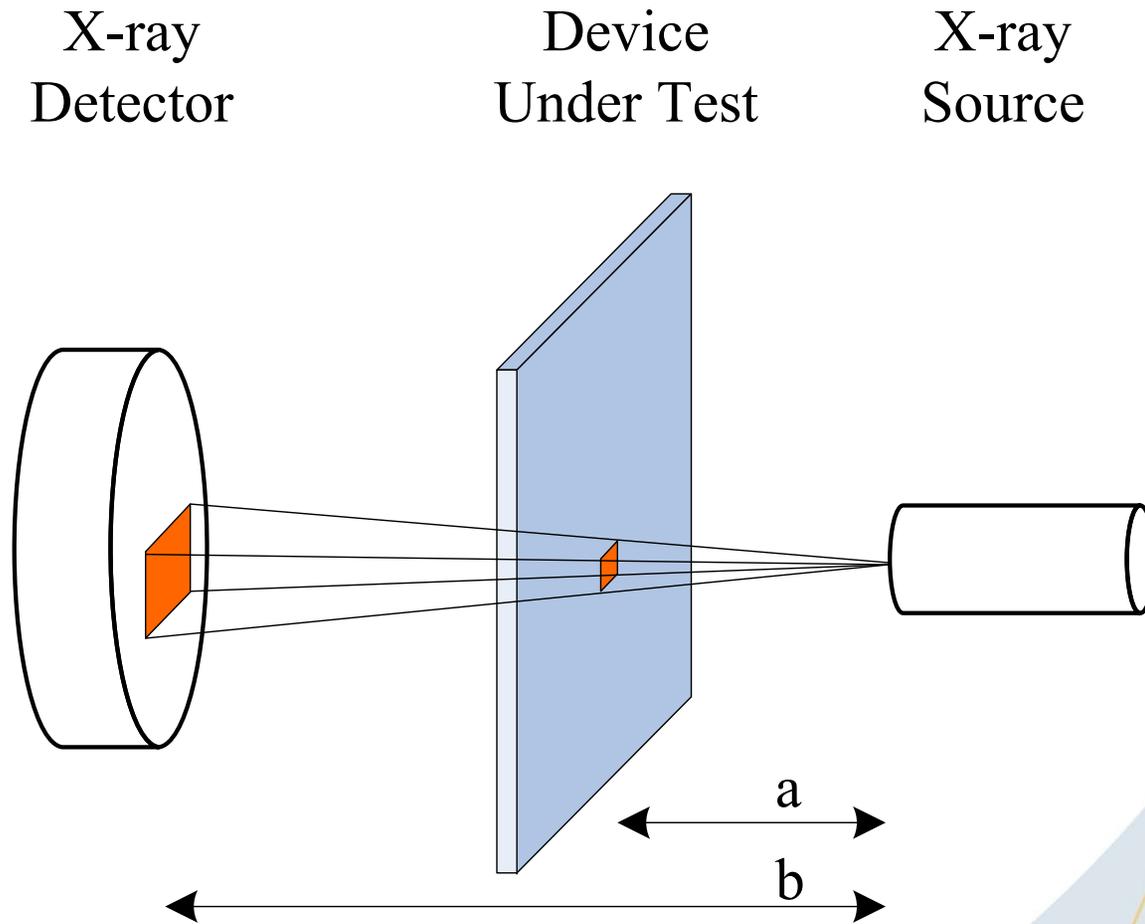
Robotic X-ray Inspection (RXI)

- The DUT is held in a fixed position.
- The X-ray source and detector are mounted within robotic heads on either side of the DUT.
- Uses a relatively low cost, highly reliable, 60KV X-ray source with a larger focal spot size.
- Uses transmissive radiography rather than laminography for routine inspection.
- Includes a full colour AOI system in each head to give a fully comprehensive test.

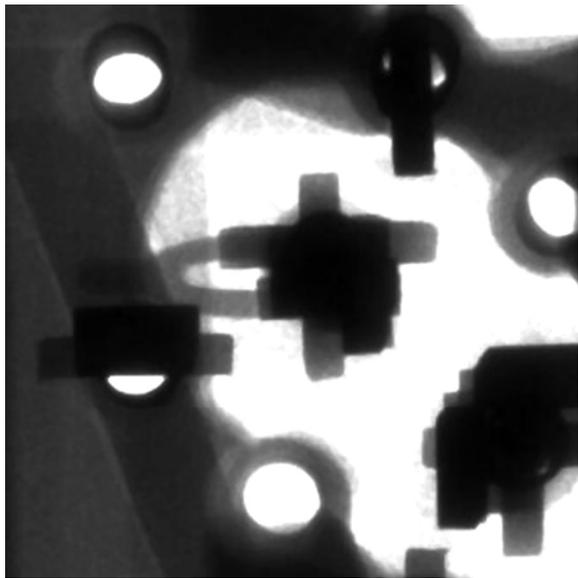
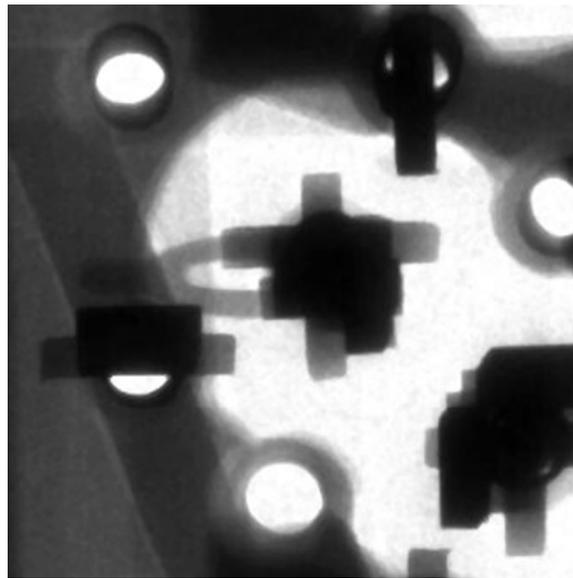
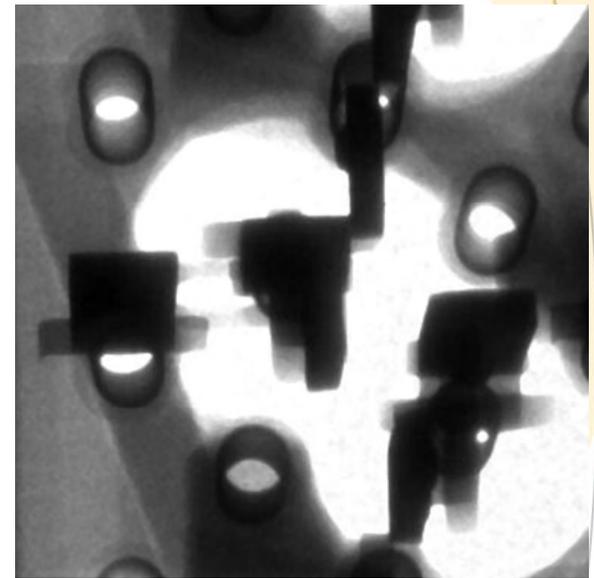
Effect of source energy on image contrast

40KV Energy,
3.4s exposure

60KV Energy,
1s exposure

80KV Energy,
0.5s exposure

- X-ray penetration increases with the third power of the X-ray photon energy.
- Image contrast degrades increasing X-ray energy.
- Exposure windows for pressing defect detection become tighter as the X-ray energy increases.
- Pressing defects in the thickest backplane samples can be imaged at 60keV.
- 50-60keV represents a good working compromise over the whole range of backplane samples tested.
- A tungsten anode source will also produce characteristic ($K\alpha_1$ and $K\alpha_2$) X-rays at 58-60 keV improving luminescence.

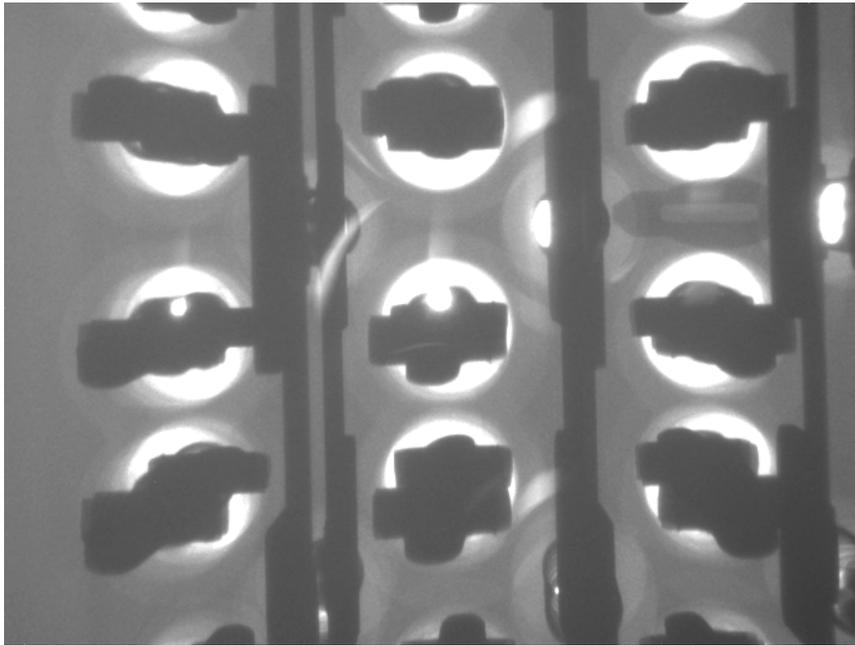
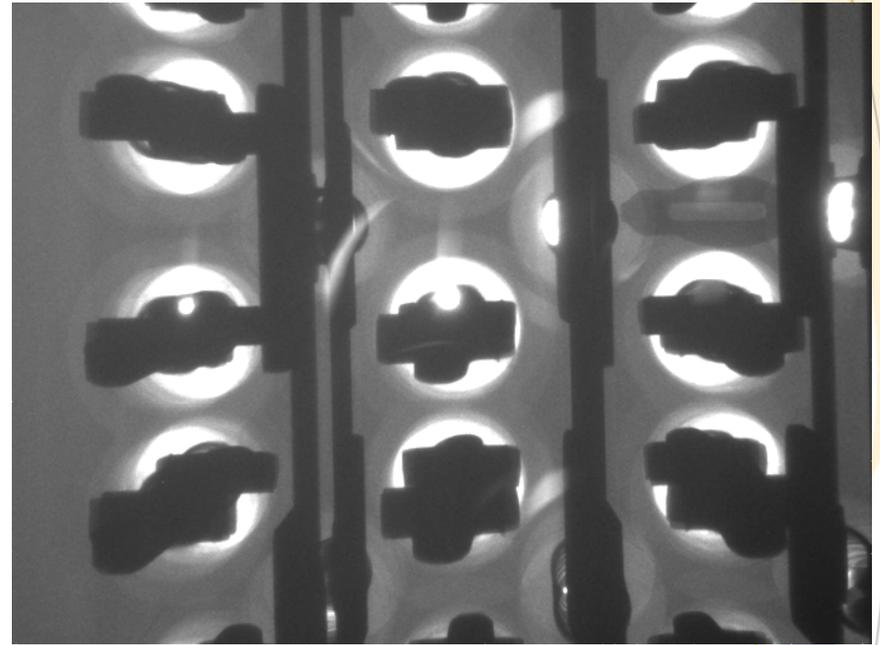
Effect of focal spot diameter on image resolution

50µm Focal Spot Diameter

20µm Focal Spot Diameter

- Parallax issues within the backplane interconnects limit how close the source can be to the DUT surface.
- It is the solid angle subtended by the source focal spot at the DUT surface that determines image resolution.
- All backplane pressing defects can be detected with a 50 μ m focal spot diameter.
- Solder joint integrity, BGA interconnects, and counterfeit component detection can all be done with a 20 μ m focal spot diameter.

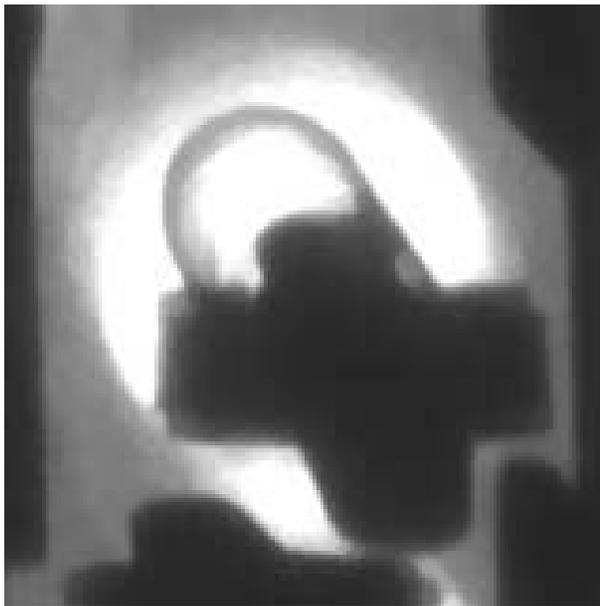
Pin missing on one
side of board

BAD

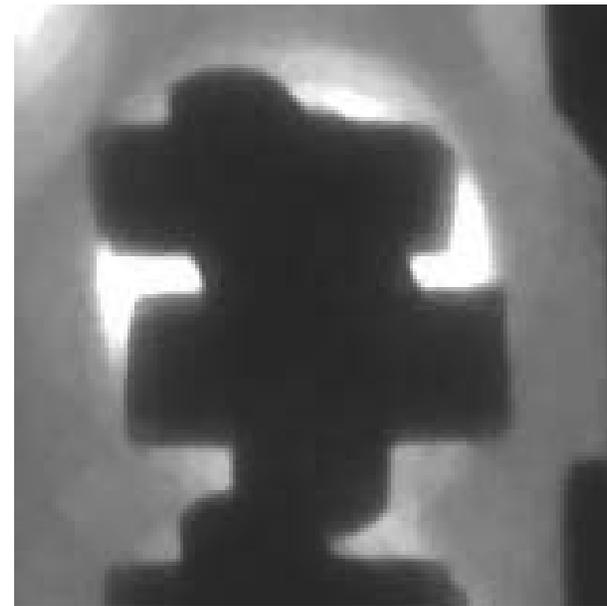
Detail image of FCI Zipline connectors sharing via barrels

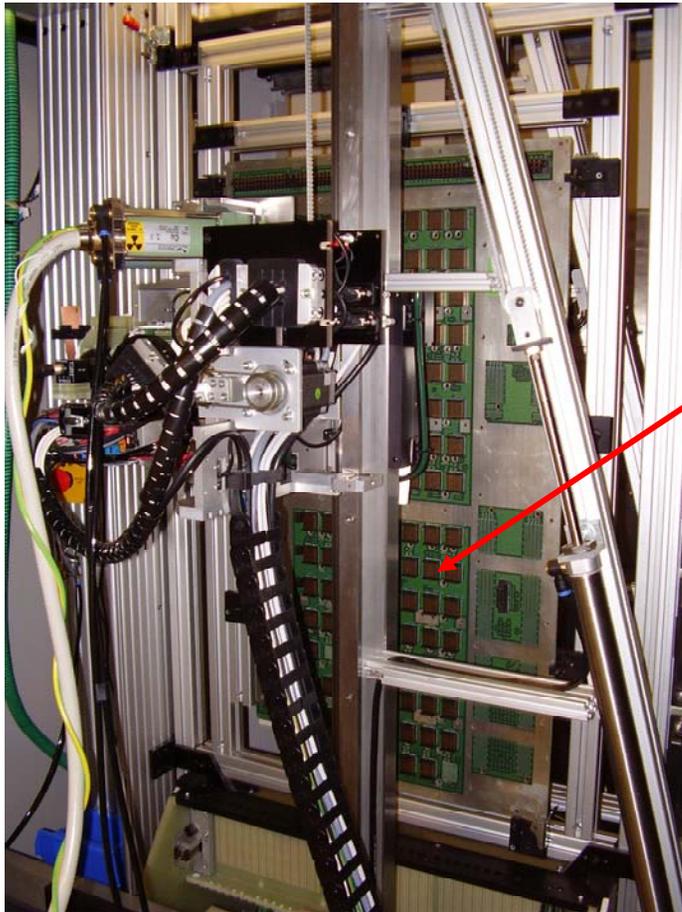
Why is automatic test vital?

- One faulty pin on one connector.
- 105 Connectors on each side.
- 420 X-ray images to inspect
