Reliability Study of Low Silver Alloy Solder Pastes

Jennifer Nguyen, David Geiger and Murad Kurwa

Flextronics International

Abstract

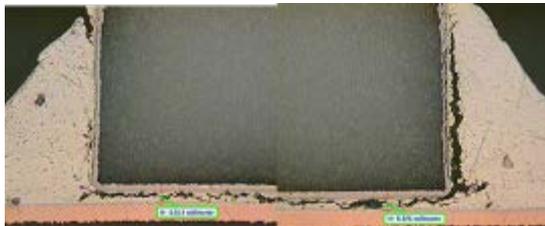
SAC305

- 2512 Resistor
